# CLOSURE REQUEST REPORT

**Paduca Breaks CGF**  
**Lea County, New Mexico**  
**Incident Number nAPP2616738118**

**Prepared for:**  
**DBM Pipeline LLC**

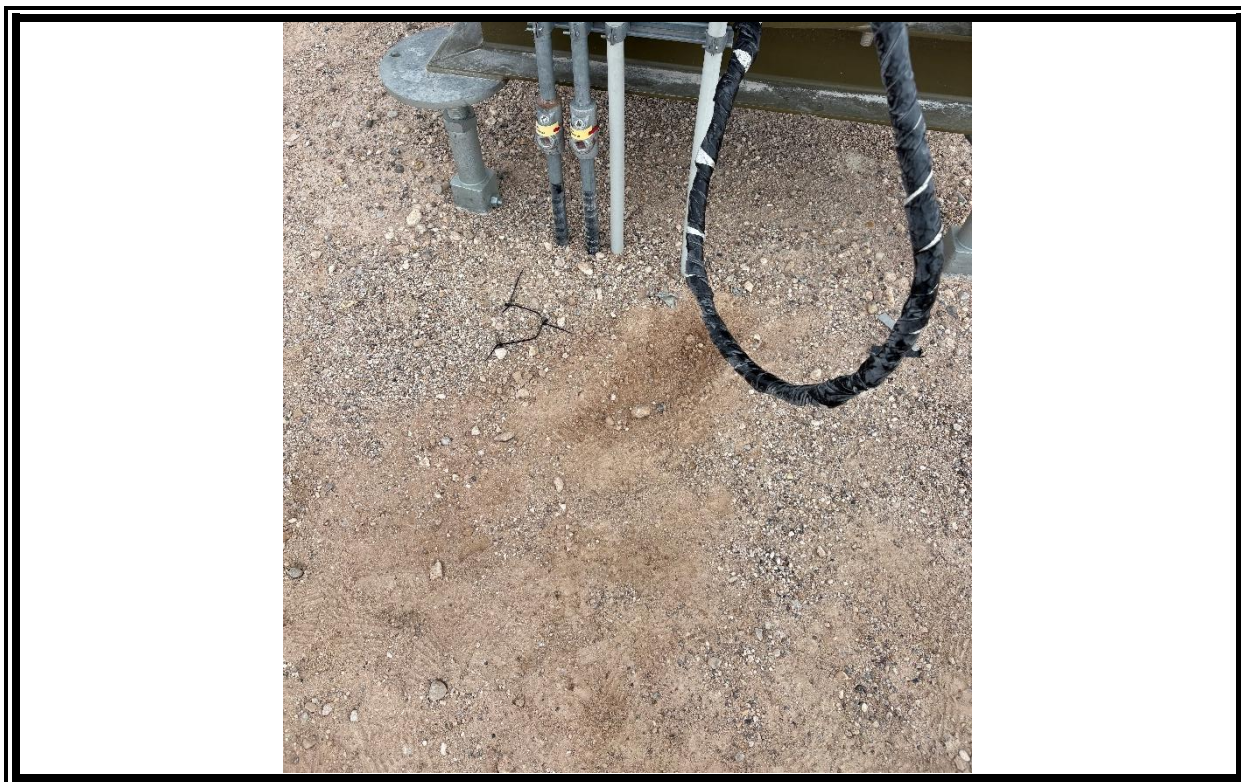
On February 10, 2026, it was discovered that a small burb from the fuel gas pilot line resulted in approximately 0.0003 barrels (bbls) of condensate to be released onto the production pad. No fluids were recovered following the release. DBM immediately notified the New Mexico Oil Conservation Division (NMOCD) of the release on a Notification of Release Form (NOR Form). On March 18, 2026, DBM reported the release to the New Mexico Oil Conservation Division (NMOCD) on a Release Notification and Corrective Action Form C-141 (Form C-141). On March 20, 2026, Etech mapped the observed extent of the release, hereafter referenced as the Area of Concern (AOC), which is presented on Figure 2 in Appendix A.

View of the site following discovery of the release. (Photo Provided by WES)

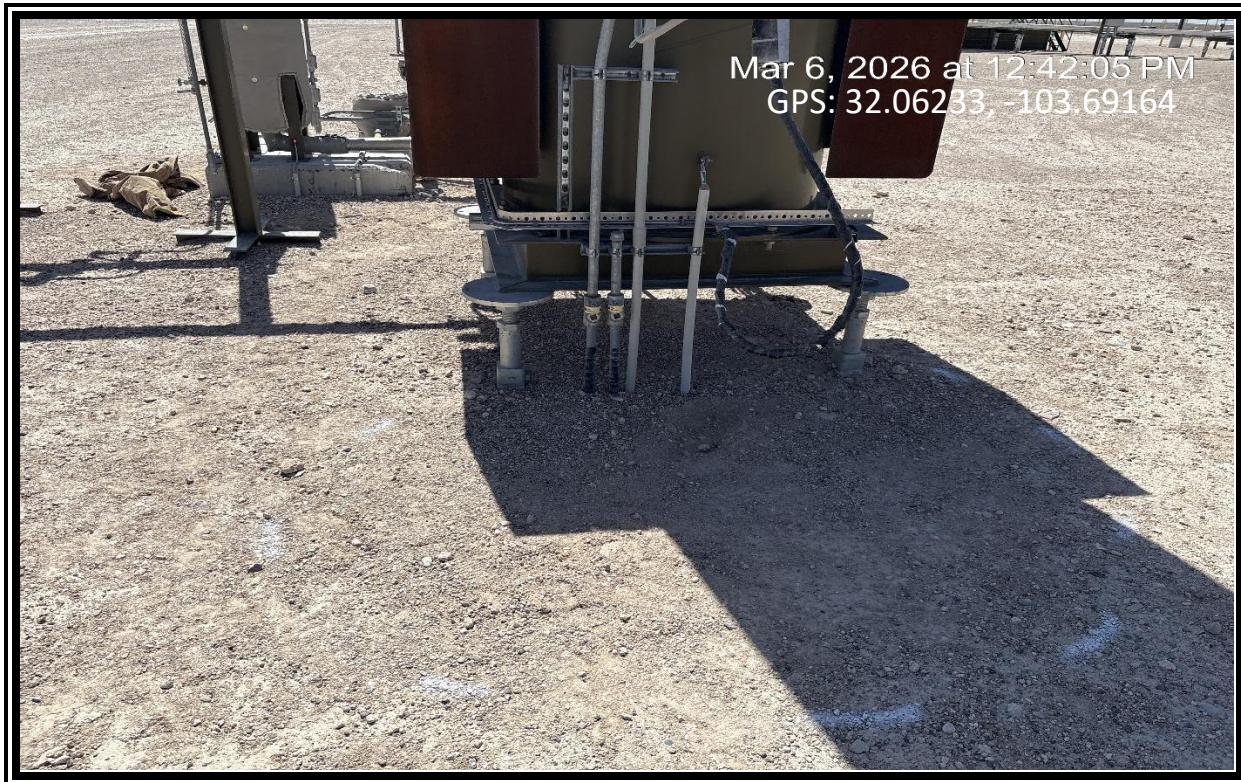
View of the site during confirmation sampling activities.

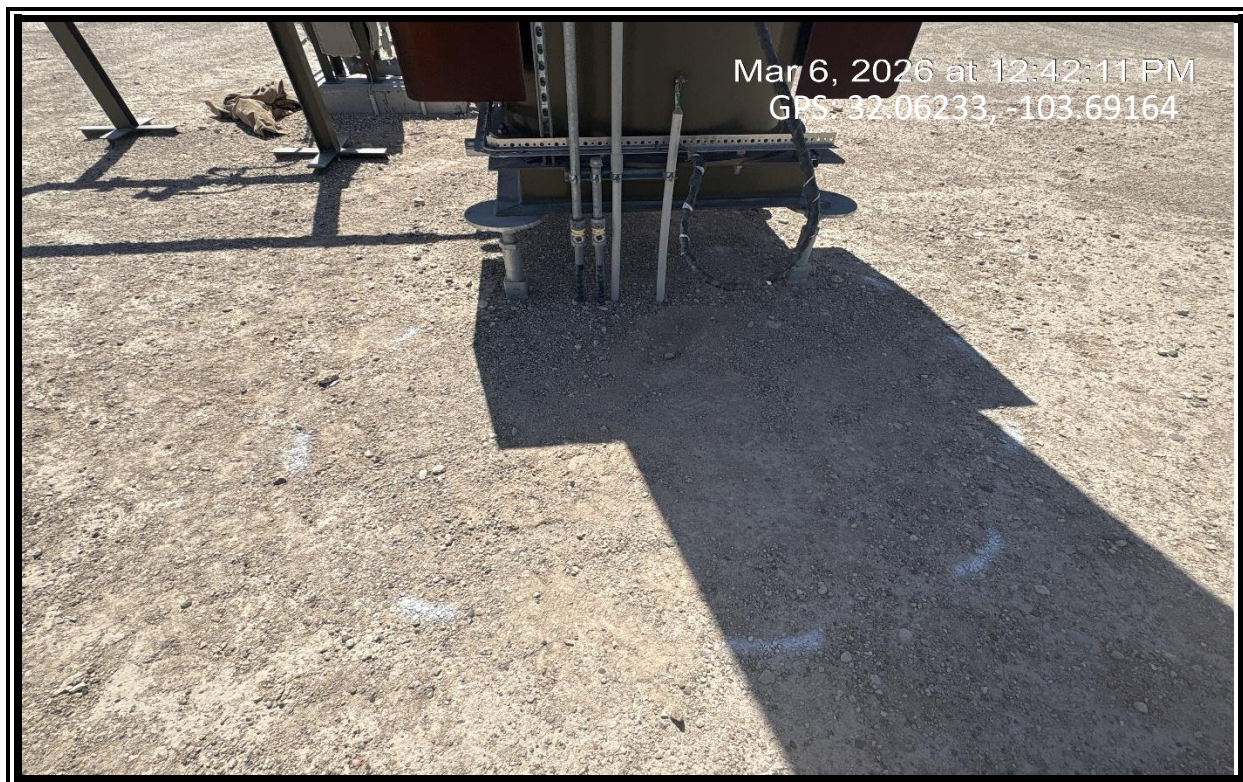
View of the site during confirmation sampling activities.
