SUBJECT: Liner Inspection and Closure Report for Hognose Viper 23 CTB 1 – July 8, 2026 Site Visit

Incident ID: nAPP2607145140, nAPP2608230038, nAPP2616126546  
Facility ID (Name): fAPP2527329875 (HOGNOSE VIPER 23 CTB 1)  
Facility Location: Unit D of Section 23, Township 23 South, Range 33 East, New Mexico  
Facility GPS Coordinates: 32.2945532, -103.5476102  
Lea County, New Mexico

# Environmental Liner Inspection Field Notes & Photolog Report

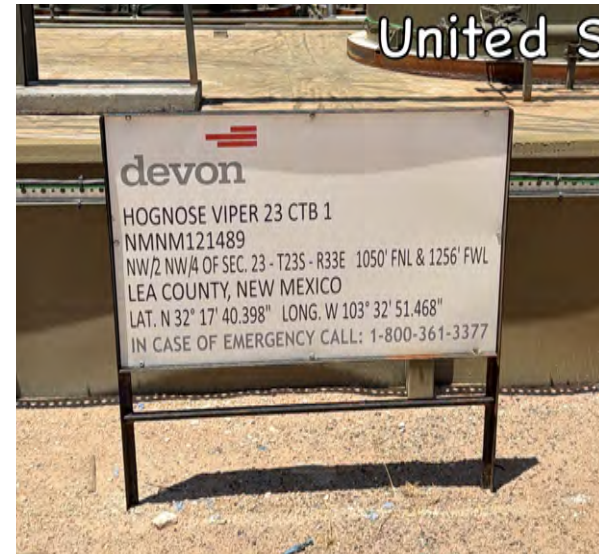
Liner Inspection 7/8/2026

- Arrive on site, check for hazards
- Walk containment, visual observations of liner to check for any rips, tears, cuts, or abrasions potential to lead to a breach of containment
- Take photos around containment at every cardinal direction, between tanks, under equipment, and congested areas.
- No signs of liner being compromised.
- Liner is clean and ready to be inspected.
- Liner integrity confirmed and passes inspection

- Visual observation of liner is complete.
- Liner integrity confirmed and passes inspection.
- Upload field notes and photos for field report for supporting documentation.
- No additional recommendations or further actions required.

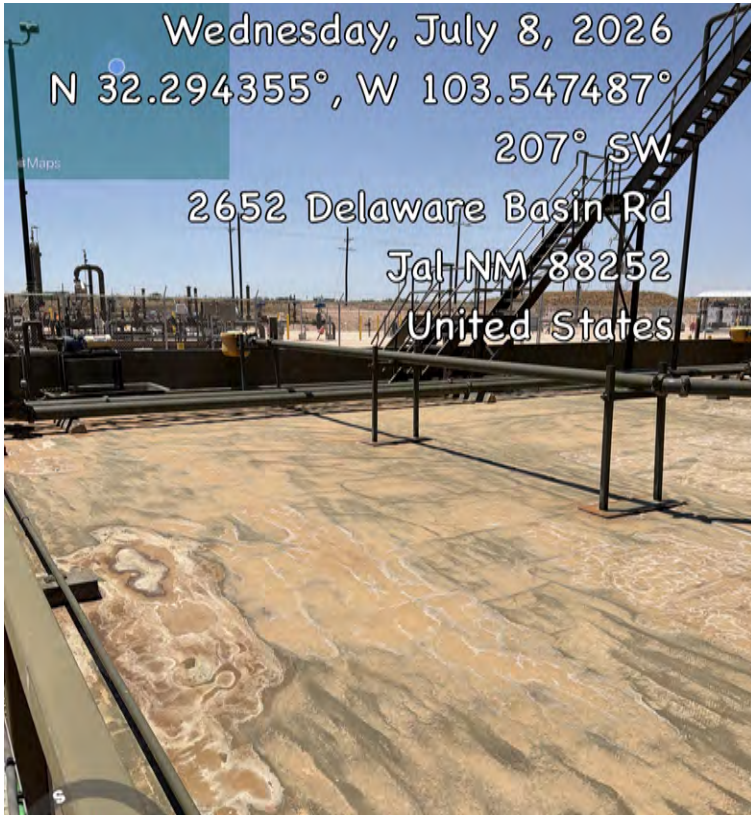
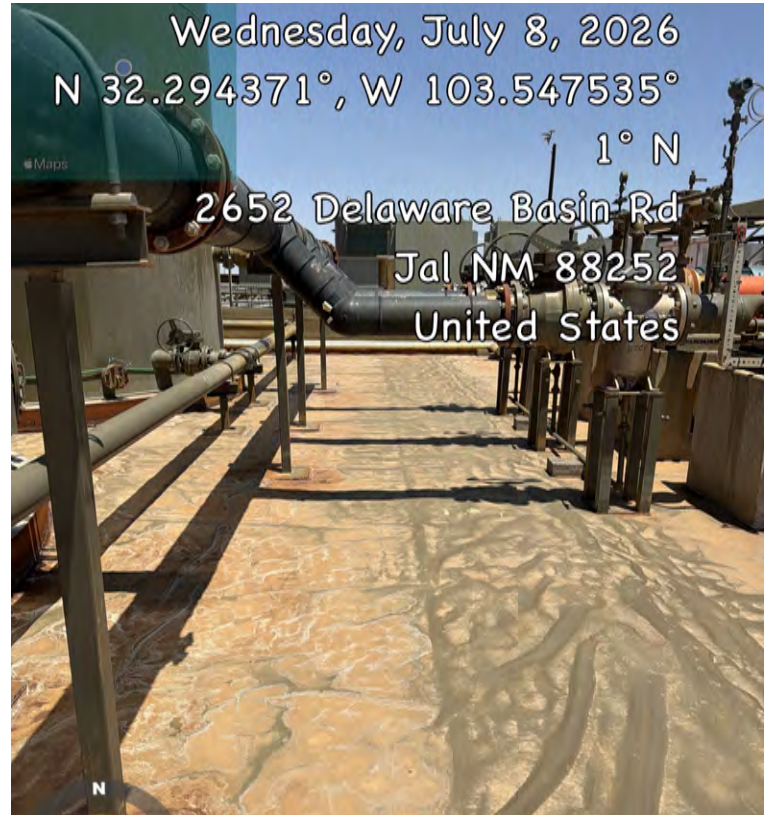
During the visit, KLJ personnel completed a visual inspection of the secondary containment to verify liner integrity. The liner was observed to be intact, with no visible signs of compromise. The inspection included assessments for perforations, rips, tears, or signs of weathering that could impact containment integrity. No issues were noted that would warrant repair or replacement. Photographic documentation is provided in the Liner Inspection Field Notes & Photolog Report (**Appendix A**).
