Re: **Remediation, Reclamation, and Revegetation Report  
Closure Report  
Jacinto Federal Com #040H Flare Release/Fire  
nAPP2612427247  
30-025-44152  
O-25-24S-34E  
Lea County, NM  
Private (Quail Ranch)**

ConocoPhillips  
Jacinto Federal Com #040H Flare Release/Fire  
Remediation, Reclamation, and Revegetation Report  
Closure Report

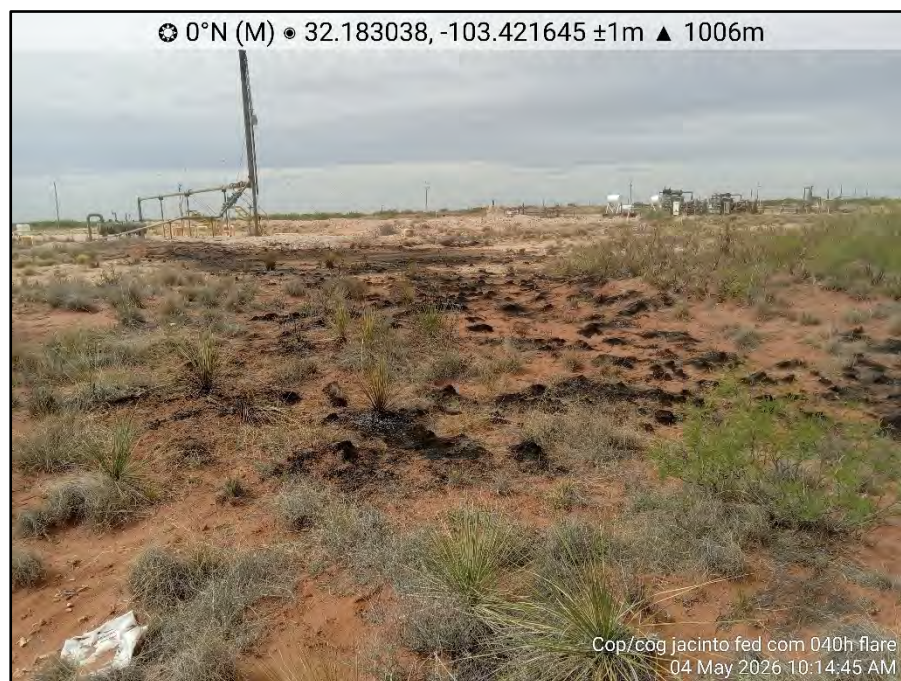
Photo 2: View of the release footprint and fire area.

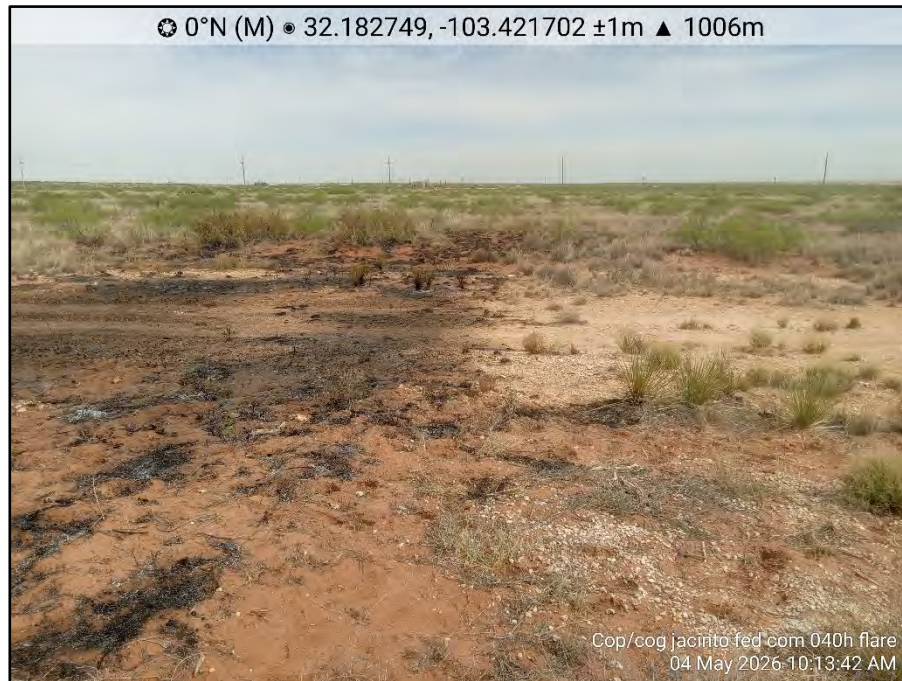
Photo 3: View of the release footprint and fire area.

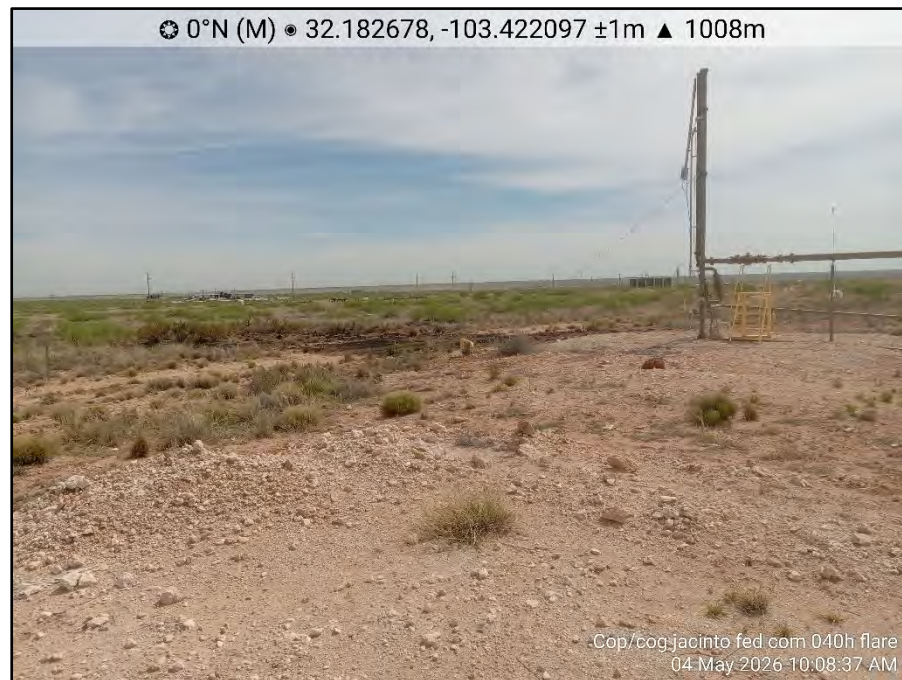
Photo 4: View of the release footprint and fire area, with flare shown.

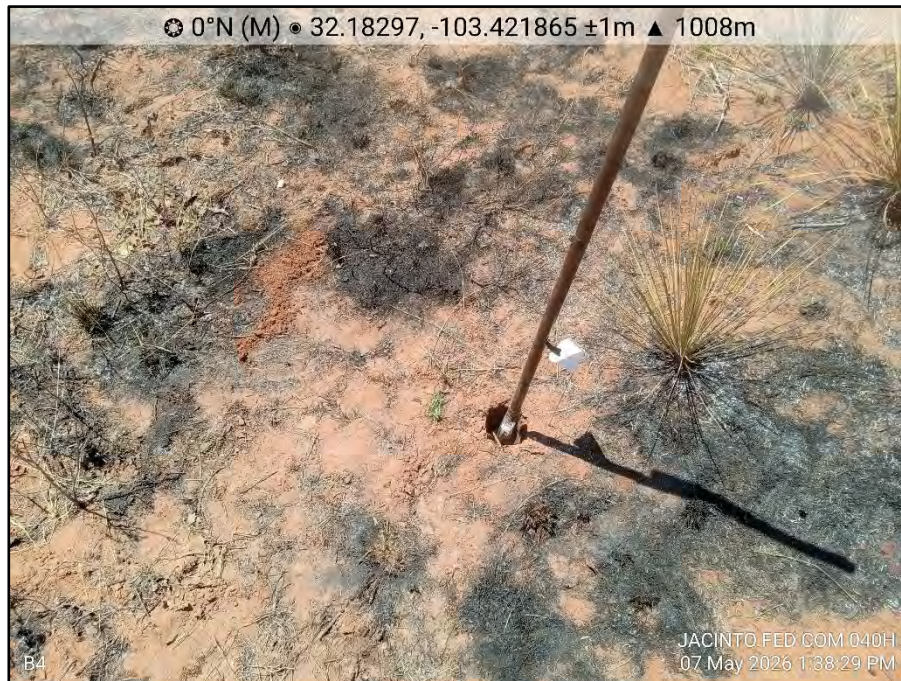
Photo 5: View of the delineation sampling activities and surface conditions.

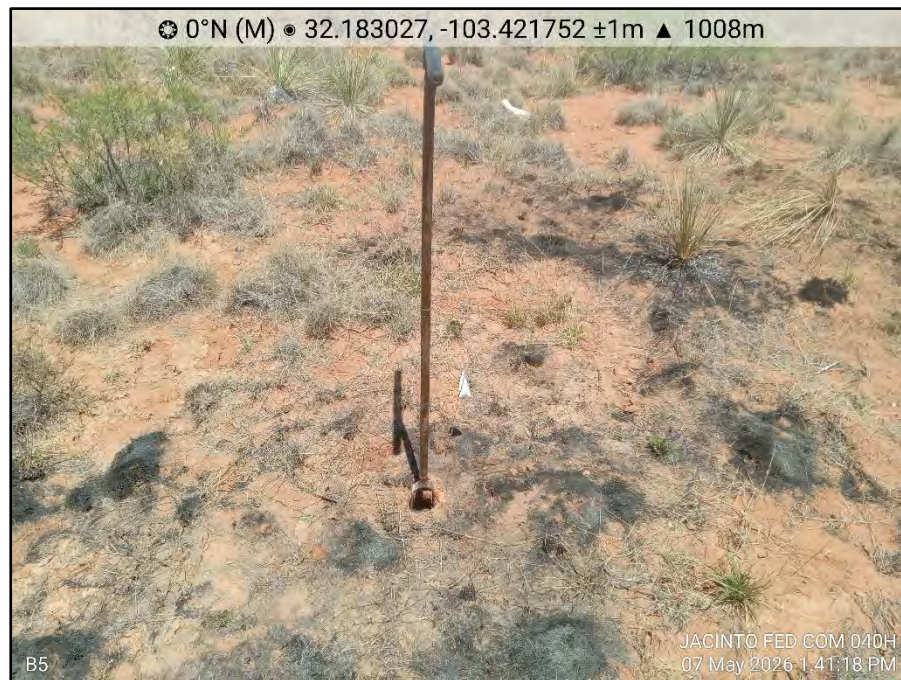
Photo 6: View of the delineation sampling activities and surface conditions.

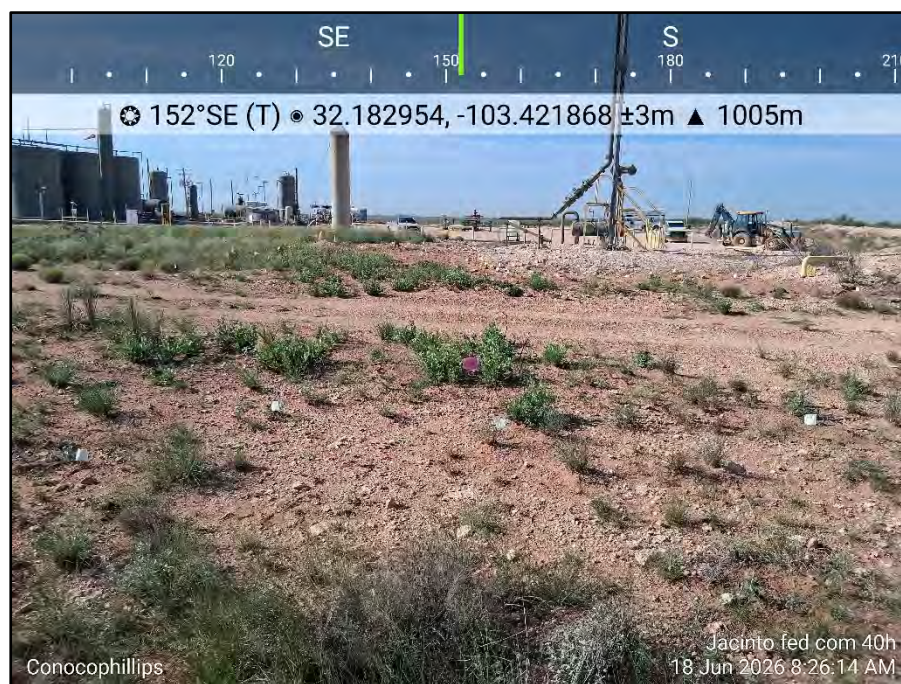
Photo 8: View of the area proposed for scrape. Vegetation present.

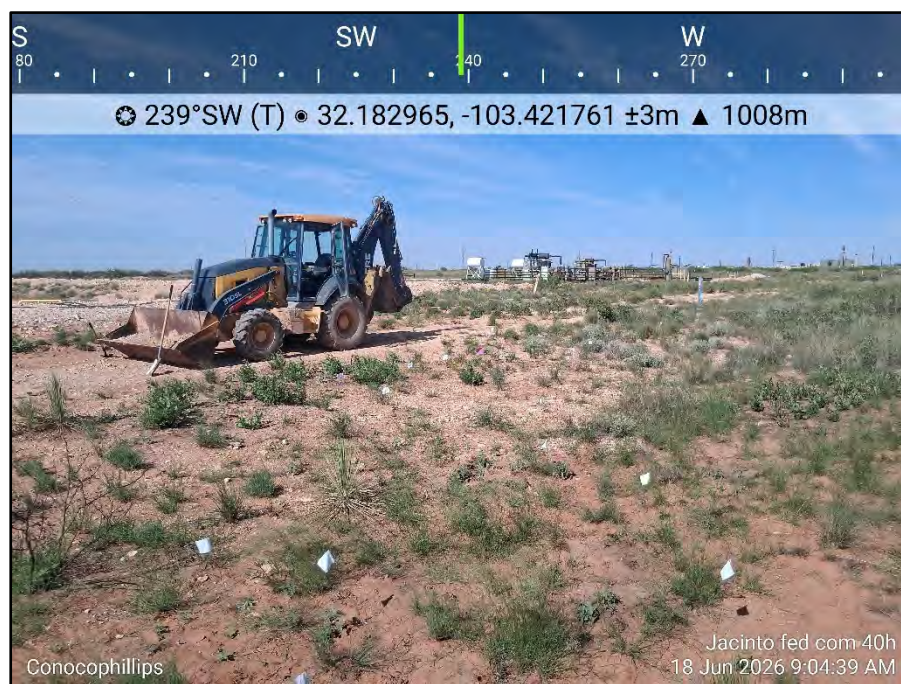
Photo 10: View of the area proposed for rake and shovel. Vegetation present.

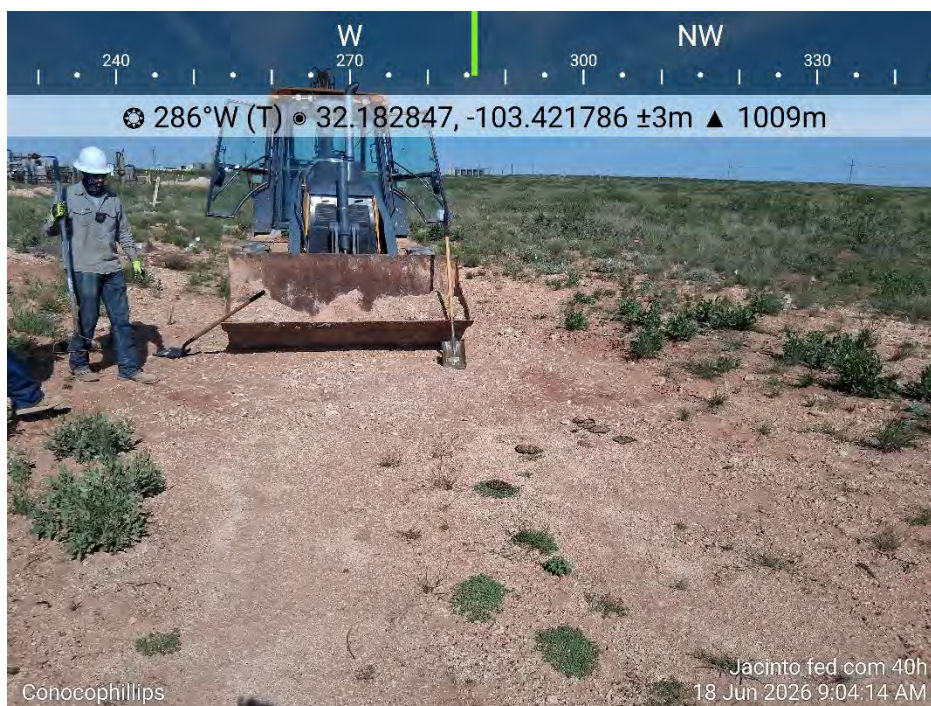
Photo 11: View of rake and shovel work in progress. Backhoe bucket used for soil transport.

The analytical data from the assessment was well below reclamation requirements of 600 mg/kg for chlorides and 100 mg/kg for TPH. ConocoPhillips elected to conduct a scrape of the impacted area to remove any surficial discoloration. During the surface scrape, personnel were cautious around existing vegetation as the release had not substantially impacted the established vegetation. Therefore, based on 19.15.29.13 NMAC, areas disturbed by the remediation have been reclaimed, as the responsible party has restored the impacted surface areas to the condition that existed prior to the release.

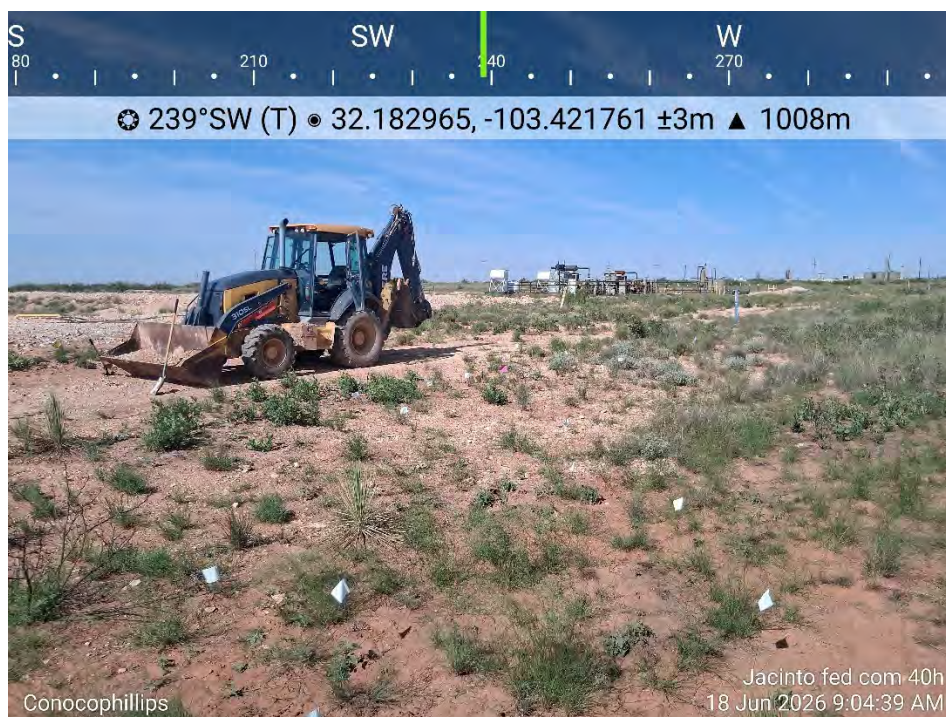
Photo 12: View of rake and shovel work in progress. Backhoe bucket used for soil transport.

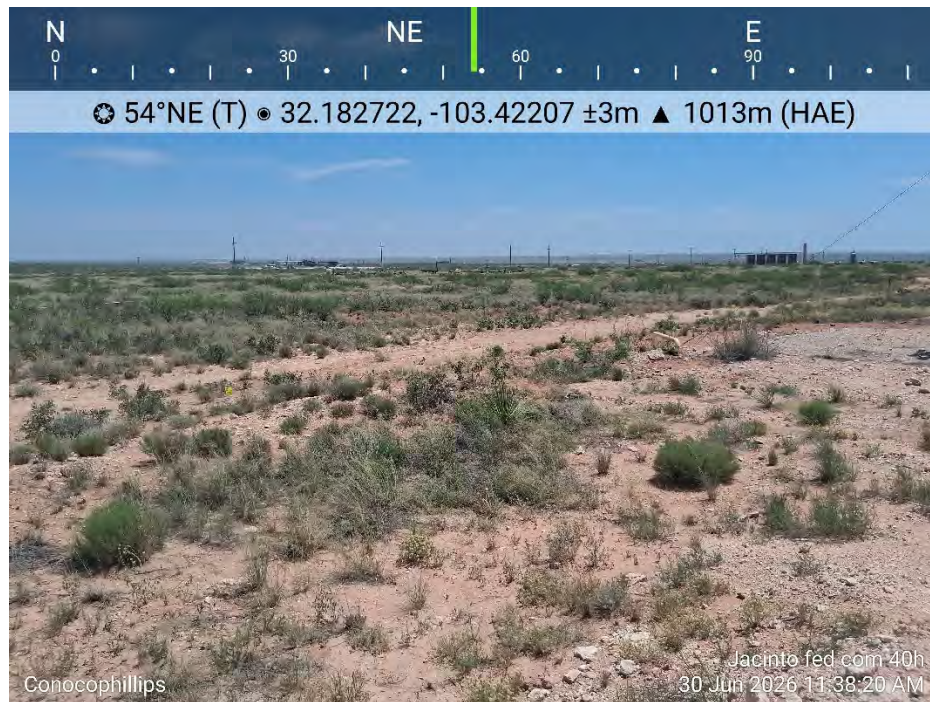
Photo 15: View of the area post-hand rake. Vegetation present.
