- An equipment failure involving a separator at the Queen 23/24 WOOP Federal Com #1H Battery was discovered on November 28, 2023. The equipment reportedly flooded following a power failure at the air compressor. The incident is documented under OCD Incident No. nAPP2334726230.

Following review of the June 3, 2024, denial and the deficiencies identified in the previous remediation work, Diamondback Disposal Services treated the site as if it were a newly reported release for remediation purposes. The original release and sampling information was used to accurately relocate the affected area, and the site characterization, delineation, excavation, and confirmation sampling process was restarted from the beginning.

MEWBOURNE OIL CO  
QUEEN 23/24 WOOP FED COM #1H  
BATTERY  
Incident #nAPP2334726230  
32.198439, -104.060189 NAD83  
NMNM 077005, 016332, 057252

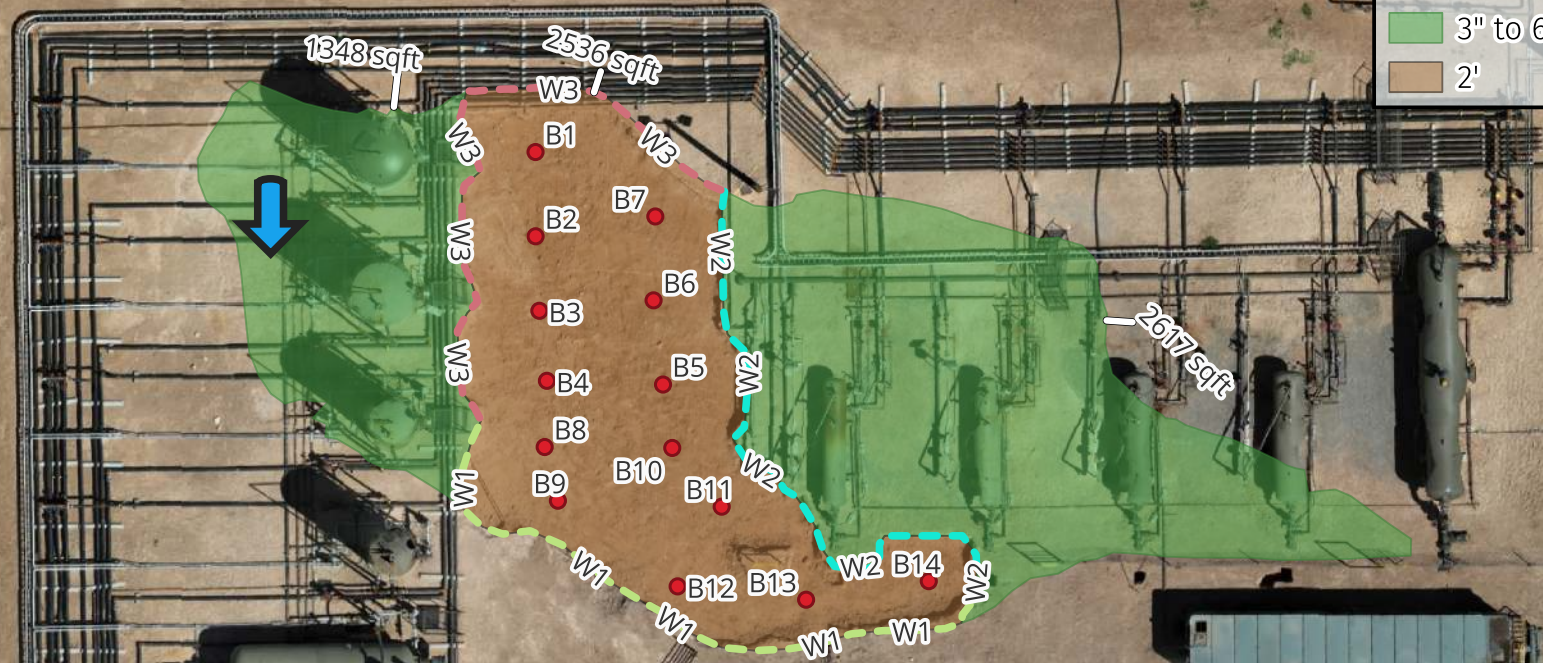
Map Contents:  
Excavation Base Location  
Sidewall Sample Location

- ↓ Release Point
- Excavation Base "B"
- W1
- W2
- W3
- Excavation
  - 3" to 6"
  - 2'

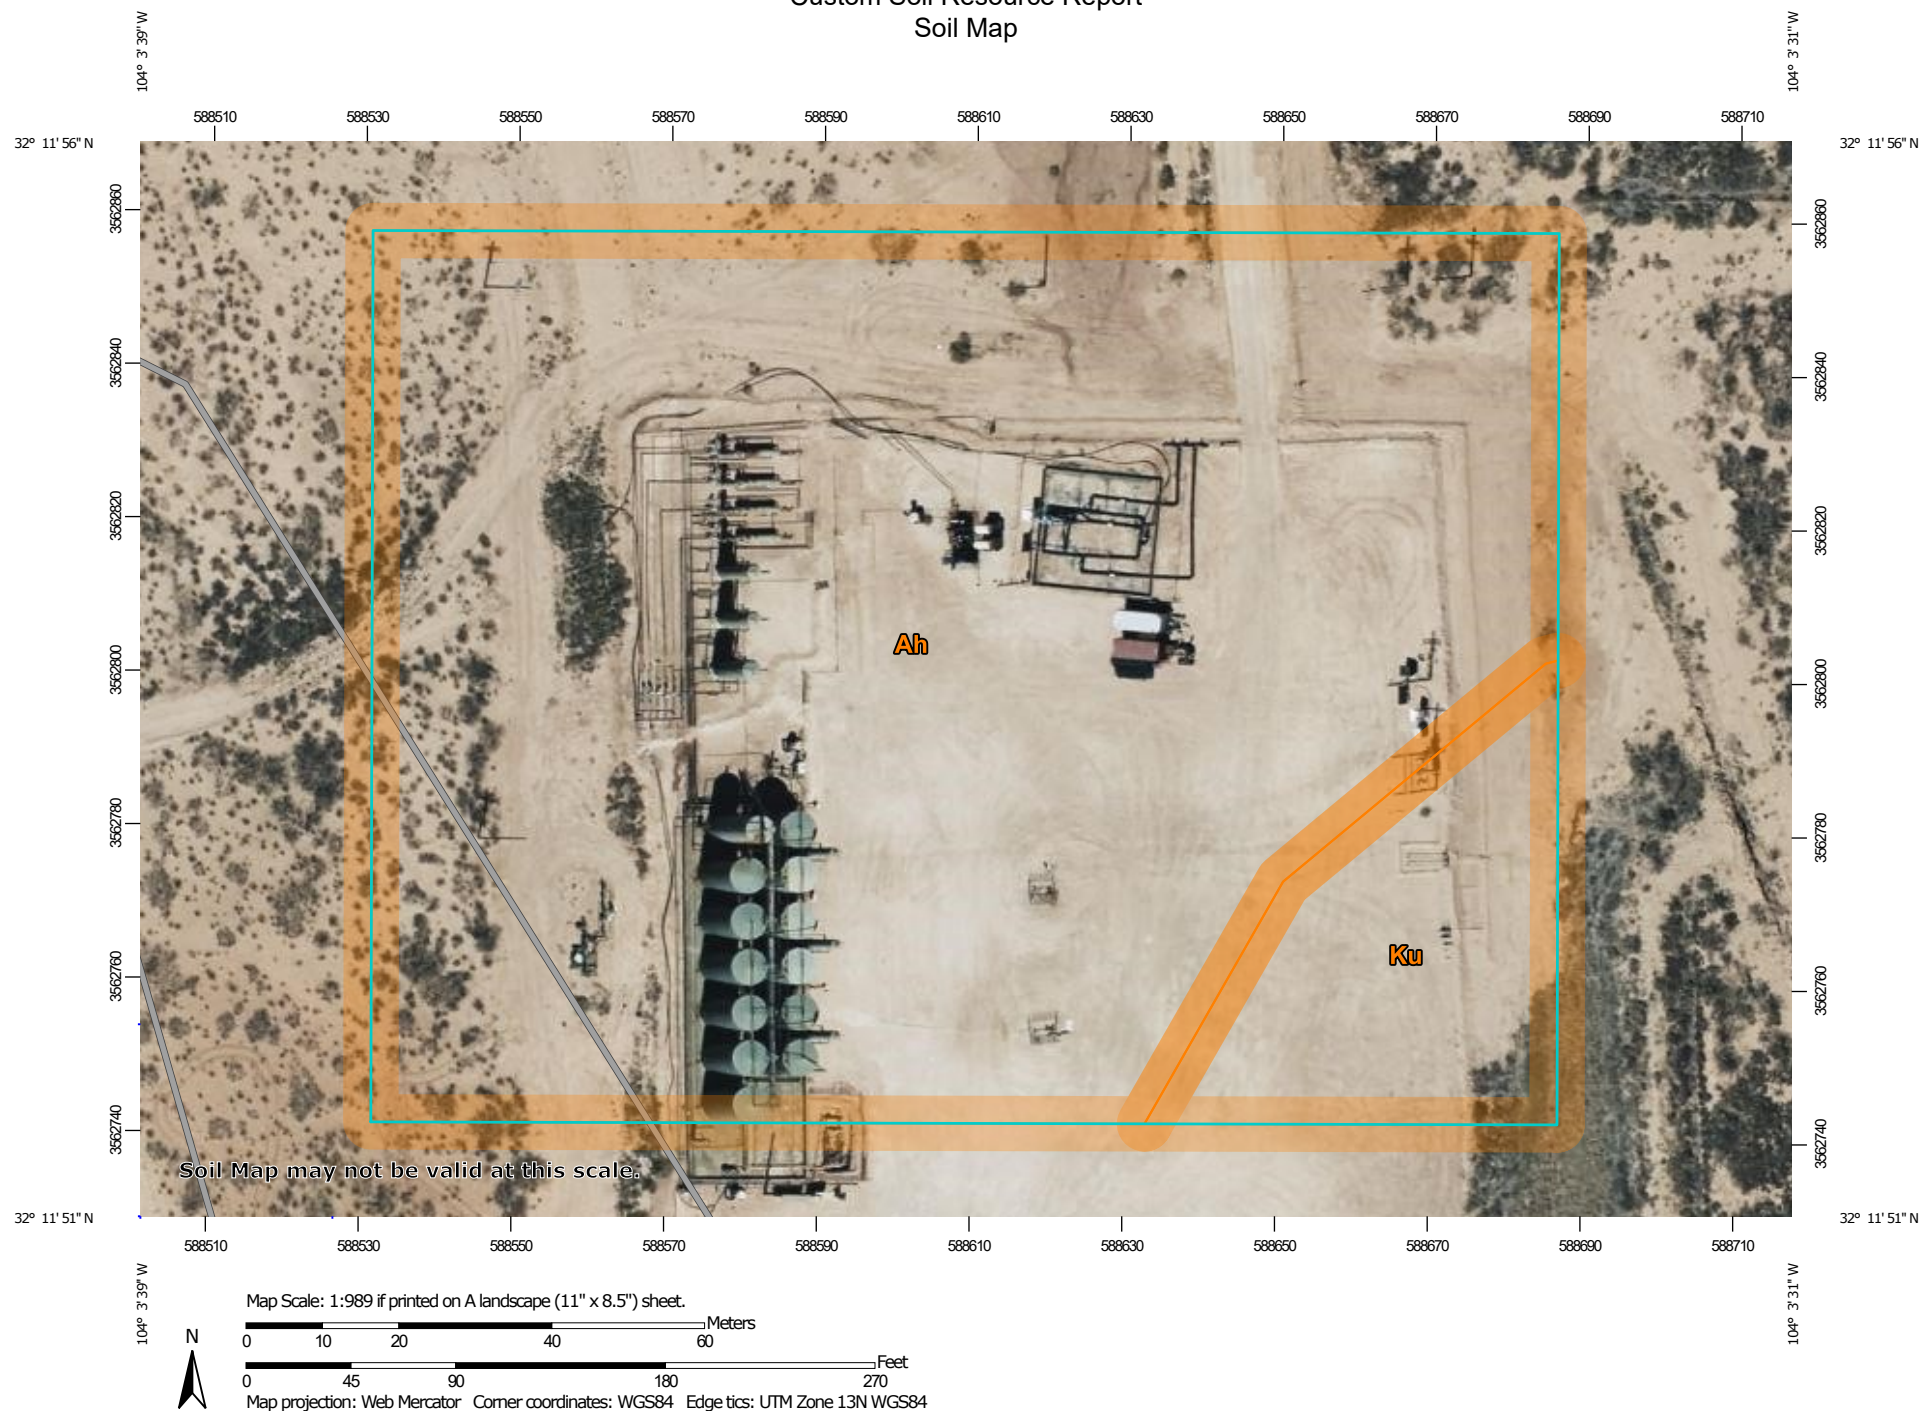
# Custom Soil Resource Report Soil Map

The soil map section includes the soil map for the defined area of interest, a list of soil map units on the map and extent of each map unit, and cartographic symbols displayed on the map. Also presented are various metadata about data used to produce the map, and a description of each soil map unit.

Enlargement of maps beyond the scale of mapping can cause misunderstanding of the detail of mapping and accuracy of soil line placement. The maps do not show the small areas of contrasting soils that could have been shown at a more detailed scale.
