# UU LINE LEAK

## Remediation Summary & Closure Report

NMOCD Incident No. nAPP2218244166  
UL "B", Sec. 13, T17S, R34E  
32.84242°, -103.5129°  
Lea County, New Mexico

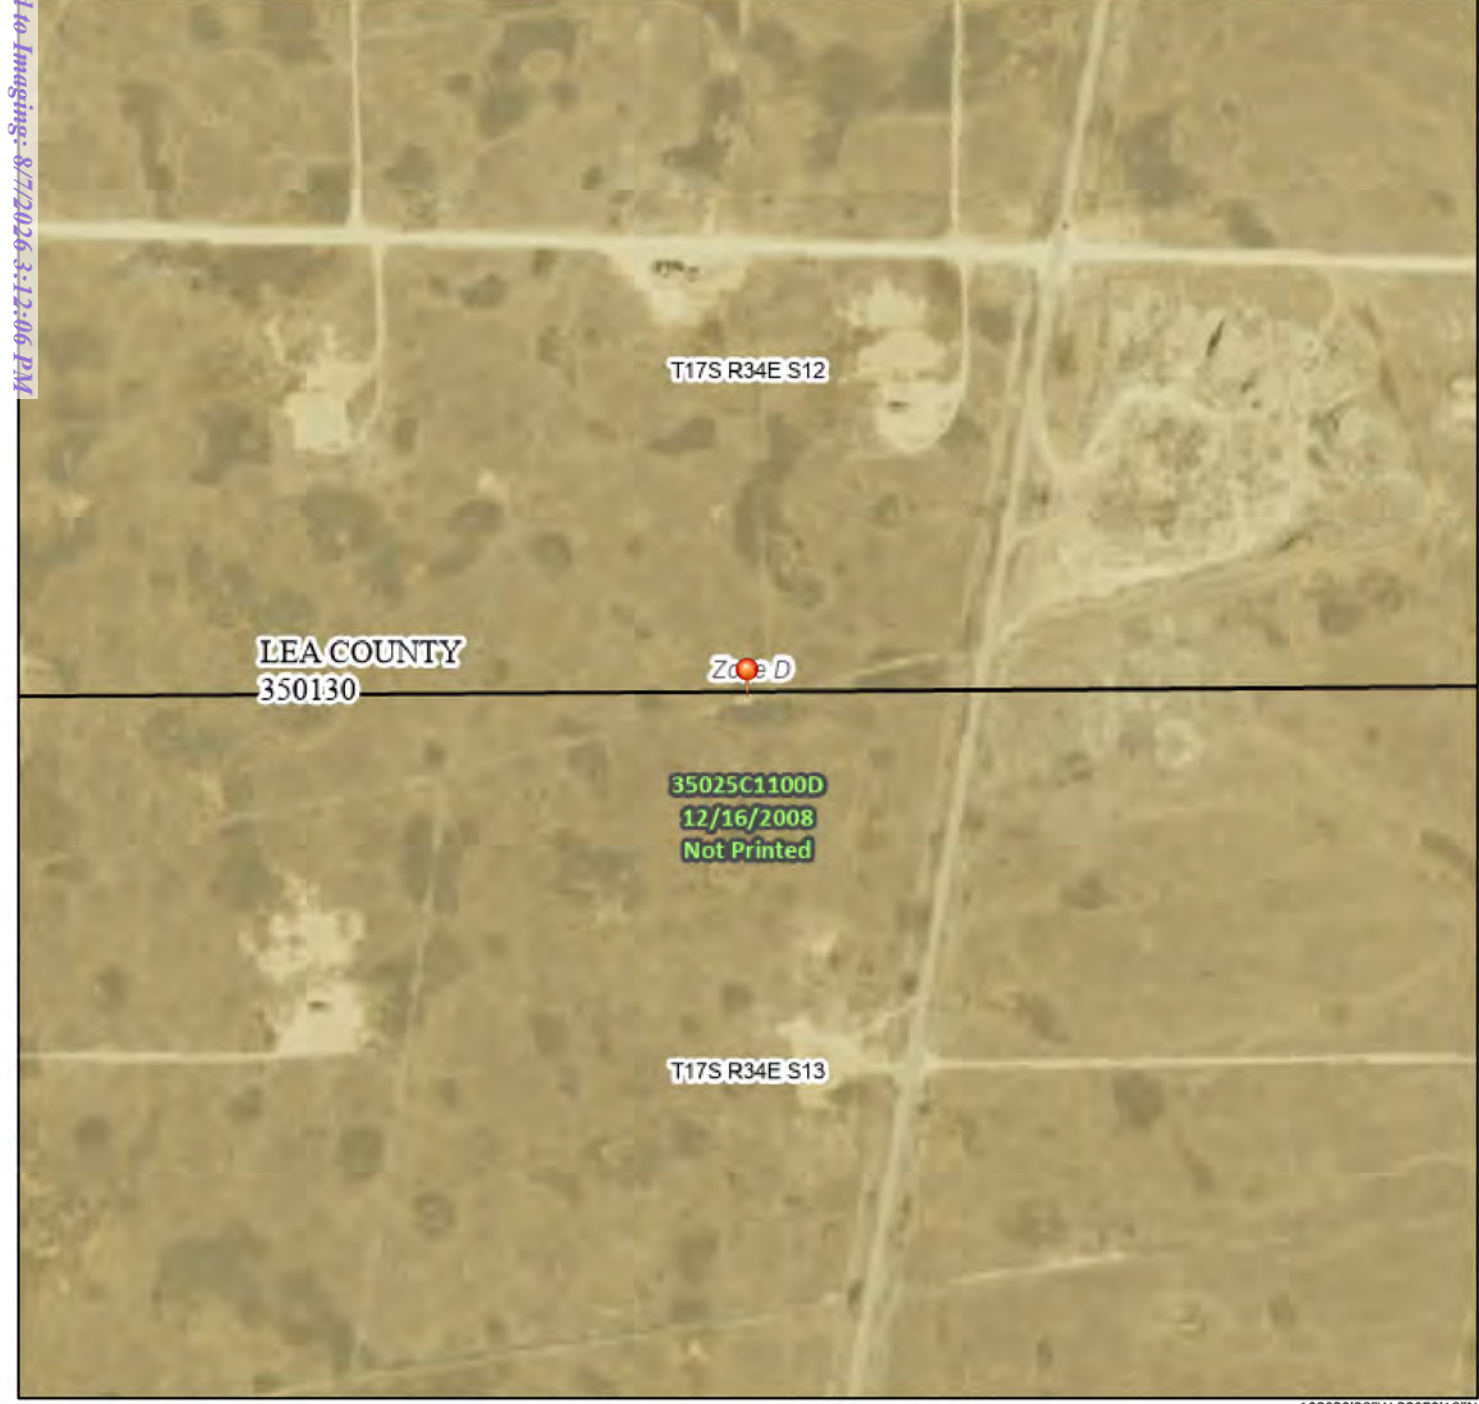
# National Flood Hazard Layer FIRMette

Review of flood map data published by the Federal Emergency Management Agency (FEMA) indicates the site is not located within a 100-year floodplain. A copy of the FEMA FIRMet Map can be found attached as Figure 4.
