## Merak 7 Fed Tank Battery

Incident ID nAPP2612528957

PREPARED BY:  
PIMA ENVIRONMENTAL SERVICES, LLC

## Site Assessment, Remediation, and Closure Report

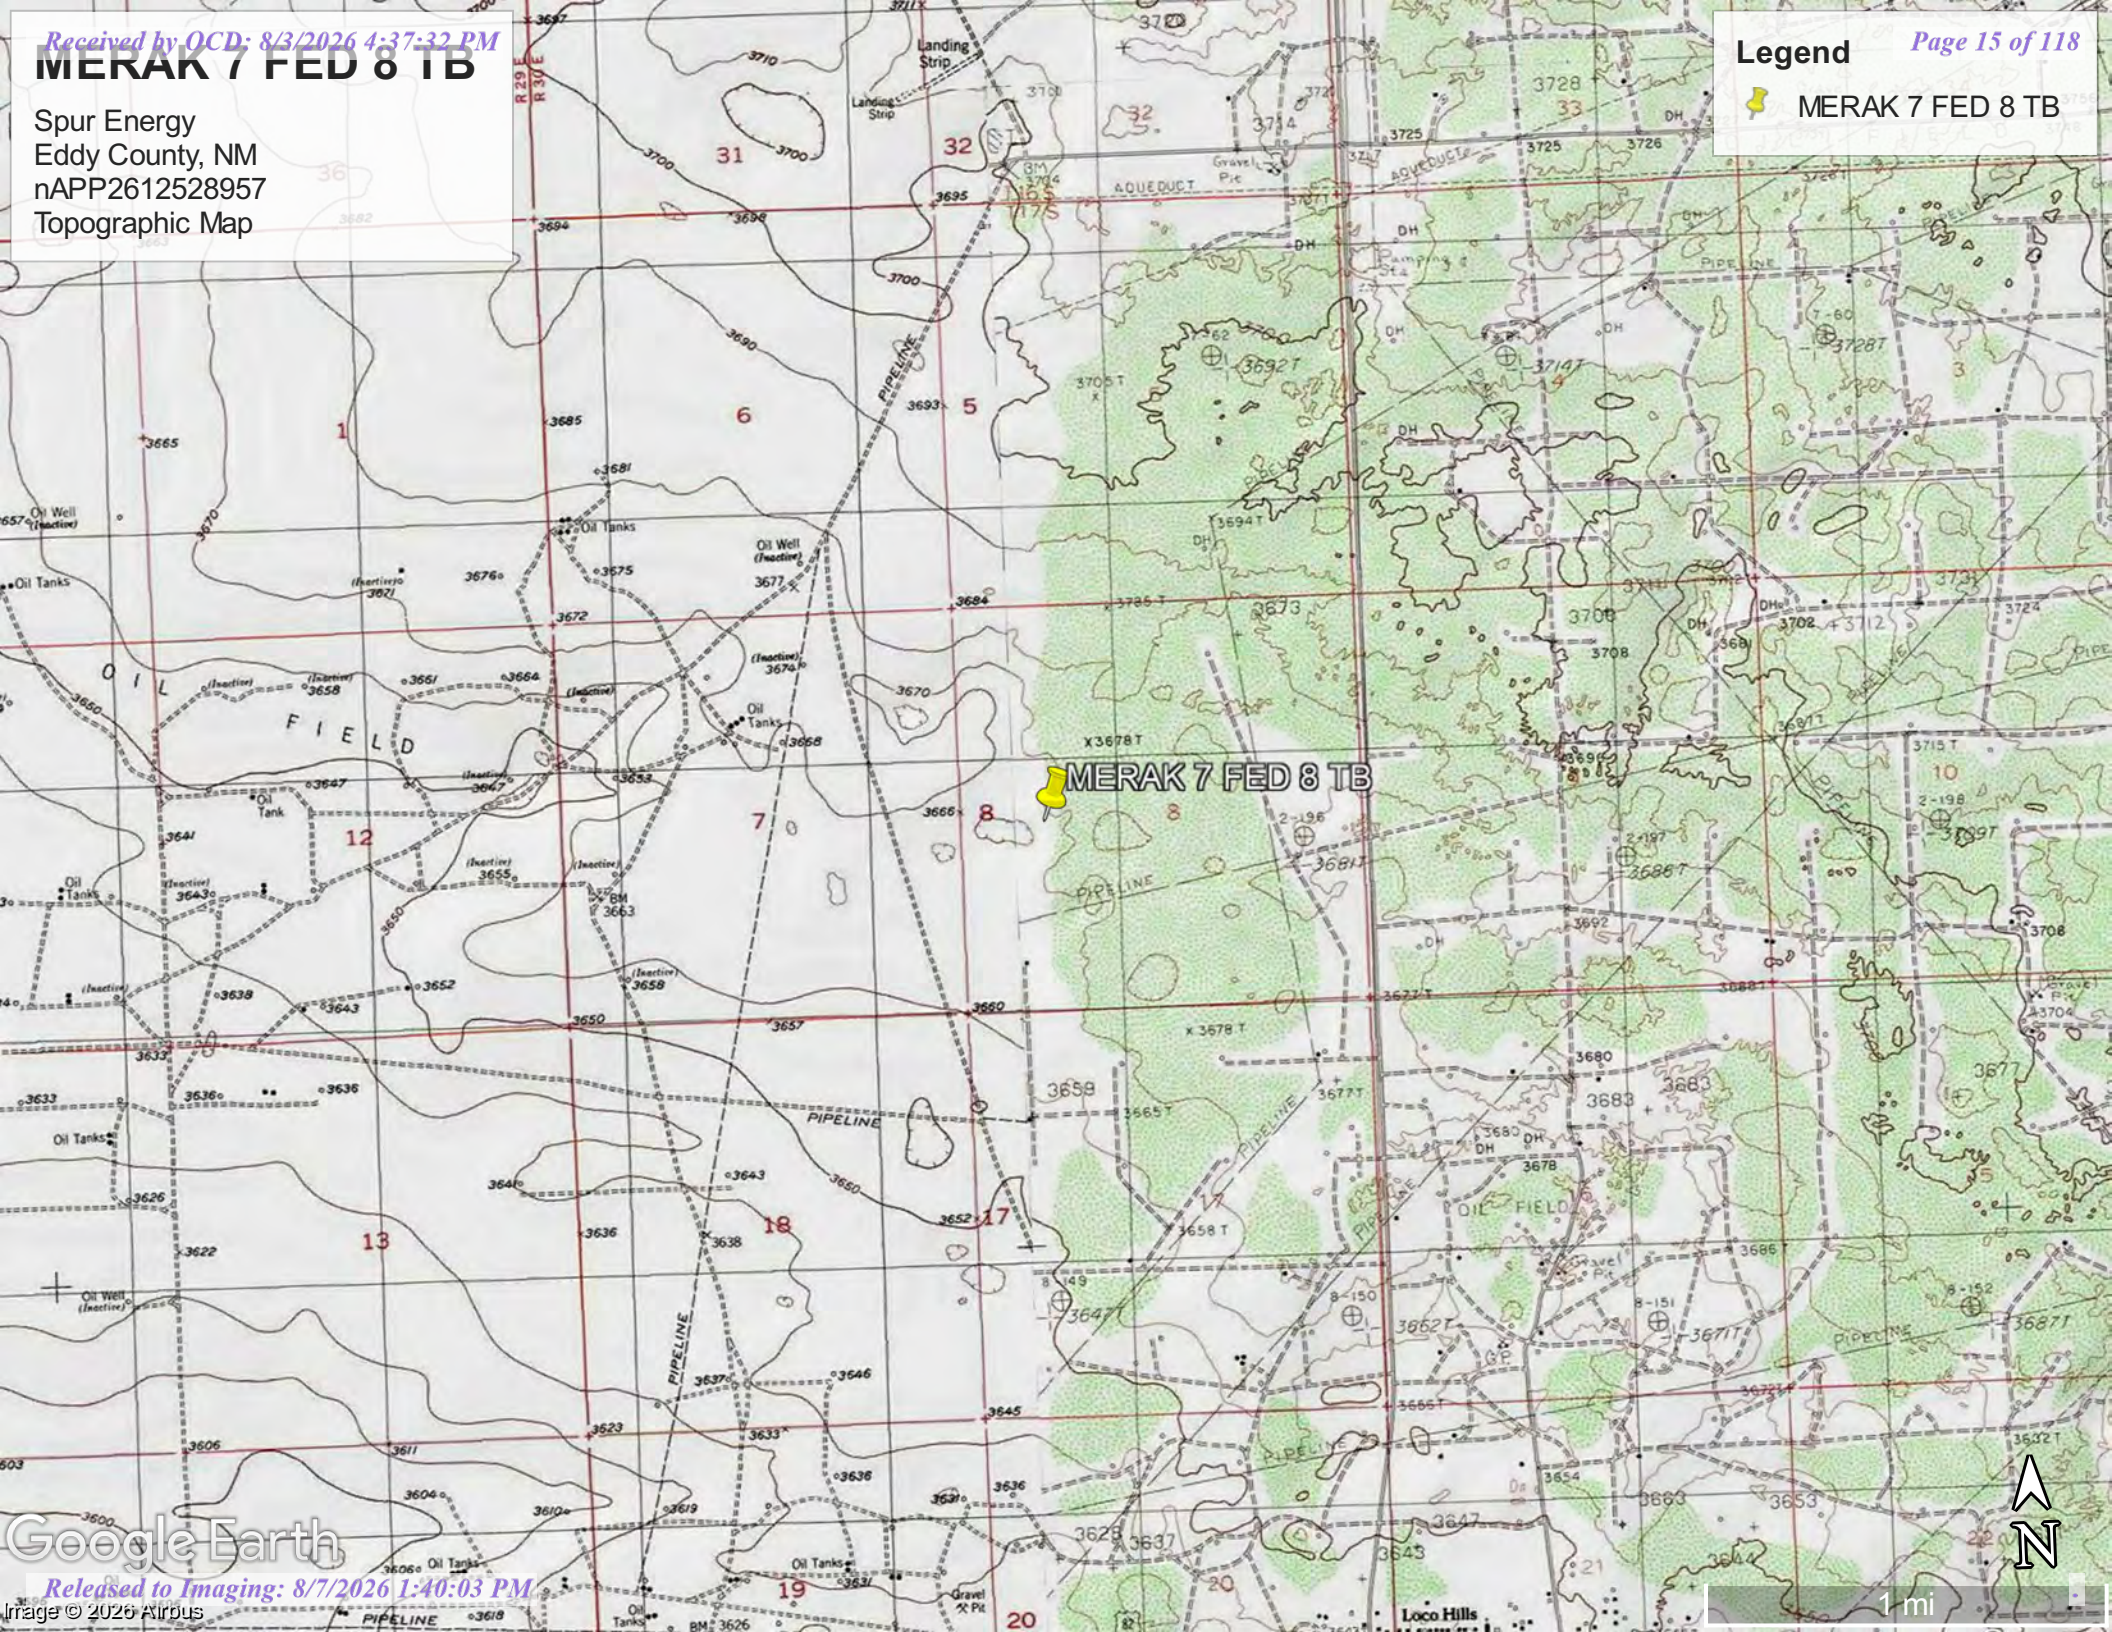
MERAK 7 FED 8 TB

Spur Energy  
Eddy County, NM  
nAPP2612528957  
Topographic Map

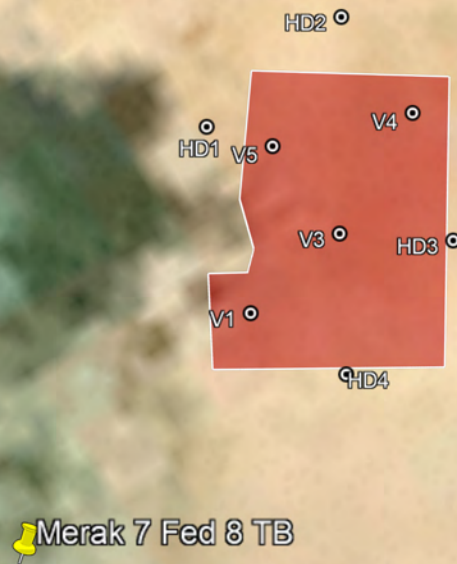
Spur Energy  
Eddy County, NM  
nAPP2612528957  
Confirmation Sample Map (1)

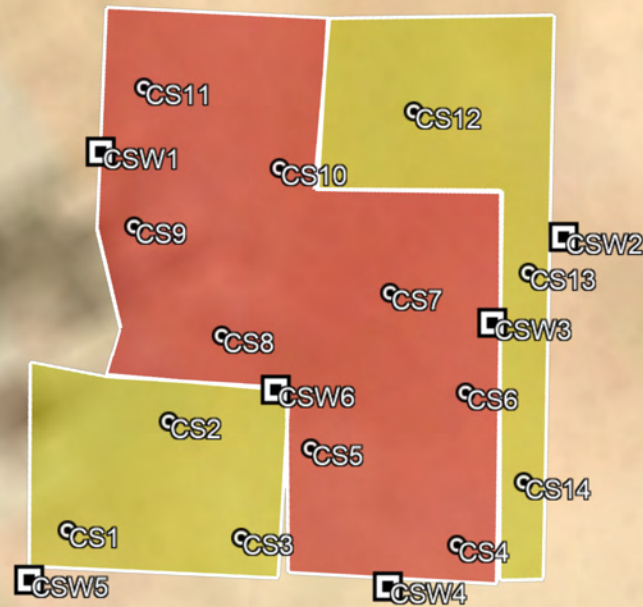
Merak 7 Fed 8 TB

Spur Energy  
Eddy County, NM  
nAPP2612528957  
Confirmation Sample MAp (2)

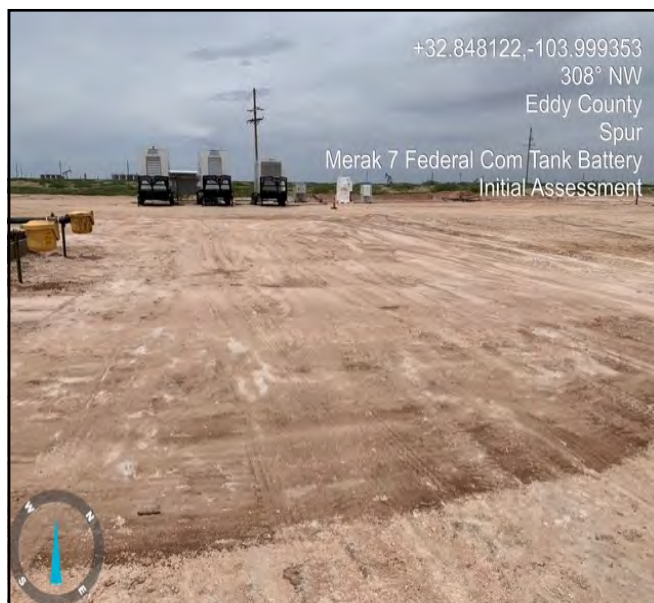
Photograph taken during initial site assessment facing northwest.

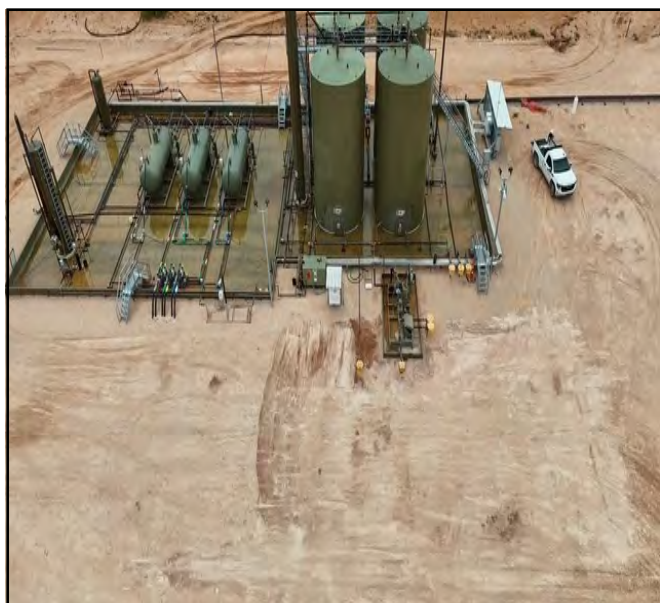
Aerial photo of initial site assessment.

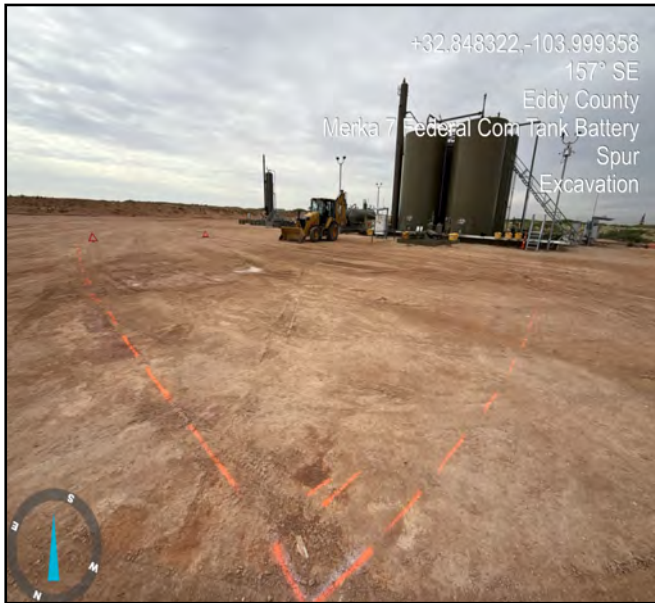
Photo taken pre- excavation process facing southeast.

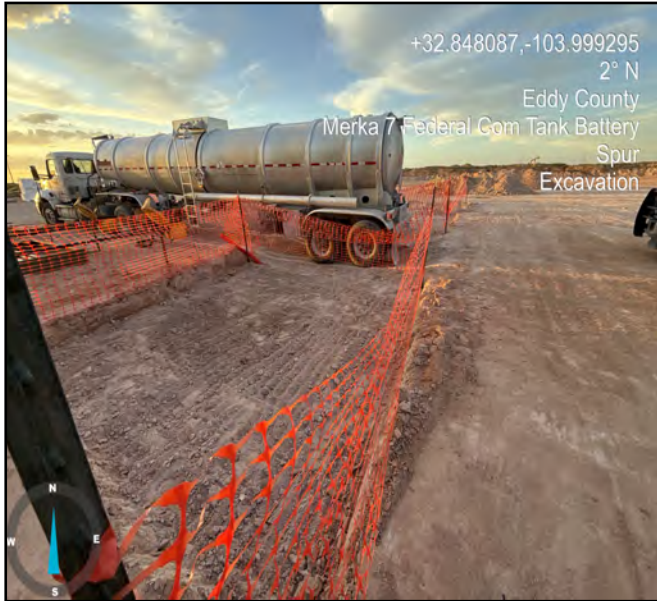
Photo taken during the excavation process facing north.

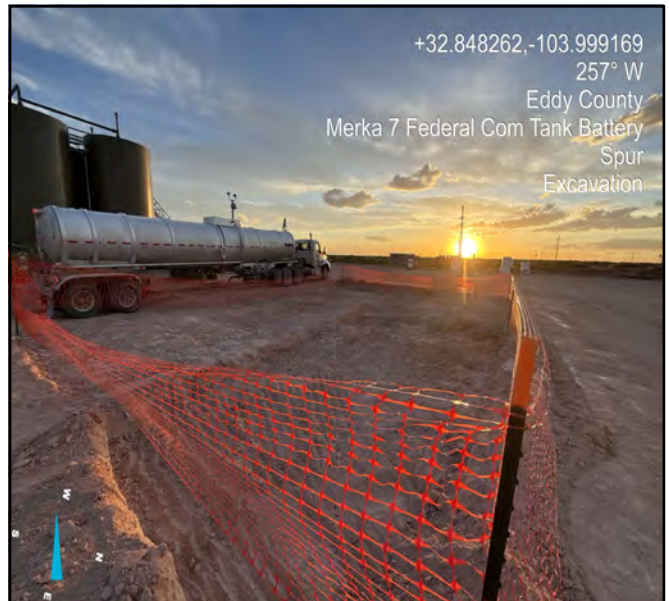
Photo taken during the excavation process facing west.

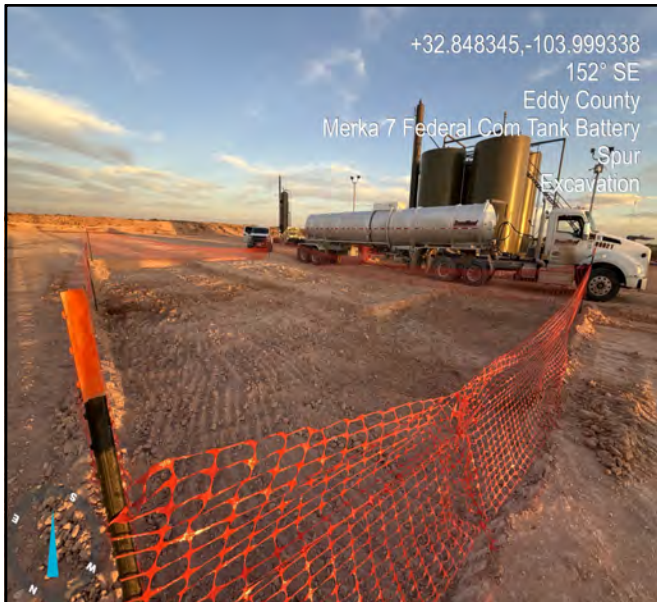
Photo taken during the excavation process facing southeast.

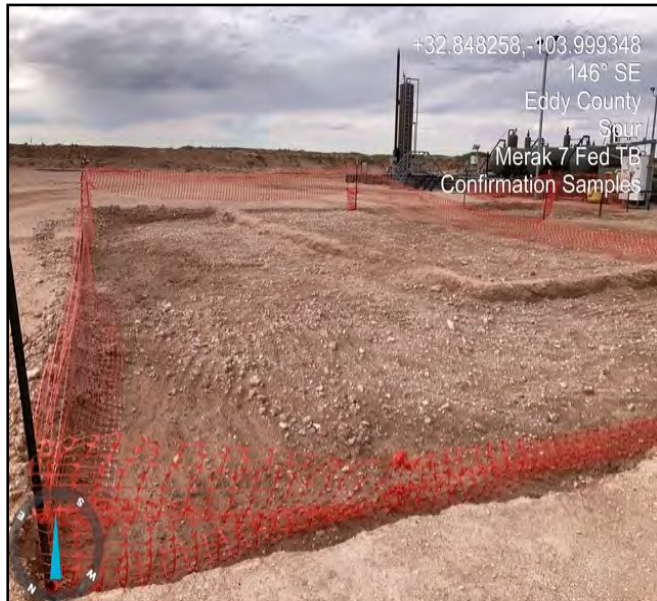
Photo taken during confirmation sampling facing southeast.

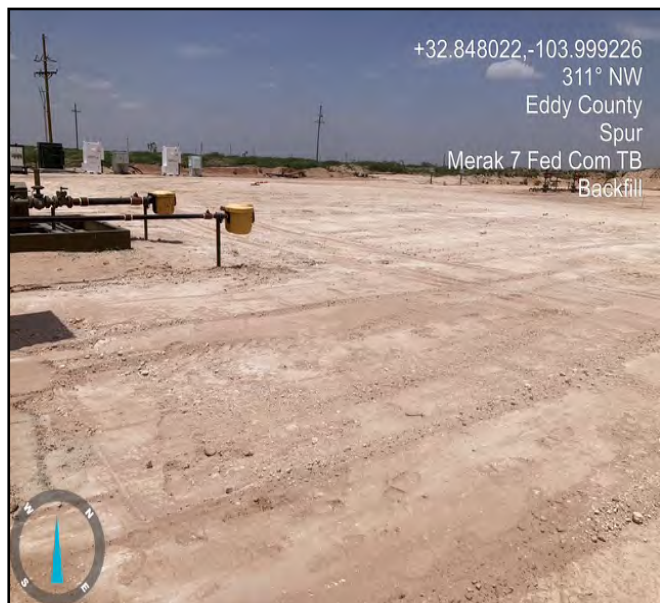
Photo taken post backfill facing northwest.

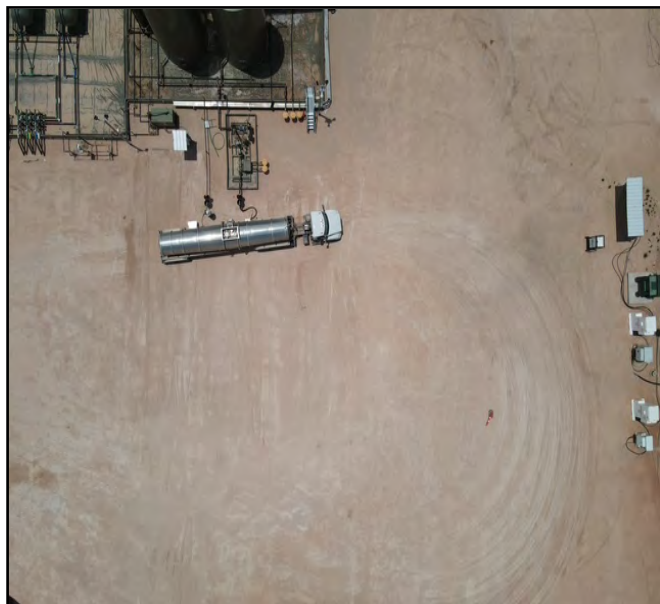
Aerial photo taken post backfill
