**Re: Remediation Work Plan  
Tiger Paw 22 Facility 2  
Incident Number: nAPP2602848478  
Eddy County, New Mexico**

Ensolum, LLC (Ensolum), on behalf of Devon Energy Production Company, LP (Devon), has prepared this *Remediation Work Plan (RWP)* to document assessment and soil sampling activities performed at the Tiger Paw 22 Facility 2 (Site). The purpose of the Site assessment and soil sampling activities was to assess impacted soil resulting from a produced water release. Devon is submitting this *RWP*, describing analytical results from soil sampling and karst survey activities associated with Incident Number nAPP2602848478 and proposing to address the release through excavation of impacted soils in a high-karst potential area.

# **Environmental Karst Study Report**

# **2D Electrical Resistivity Imaging Report Tiger Paw 22 Facility 2 v2 Eddy County, New Mexico**

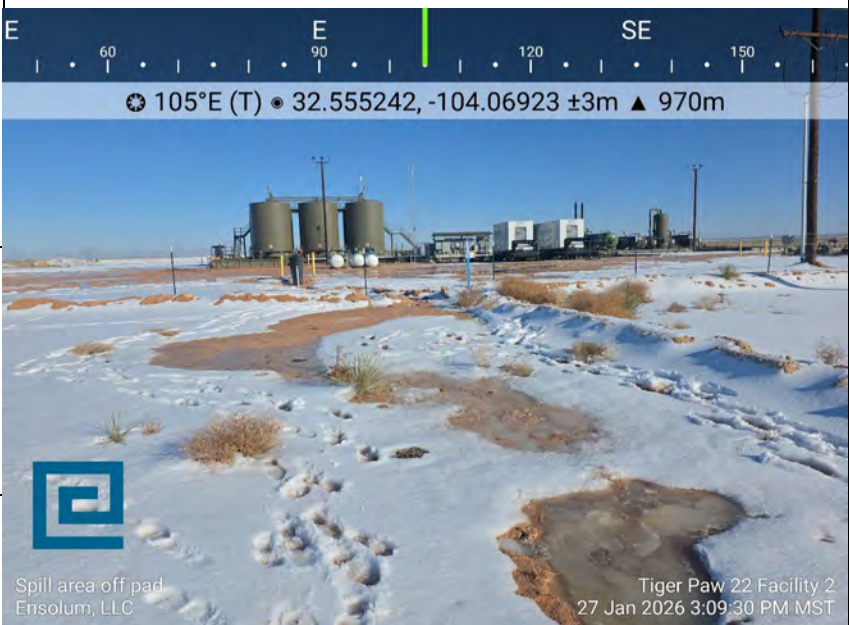
| Photograph<br>1 | Date<br>1/27/2026 | <p>Spill area off pad<br/>Ensolum, LLC</p> <p>Tiger Paw 22 Facility 2<br/>27 Jan 2026 3:09:30 PM MST</p> |
| Description<br>Spill area off pad | | |

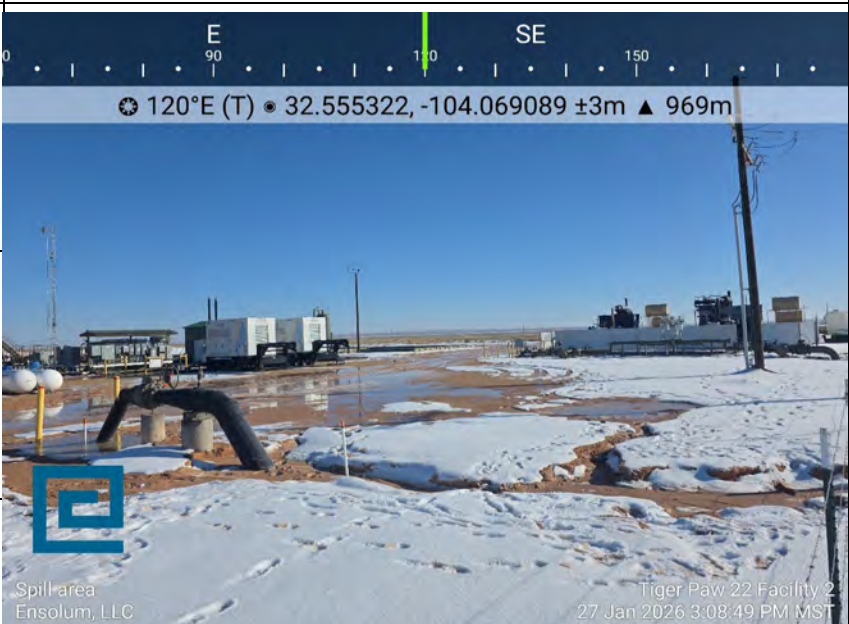
| Photograph<br>2 | Date<br>1/27/2026 | <p>Spill area<br/>Ensolum, LLC</p> <p>Tiger Paw 22 Facility 2<br/>27 Jan 2026 3:08:49 PM MST</p> |
| Description<br>Spill area off pad | | |
