Our ref.: 12700031-NMOCD-1

Closure Report  
Marathon Oil Permian LLC  
Sterling 20 State 2H  
Unit Letter O, Section 17, T23S, R27E  
GPS: 32.29862, -104.20916  
Eddy County, New Mexico

Marathon Oil Permian LLC  
Sterling 20 State 2H  
Incident No. nAPP2615646424  
Eddy County, New Mexico

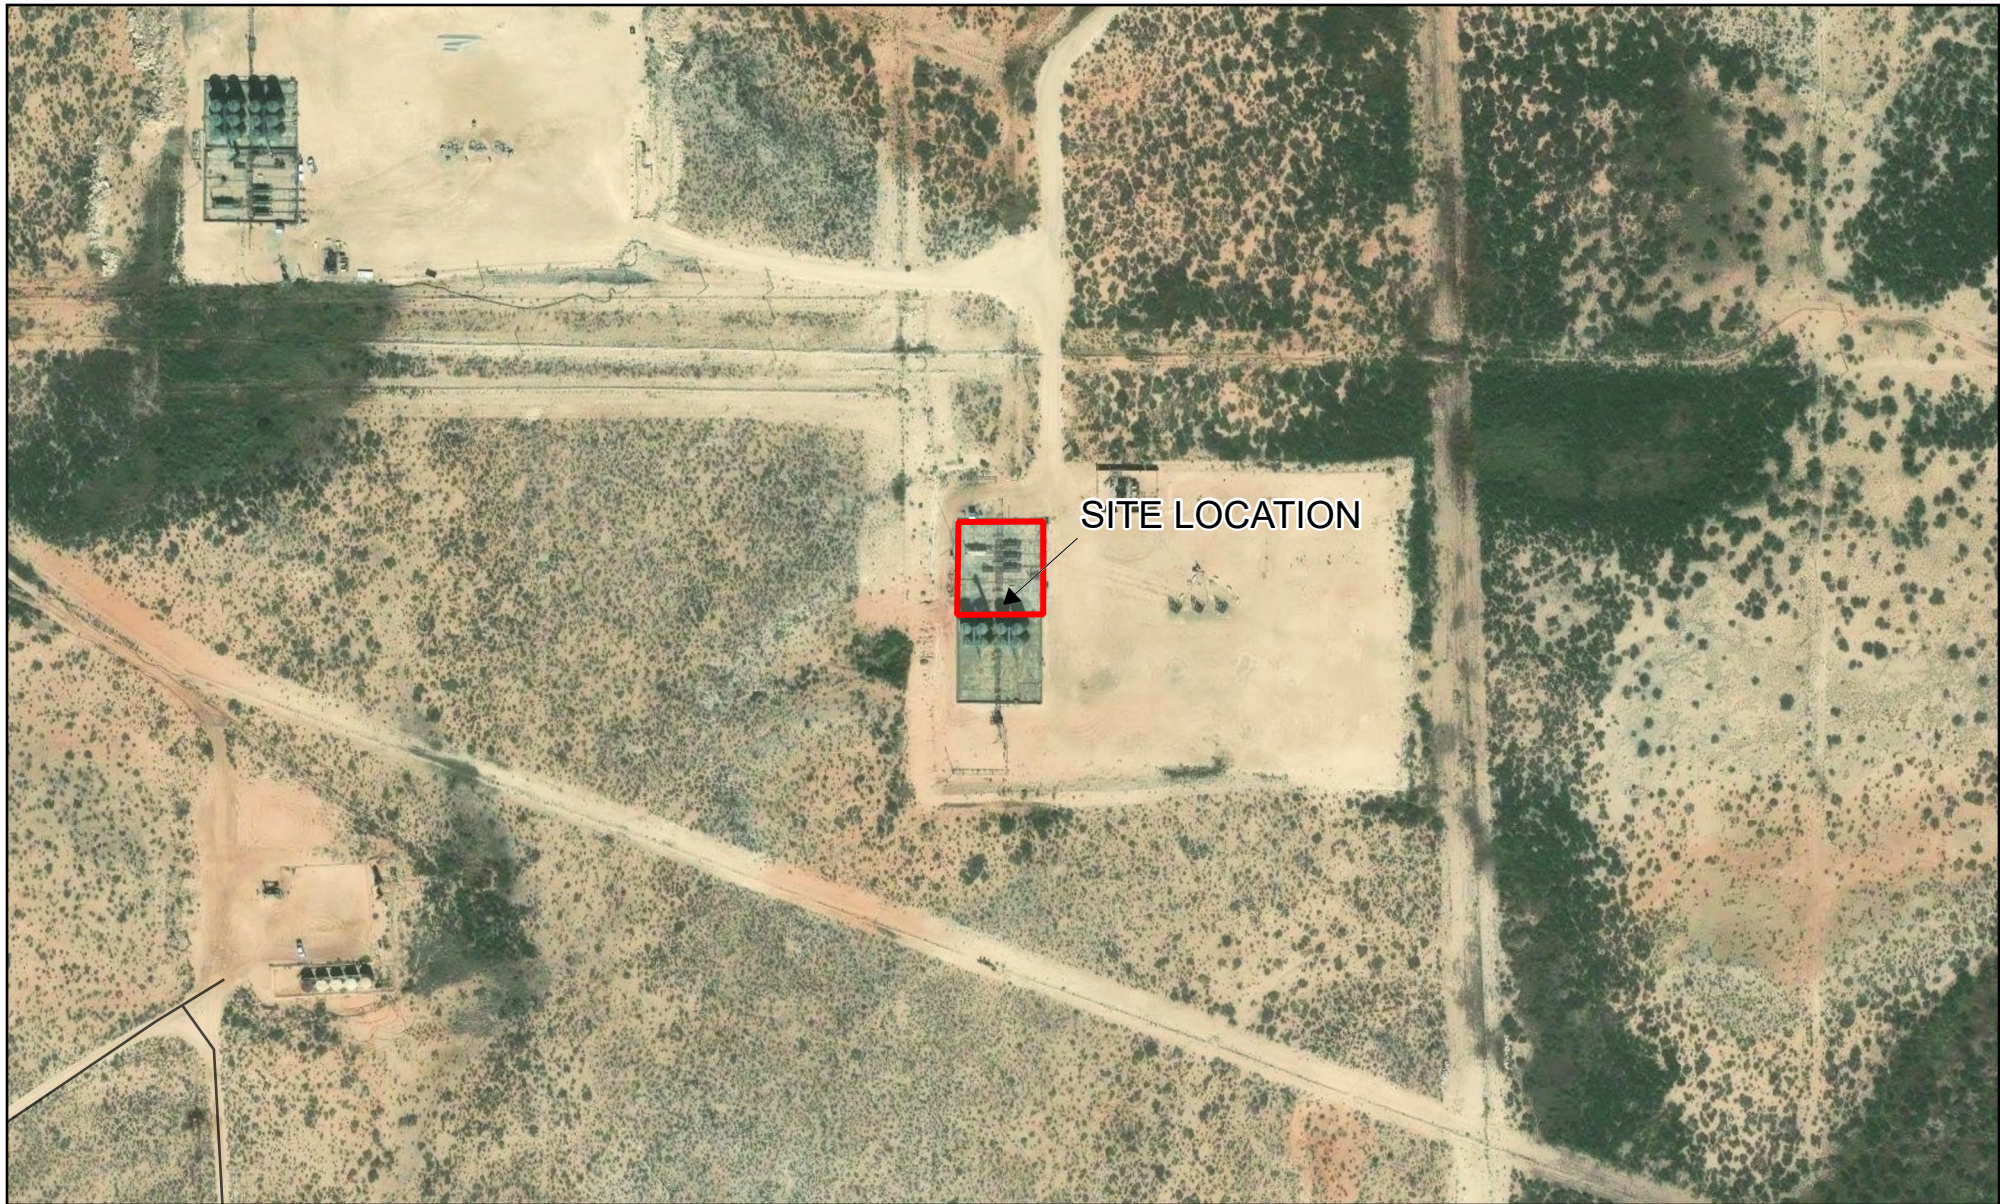
**SITE DETAILS MAP**

The Site was characterized to assess applicability of Table I, Closure Criteria for Soils Impacted by a Release, of Title 19, Chapter 15, Part 29 (NMAC 19.15.29) of the New Mexico Administrative Code (NMAC). Results from the characterization desktop review are summarized below and a Site Map is presented on **Figure 1**.

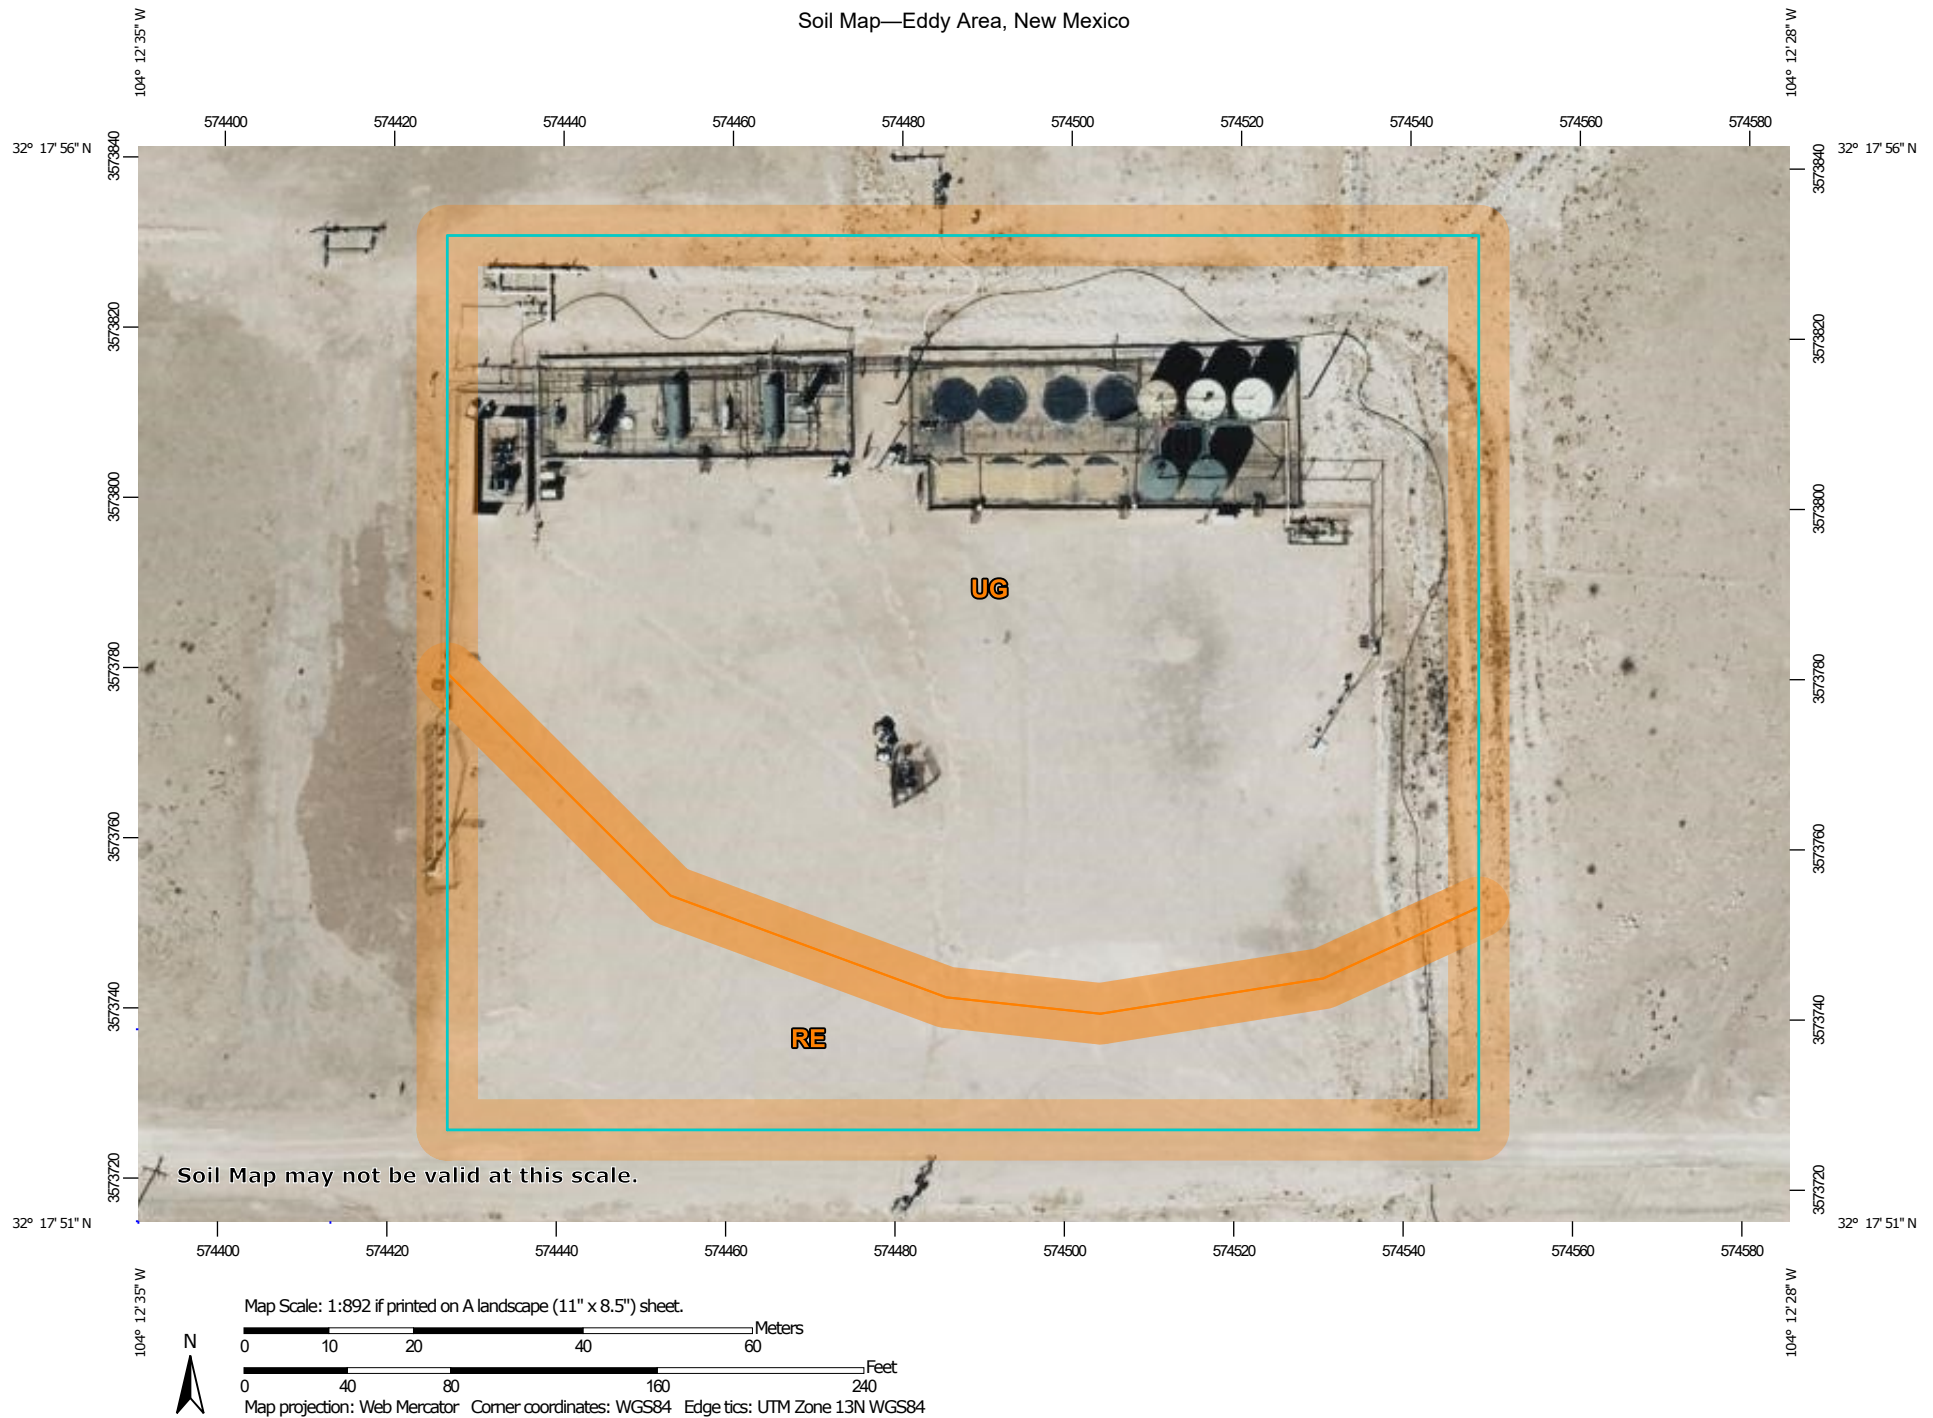
## Soil Map—Eddy Area, New Mexico

According to the soil survey provided by the United States Department of Agriculture National Resources Conservation Services, the soils located within the Site consists of the Reagan-Upton association (0 to 9 percent slopes), which includes Reagan loam and Upton gravelly loam soils. The Site is within a high potential karst area.

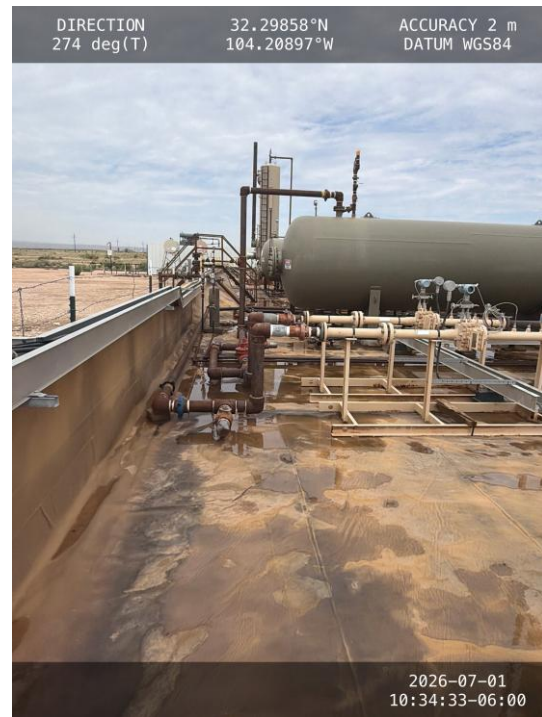
**Photo 2** View of the containment area facing west. Residual water from rainfall event.

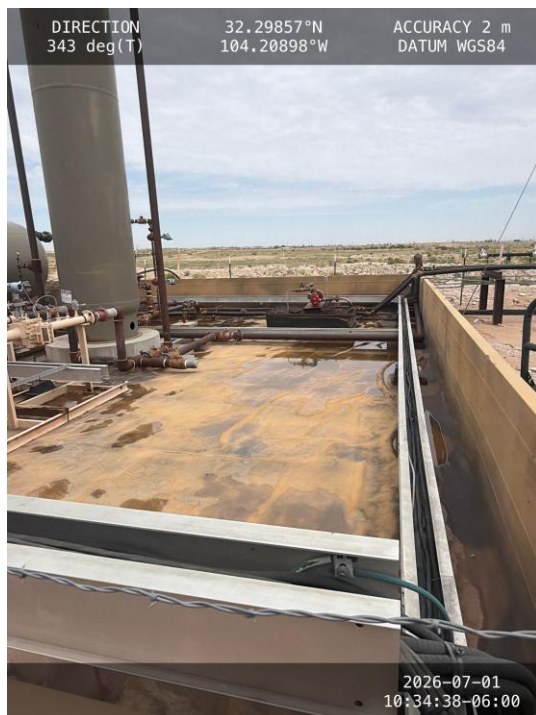
**Photo 1** View of the liner corner of the containment area facing north northwest. Residual water from rainfall event.

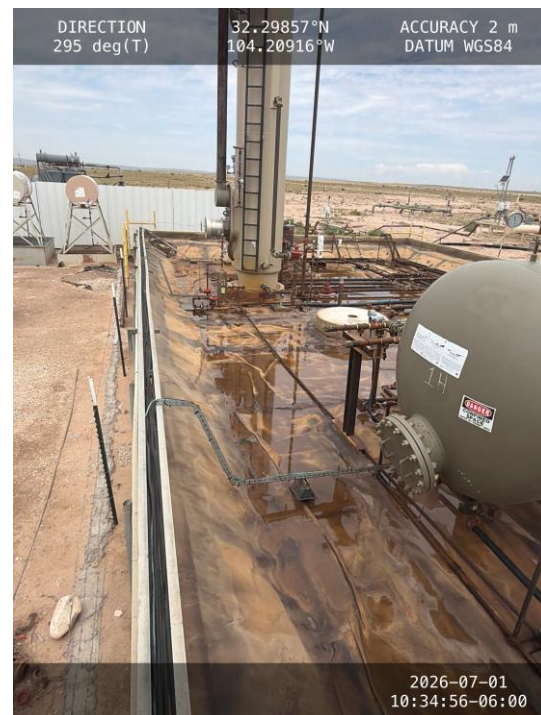
**Photo 2** View of the liner corner of the containment area facing west northwest. Residual water from rainfall event.

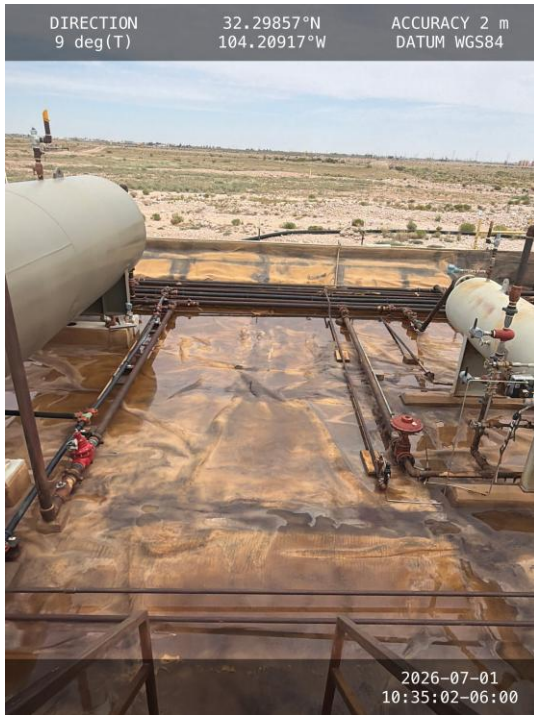
The liner inspection notice was provided on June 29, 2026. A liner integrity inspection was scheduled for July 1, 2026. The liner was visually inspected and no rips, tears, holes, or damage in the liner were observed. The liner was determined to be intact with no integrity issues. Photographic documentation of the liner inspection is presented in **Attachment C**.

**Photo 5** View of the liner in containment area facing north.  
Residual water from rainfall event.
