Standard Safety and Supply

Site Characterization and Liner Inspection Closure Report  
Stray Cat 8 CTB 2  
nAPP2522650393 & nAPP2525127049  
32.314899, -103.699016  
N-08-23S-32E

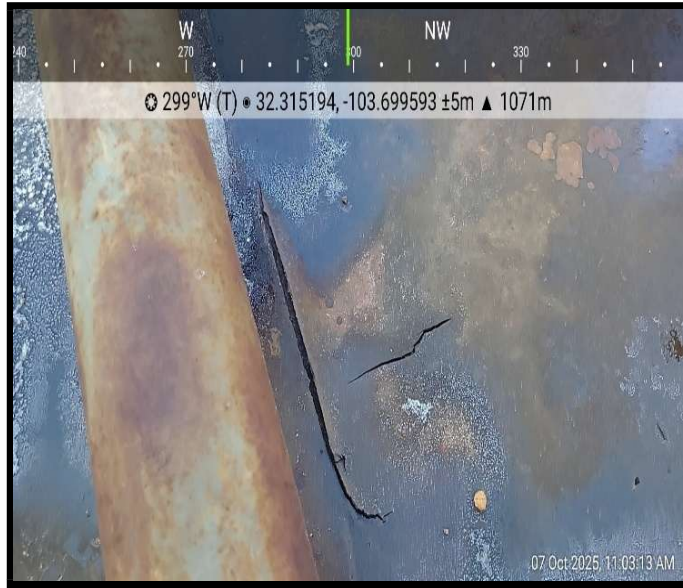
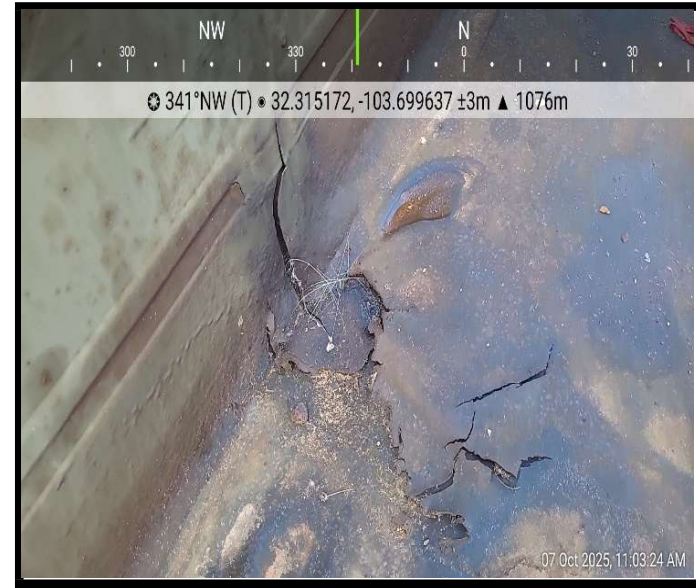
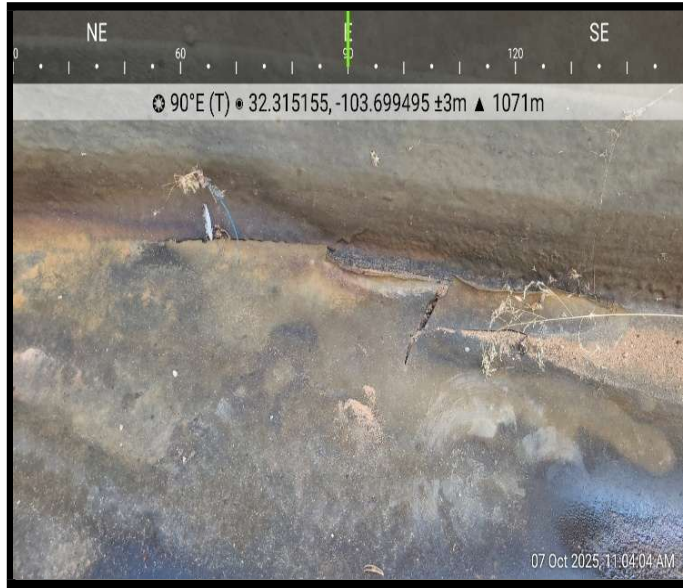
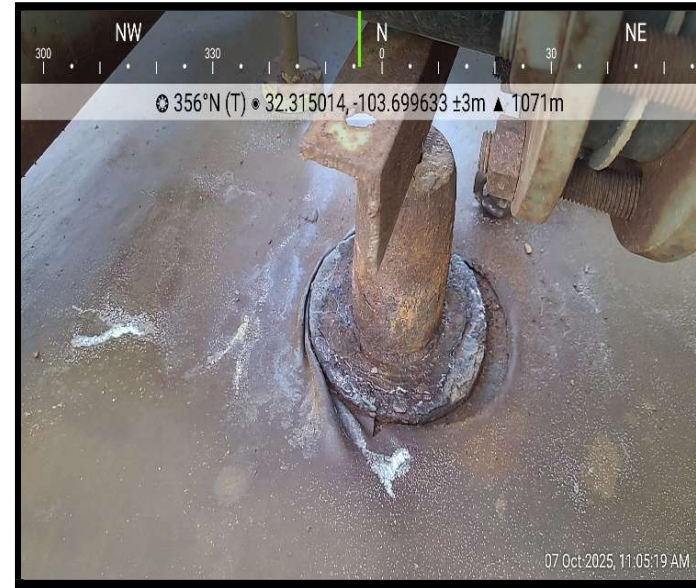
After the liner was cleaned on October 07, 2025, Standard performed a liner inspection. There was standing fluid within the liner, chloride precipitate, and four (4) liner breaches at the time of inspection.

View of Liner Crack

After the liner was cleaned and primary liner breaches repaired, on June 11, 2026, Standard performed a second liner inspection. No staining, tears, holes, or breaches were present within the secondary containment. However, rainwater was present due the recent weather within the vicinity of the site.

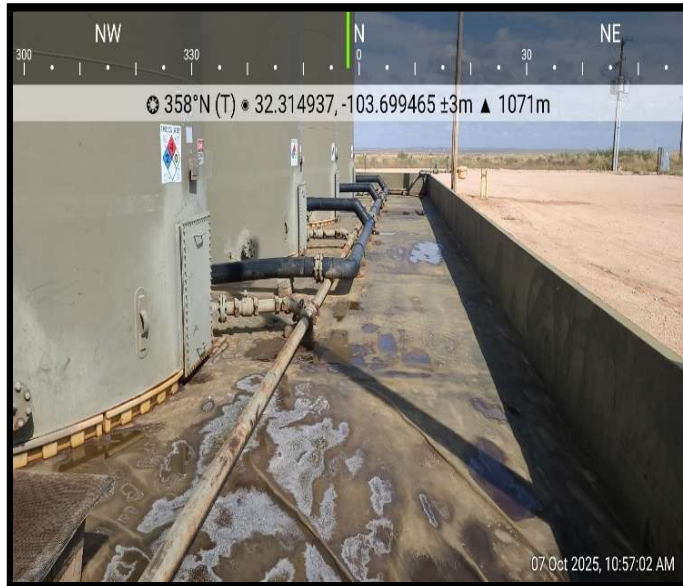
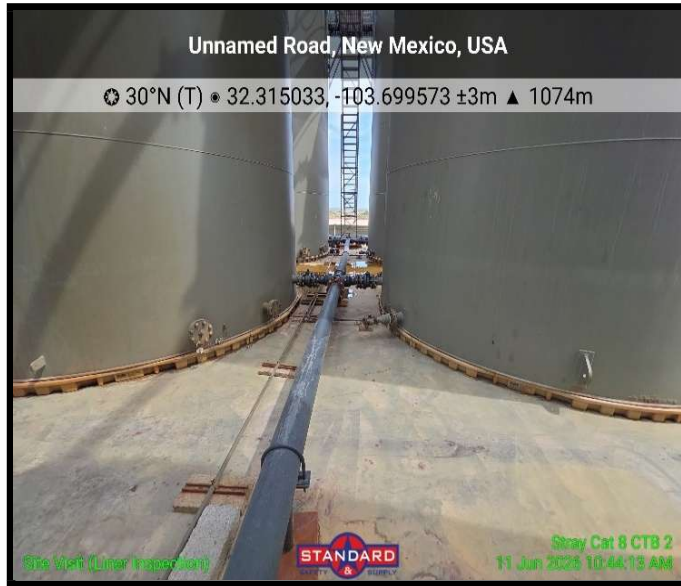
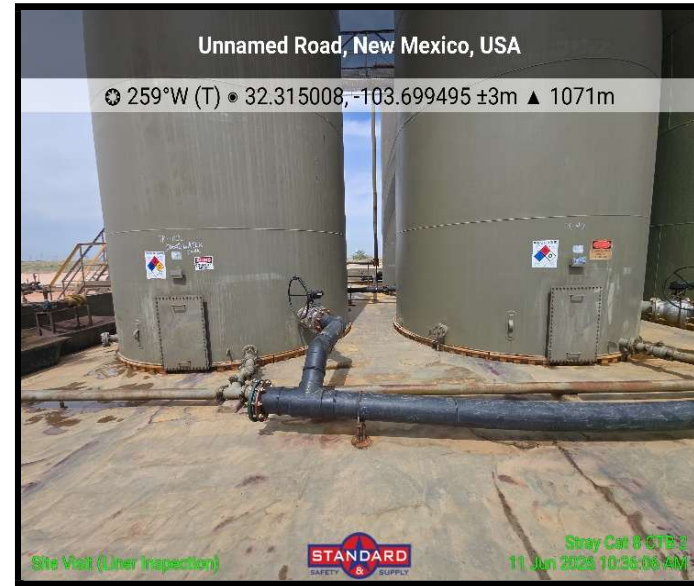
View of Secondary Containment

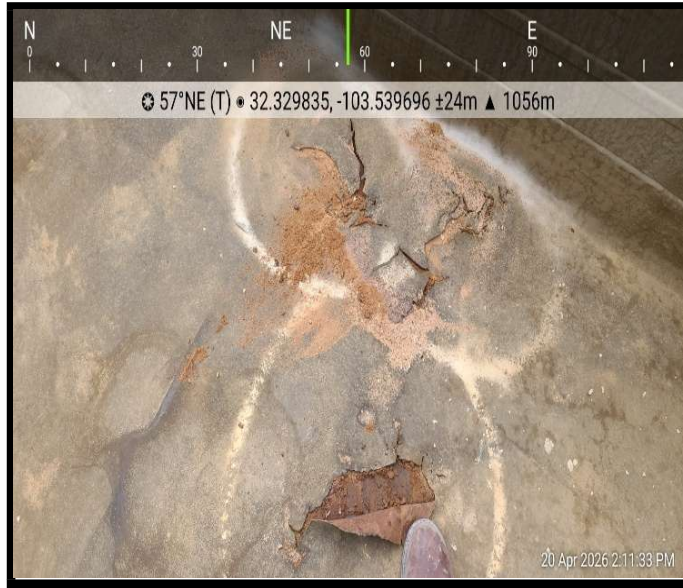
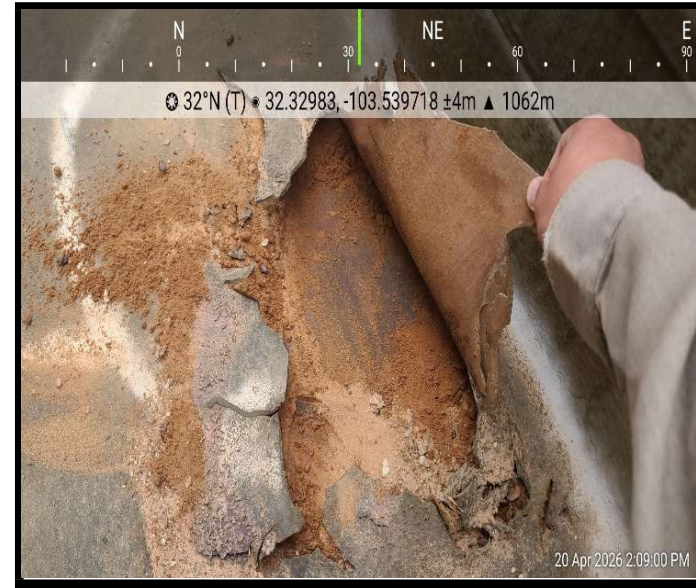
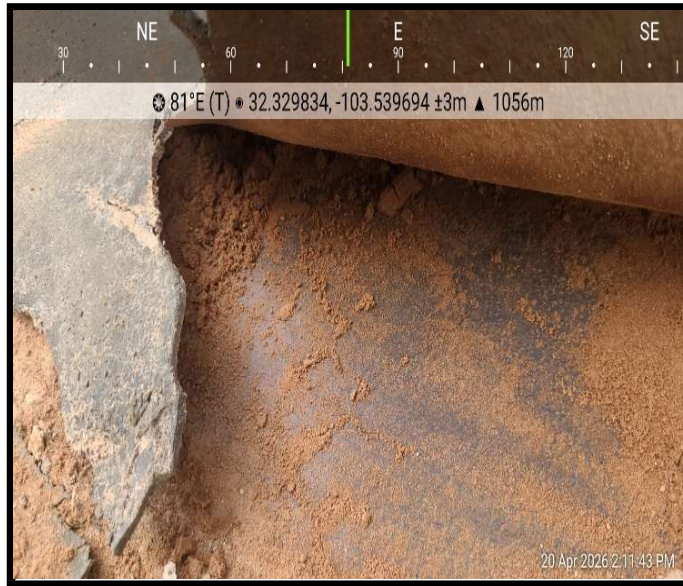
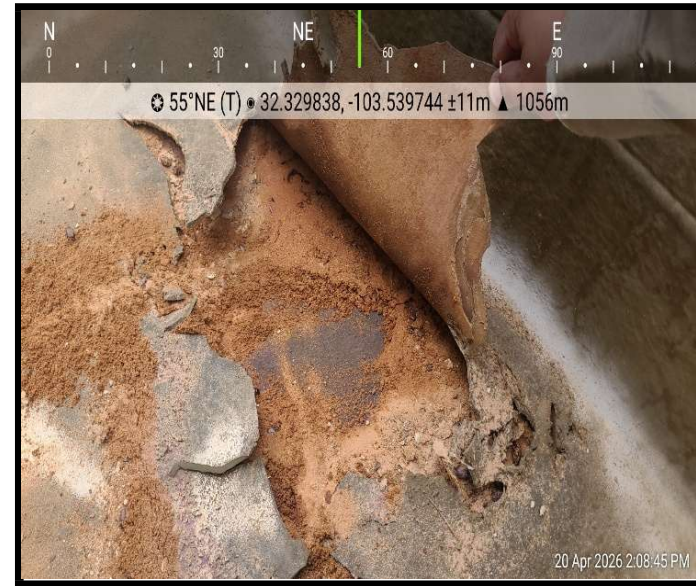
On April 20, 2026, Standard was onsite to assess the extent of impacts from the four (4) liner breaches and discovered a secondary liner underneath the primary liner. Upon further investigation, the secondary liner integrity was intact.

View of secondary liner under primary liner

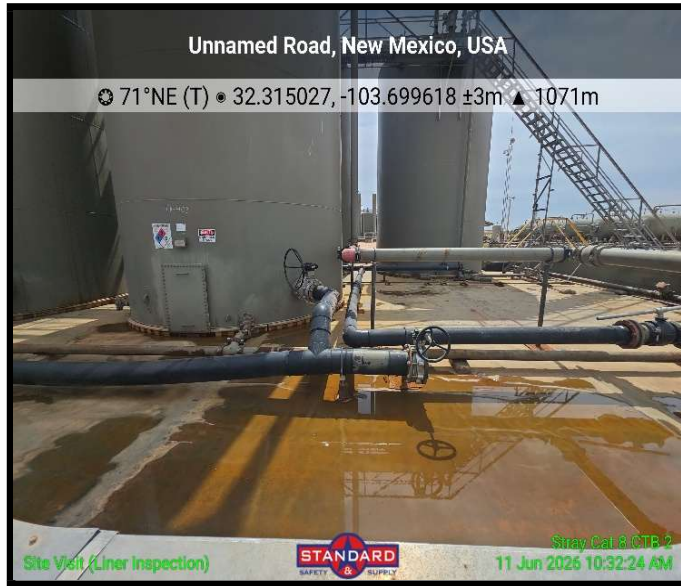
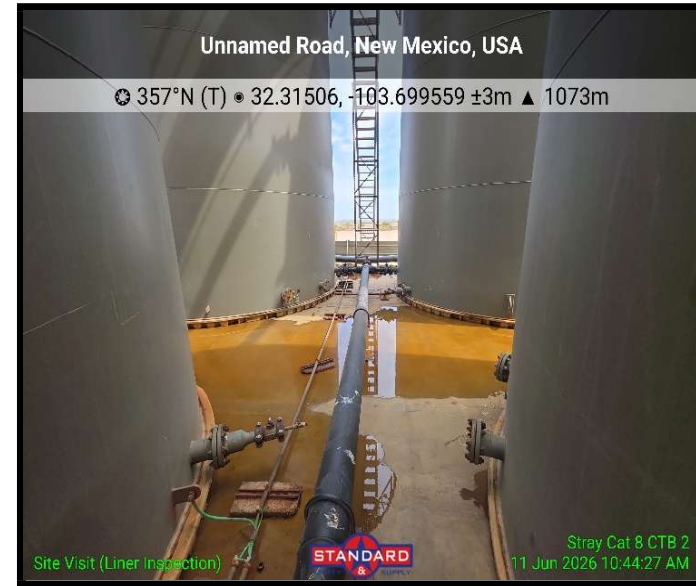
View of fluid in Secondary Containment

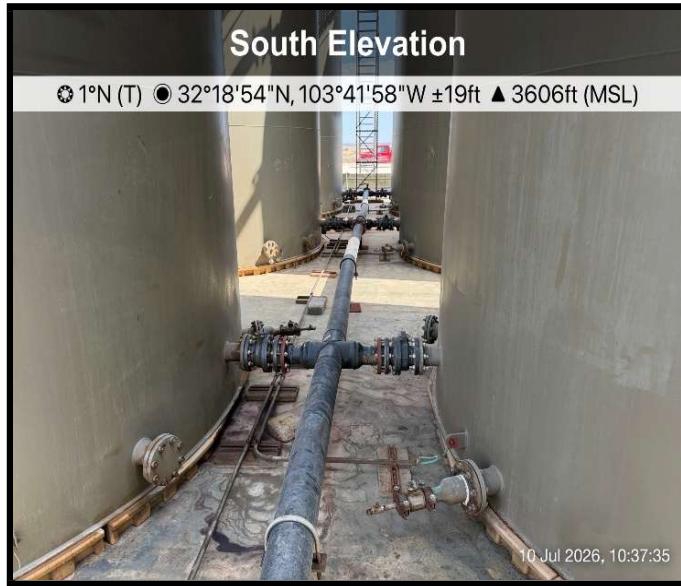
On July 10, 2026, Standard performed a third liner inspection. No standing fluids, staining, tears, holes, or breaches were present within the secondary containment.

View of Secondary Containment
