**Re: Site Assessment and Closure Report  
Halberd 27 St Com North TB  
GPS: Latitude 32.81204 Longitude -104.15424  
UL "D", Sec. 26, T17S, R28E  
Eddy County, NM  
NMOCD Ref. No. NAPP2616930838**

Paragon Environmental, LLC (Paragon) has been contracted by Spur Energy Partners (Spur) to perform a spill assessment, conduct remediation activities, and write a closure report for the release site known as the Halberd 27 St Com North TB (Halberd). Details of the release are summarized below:

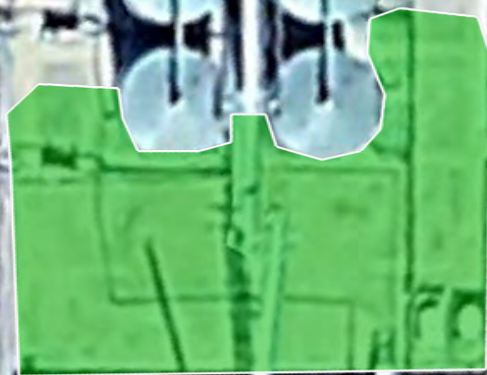
Halberd North St Com TB  
Eddy County, NM  
Site Map

Spill Area 2400 s/f

90 ft

A Site Map is provided in Figure #1.

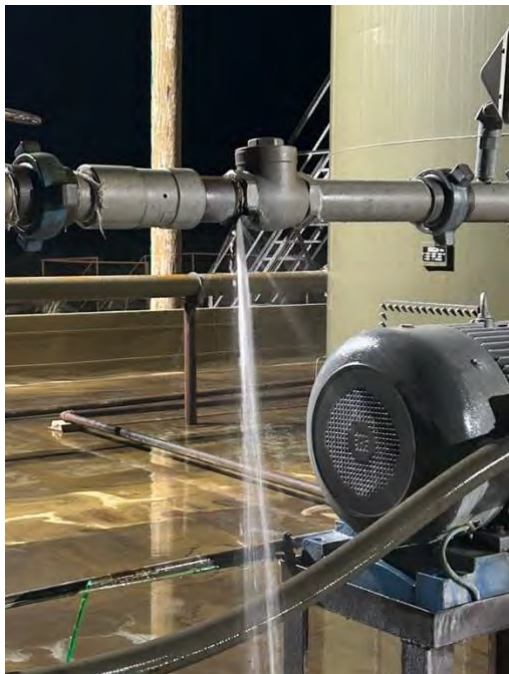
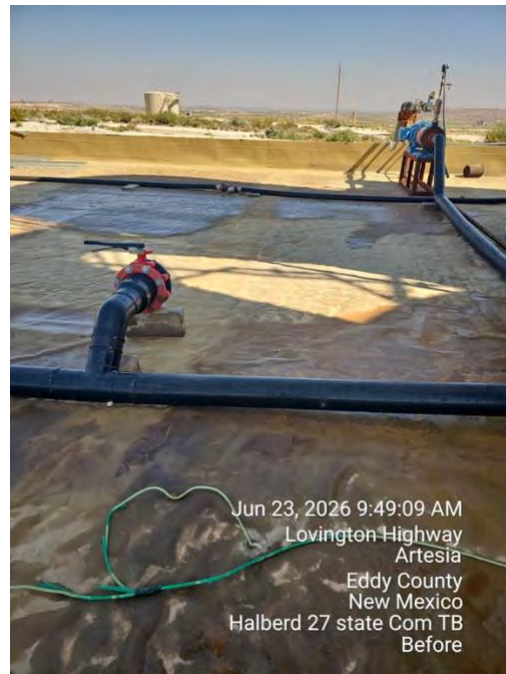
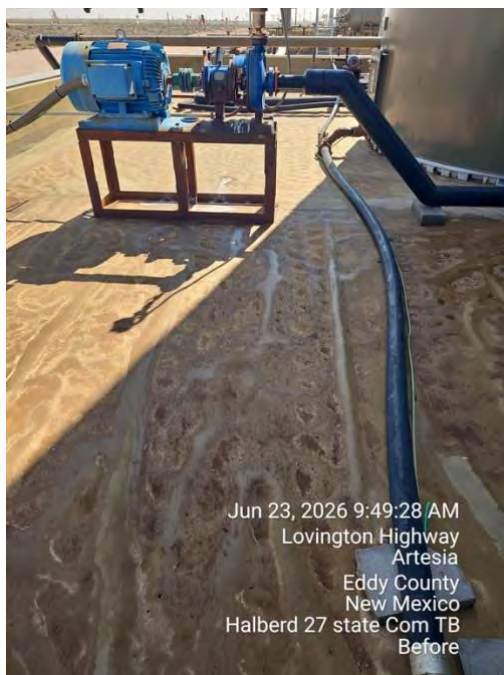
**Photographic Documentation  
Before**

The stained area measured approximately 2400 s/f. The spill was just PW, so we just used heated water to power wash the liner clean. A vac truck was on site, sucking up the fluids as the crew sprayed the liner down and used a squeegee to move the fluids to the vac truck.

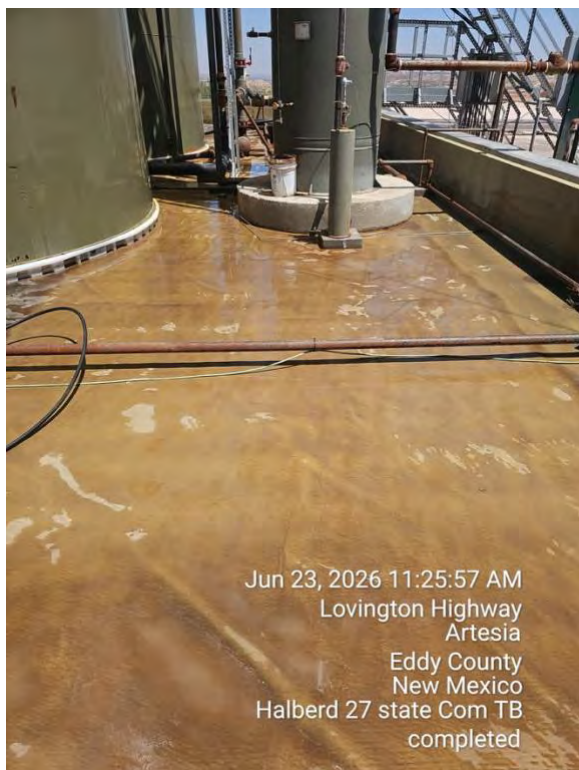
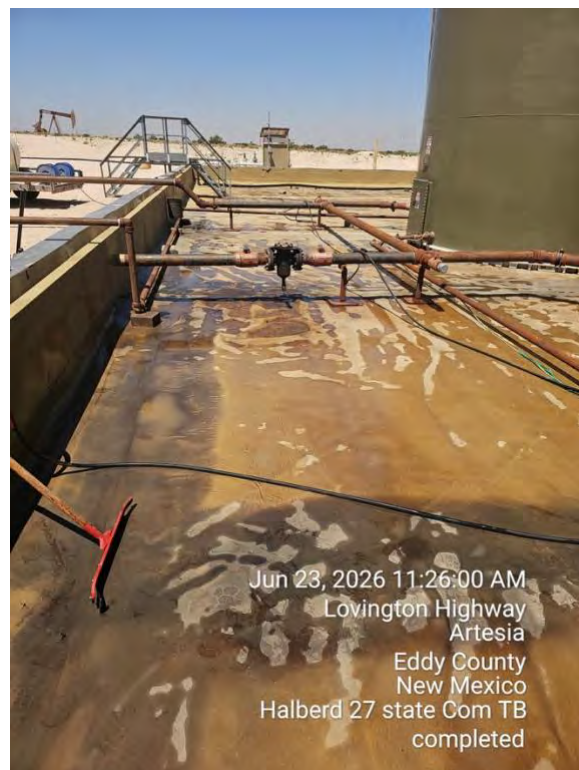
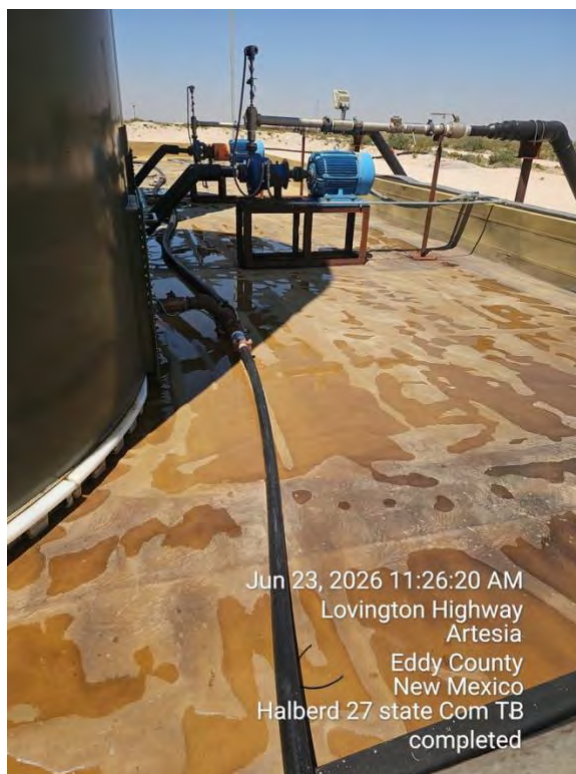
Completed

| Created By | Condition | Condition Date |
|---|---|---|
| michael.buchanan | Liner inspection and closure approved. Liner appears to be in good condition. | 8/20/2026 |
