SUBJECT: Liner Inspection and Closure Report for Broadside 12 Facility 1 – July 24, 2026 Site Visit

Incident IDs: nAPP2616935401

Facility ID (Name): fAPP2123645812 (BROADSIDE 12 FACILITY 1)

# Environmental Liner Inspection Field Notes & Photolog Report

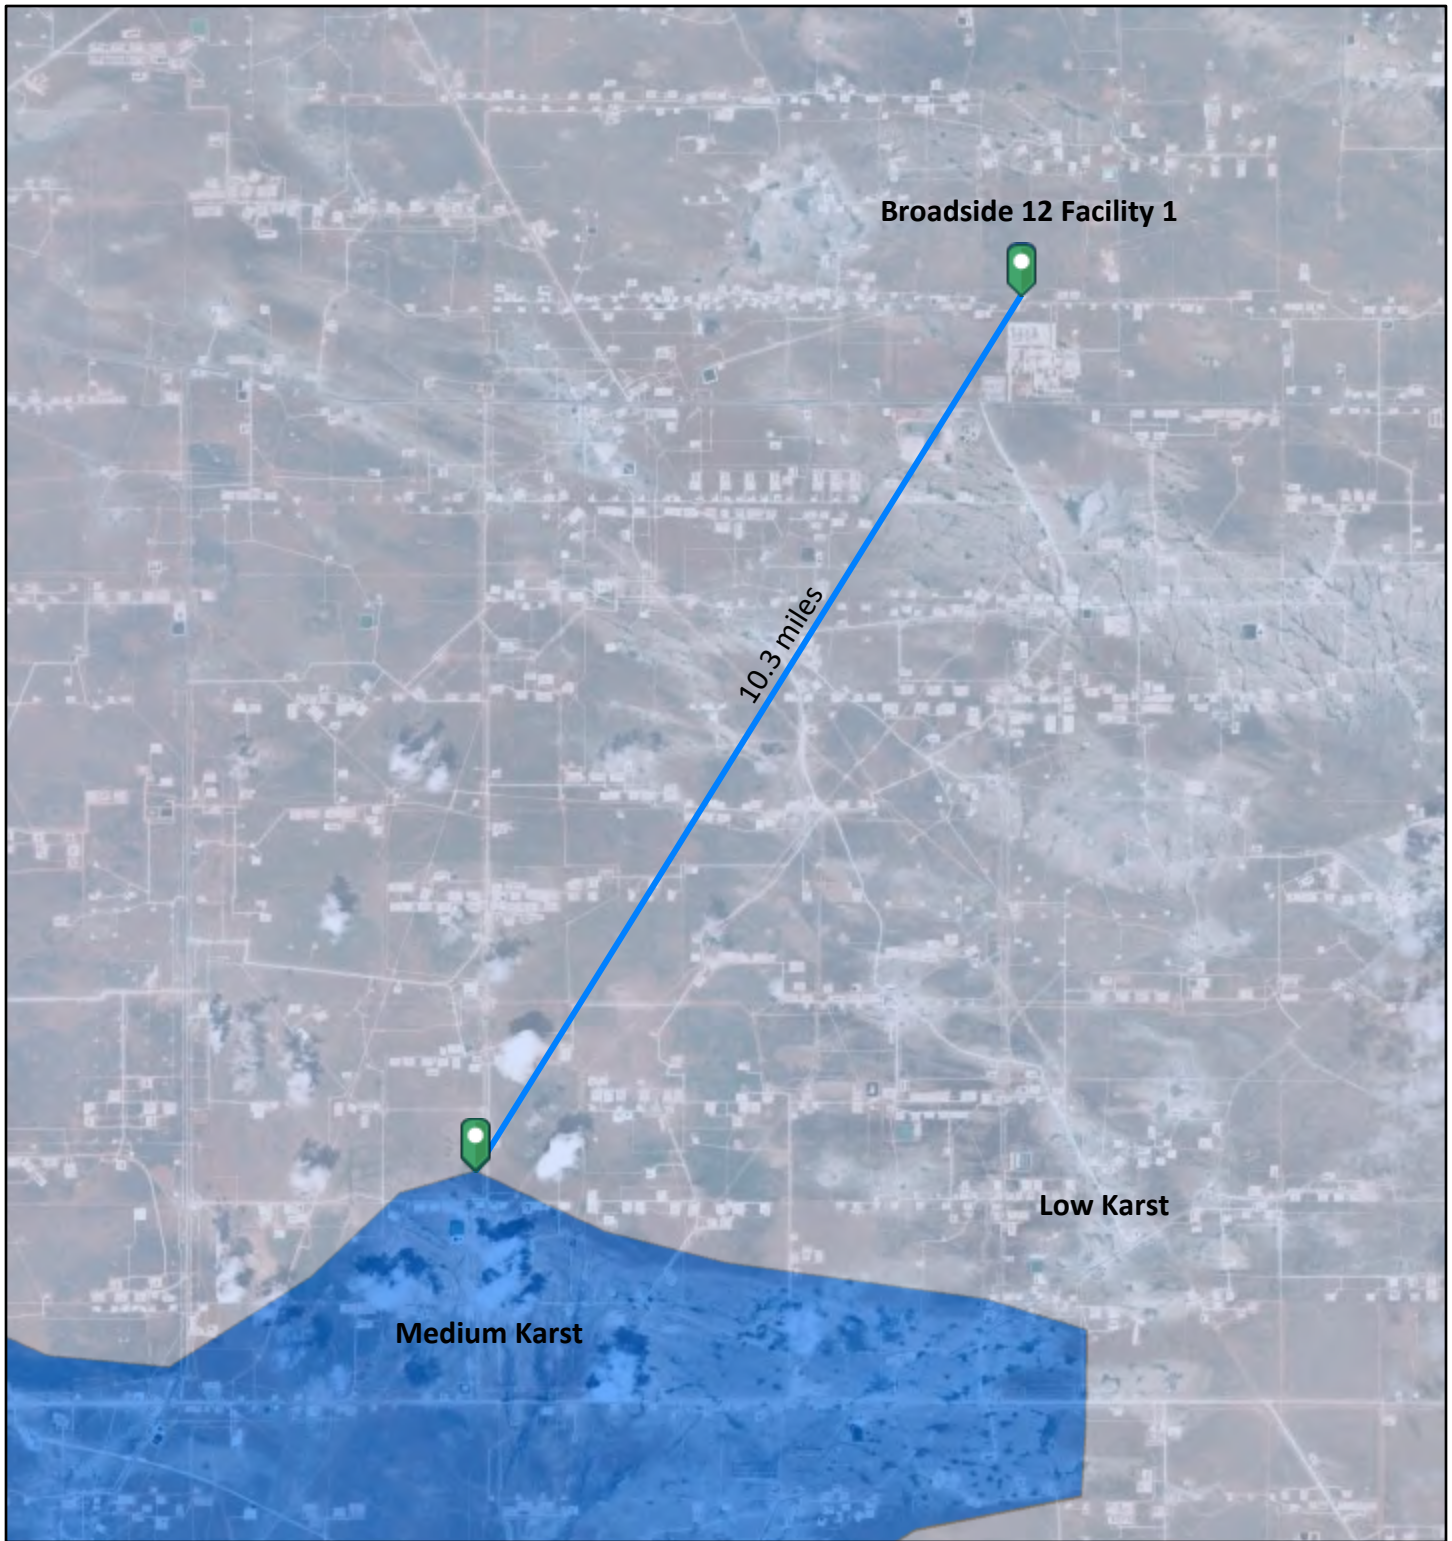
# Broadside 12 Facility 1 Karst Potential Map

Karst potential for the Site is identified as low, with the nearest area of medium karst potential located 10.3 miles to the southwest. The Site is in a FEMA flood hazard area identified as Zone D (undetermined hazard); the nearest identified FEMA flood hazard area, classified as Zone AE, is 20.6 miles to the southeast.
