# Remediation Report and Deferral Request

Python 36 State CTB #501 Separator

Facility ID #: fAPP2203952933

Remediation Report and Deferral Request  
Python 36 CTB Facility # fAPP2203952933  
August 24, 2026

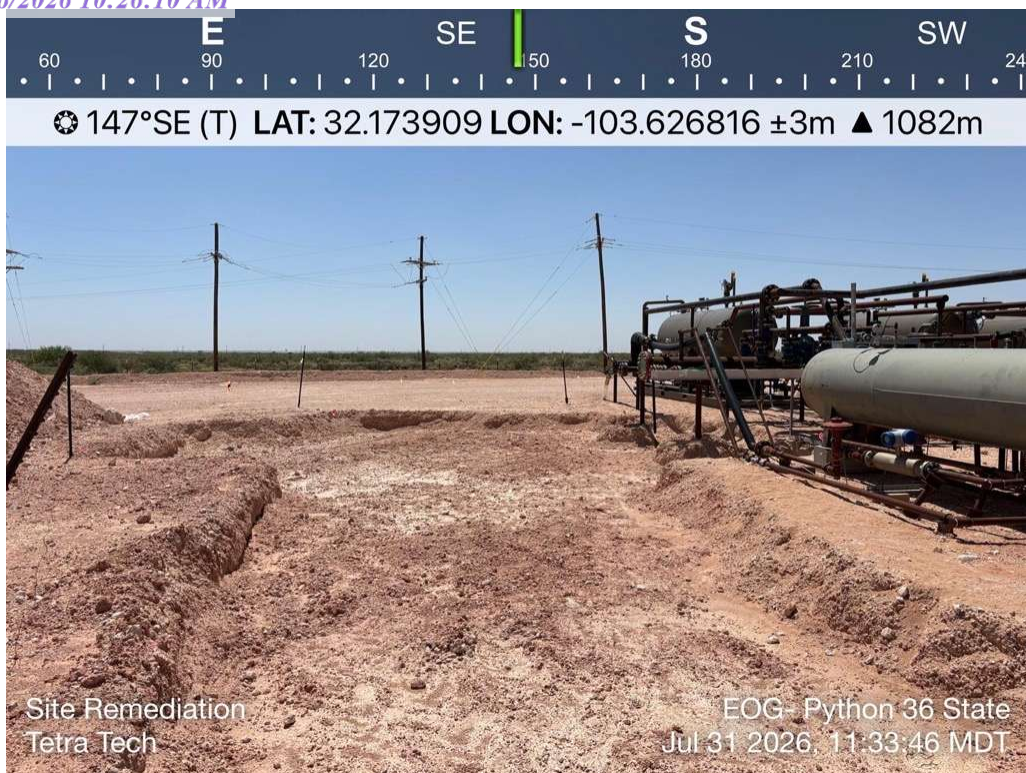
| Tetra Tech Inc. | Description | View Southeast View of production-related equipment and remediation excavation. | 3 |
