**REMEDATION CLOSURE REPORT****INTRODUCTION**

- Responsible Party: Maverick Permian, LLC
- Responsible Party and Document Submitter Contact Info:
  - Diversified Energy, LLC – Bryce Wagoner @ [bwagoner@dgoc.com](mailto:bwagoner@dgoc.com)
  - KSUE Environmental, LLC – Tom Bynum @ [tombynum@gmail.com](mailto:tombynum@gmail.com)
- Site Name: East Vacuum (GSA) Unit #010
- API #: 30-025-21382
- NMSLO Lease # and Lessee: B0-1845-01 Chevron USA INC
- ROE # for Remediation: N/A
- NMOCD Incident #: NOY1801748389
- PLSS and County: N – 34 – 17S – 35E Lea County
- Latitude and Longitude: 32.7866249°, -103.4487305°
- Reason for the project: Remediation of release discovered on January 15, 2018

## East Vacuum (GSA) Unit #010

Maverick Permian  
API #30-025-21382  
Lea County, NM  
NOY1801748389  
Surface Water Map

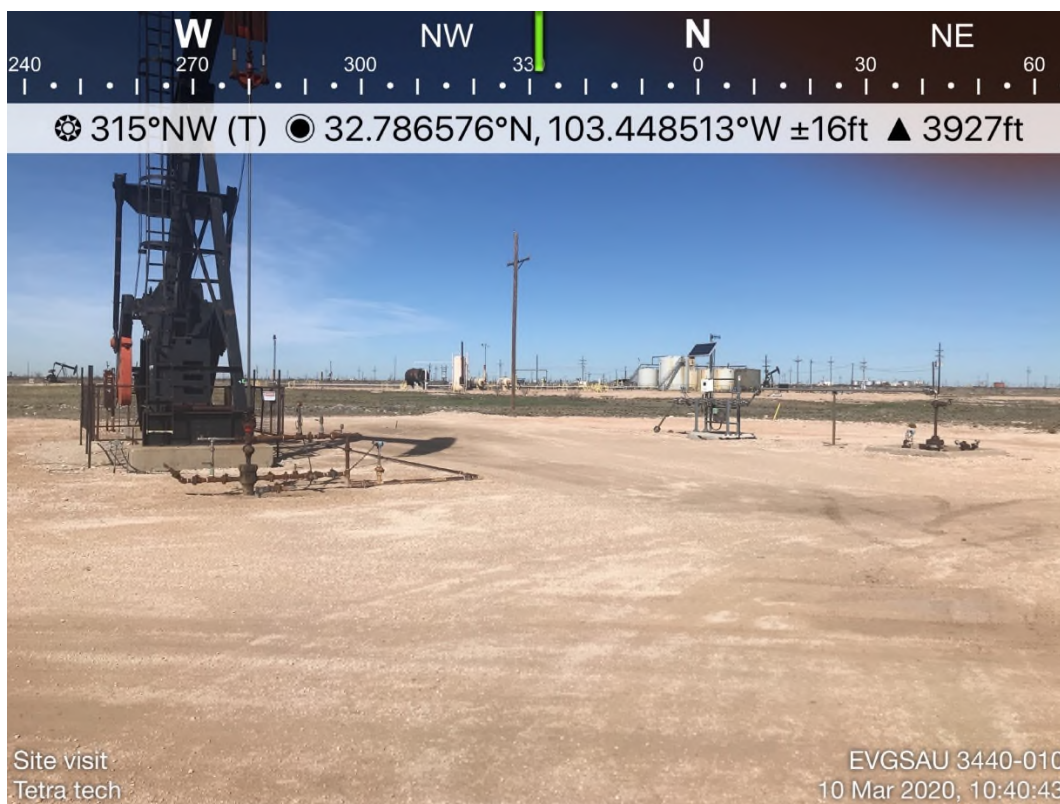
| TETRA TECH, INC.<br>PROJECT NO.<br>212C-MD-01796 | DESCRIPTION | View west-northwest of formerly impacted surface area. | 2 |

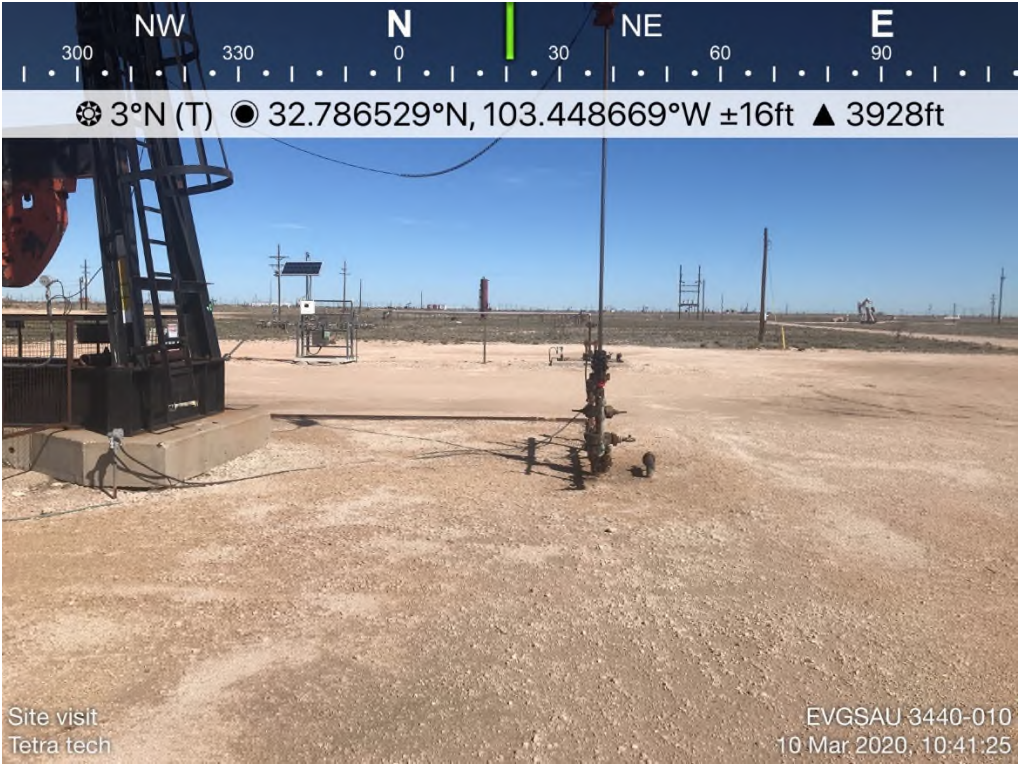
| TETRA TECH, INC.<br>PROJECT NO.<br>212C-MD-01796 | DESCRIPTION | View of wellhead at Site. | 3 |

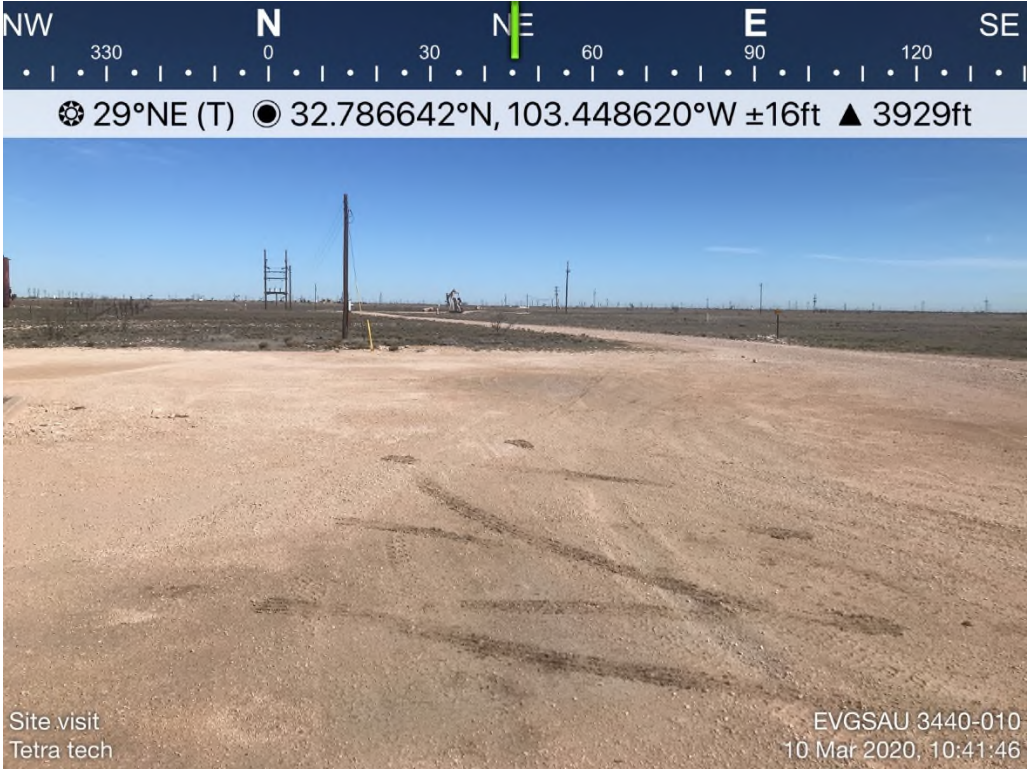
| TETRA TECH, INC.<br>PROJECT NO.<br>212C-MD-01796 | DESCRIPTION | View northeast of approximate release point and the former impacted surface area.. | 4 |

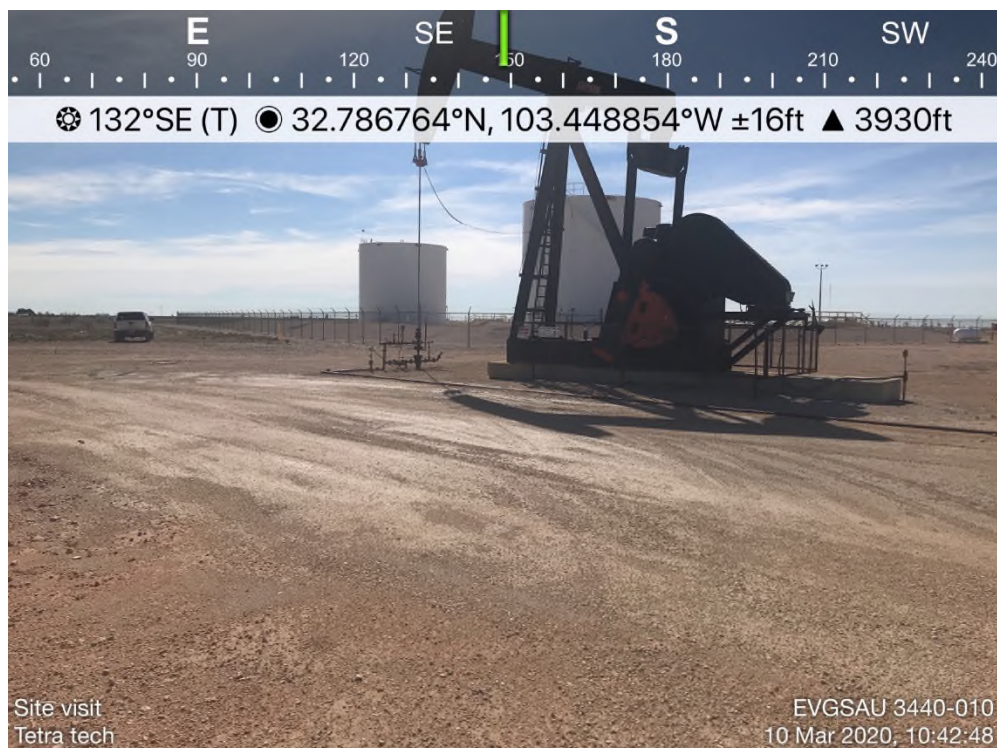
| TETRA TECH, INC.<br>PROJECT NO.<br>212C-MD-01796 | DESCRIPTION | View southeast of the well pad and formerly impacted area. | 5 |
