Re: Closure Report  
Lone Tree Draw 13 St CTB  
Incident Number nAPP2510546348  
Eddy County, New Mexico

Safety & Environmental Solutions (SESI), on behalf of Devon Energy Production Company, LP (Devon), has prepared this Closure Report to document assessment, delineation, excavation, and confirmation soil sampling activities at Lone Tree Draw 13 St CTB (Site). The purpose of the Site assessment and soil sampling activities was to assess the presence or absence of impacts to soil following a release of produced water at the Site. Based on field observations and soil sample laboratory analytical results, Devon is submitting this Closure Report, describing Site assessment, delineation and excavation activities that have occurred to date for Incident Number nAPP2510546348.

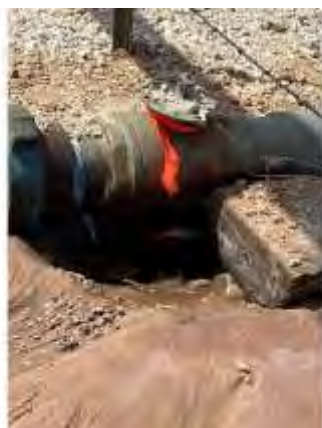
**Photo Number:** 2**Heading:** Release source documentation**GPS:** Not available**GPS Accuracy:** Not available**Elevation:** Not available**Bearing:** Not available**Date/Time:** April 23, 2025; time not available**Description:** Close-up view of piping at the reported release source area.

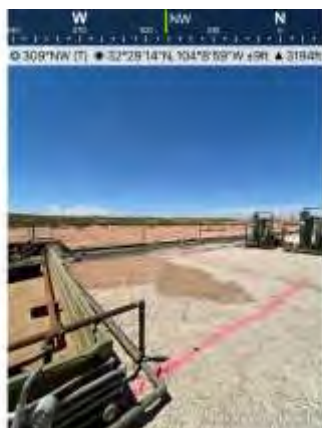
**Photo Number:** 3**Heading:** Initial assessment**GPS:** 32.487306, -104.149922**GPS Accuracy:** ±9 ft**Elevation:** 3,195 ft (973.7 m)**Bearing:** 309° NW (T)**Date/Time:** April 21, 2025, 1:36:11 PM**Description:** Overview of the release area and marked limits adjacent to site piping and production equipment.

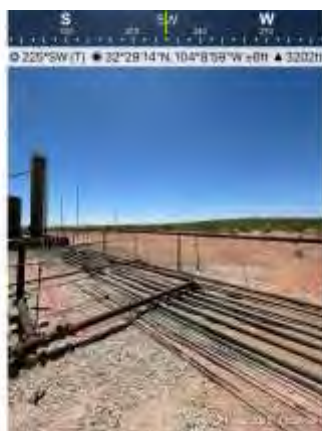
**Photo Number:** 4

**Description:** View of the marked release area along the pipeline corridor.

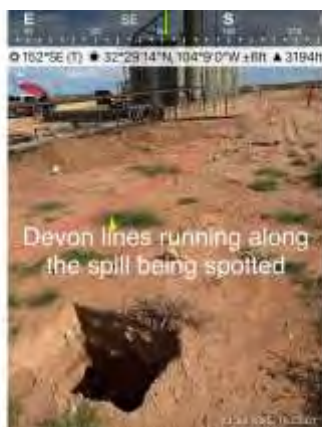
**Photo Number:** 9

**Description:** Excavation adjacent to existing production lines within the affected area.

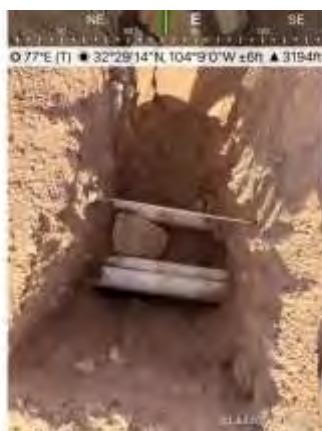
**Photo Number:** 10

**Description:** Narrow excavation beneath the pipeline corridor showing subsurface piping.

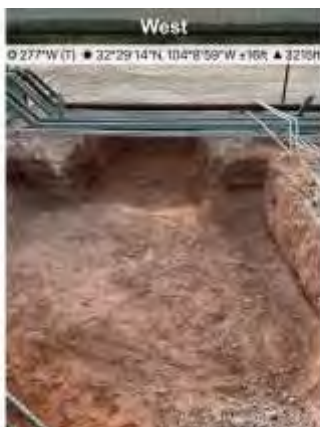
**Photo Number:** 26

**Description:** Excavation beneath the pipeline corridor following additional soil removal.

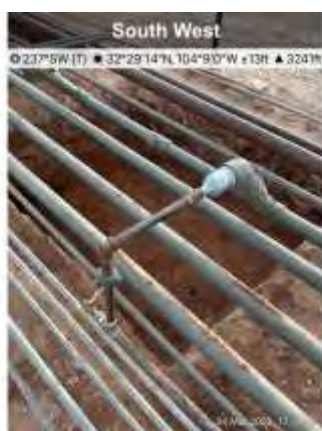
**Photo Number:** 29

**Description:** View of the excavation beneath multiple pipelines during final remediation work.

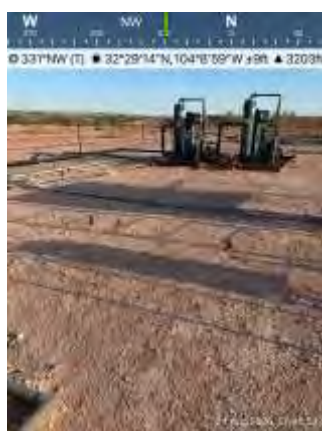
**Photo Number:** 30

**Description:** Overview of the previously remediated area during the follow-up inspection. The backfilled and graded surface remained intact around the production equipment.

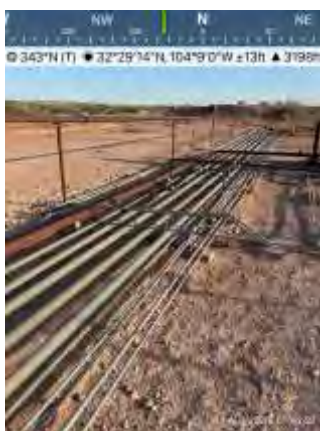
**Photo Number:** 32

**Description:** View looking north along the pipeline corridor showing the intact restored ground surface.
