SUBJECT: Liner Inspection and Closure Report for North Thistle 3 CTB 1– August 7, 2026 Site Visit

Incident ID: nAPP2619052454  
Facility ID (Name): fAPP2130622273 (NORTH THISTLE 3 CTB 1)  
Facility Location: Unit P of Section 3, Township 23 South, Range 33 East, New Mexico  
Facility GPS Coordinates: 32.32966643, -103.554004  
Lea County, New Mexico

# Environmental Site Inspection Field Notes & Photolog Report

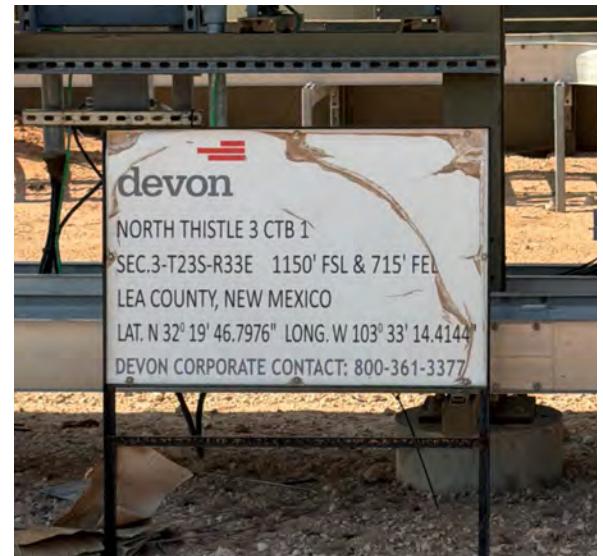
**Linear Inspection** 8/08/2026 8:39 AM

- Arrive on site, JHA, check surroundings
- Begin Inspection by visually observing liner by walking the containment
- Checking liner for any abrasions, rips, tears, cuts and UV damage
- Photos taken at different angles and each cardinal direction to verify visual observations.
- No signs of liner being compromised or breached leading to fluids outside of containment.
- Liner integrity confirmed, passes inspection.

- No further action necessary.
- Upload photos and notes.
- Complete closure report and submit for approval.

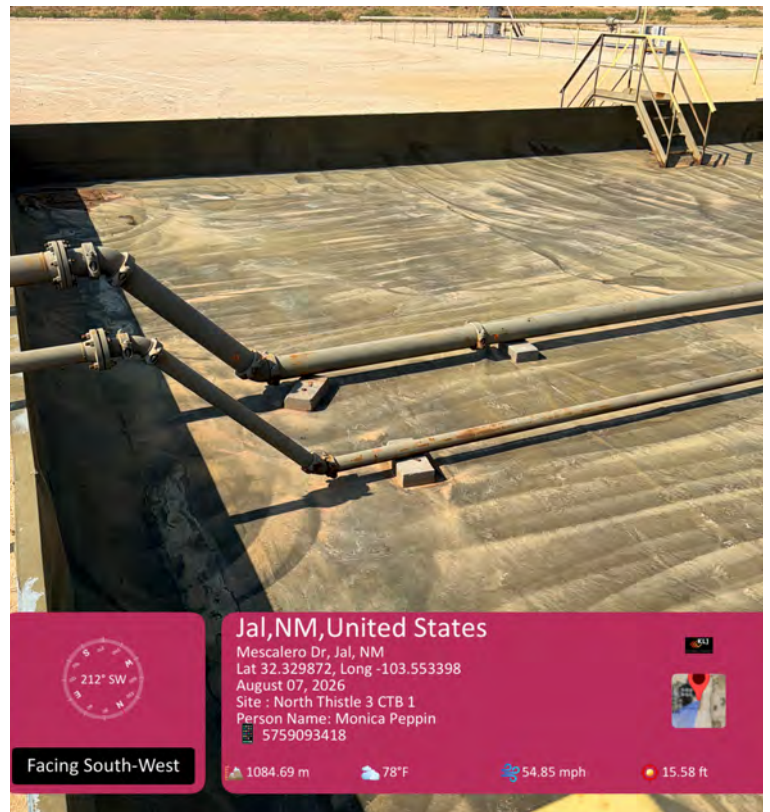
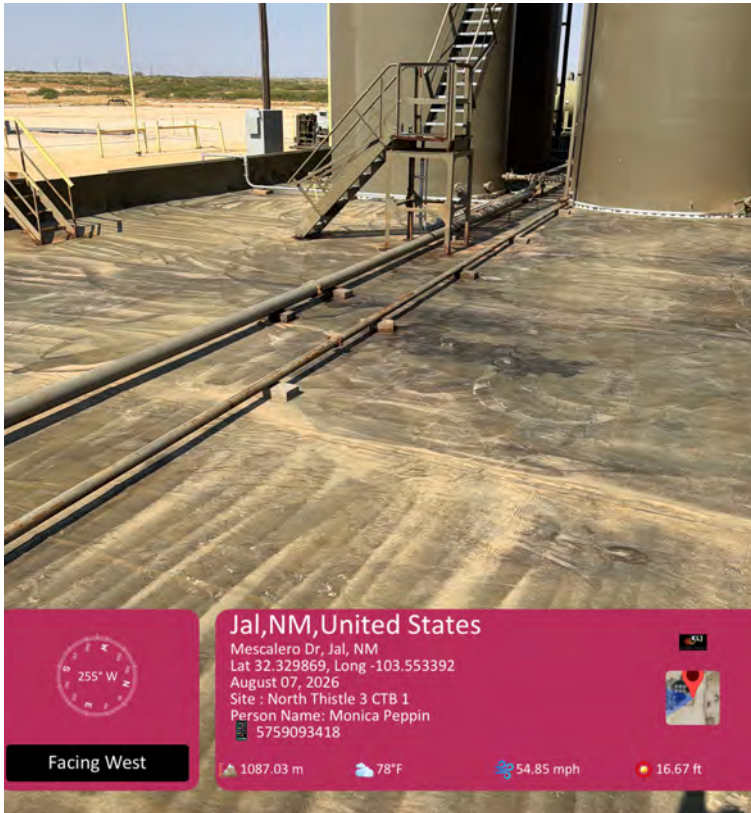
# Photolog

During the visit, KLJ personnel conducted a visual inspection of the secondary containment to verify liner integrity. Observations included checks for perforations, tears, UV damage, or defects that could compromise containment performance. The liner was confirmed to be intact, with no observed integrity issues or conditions requiring repair or replacement. Photographic documentation is included in the Liner Inspection Field Notes & Photolog Report (**Appendix A**).

Based on the findings of the liner inspection, KLJ concludes that liner integrity is adequate to contain fluids and there are no further actions required in relation to incident nAPP2619052454.

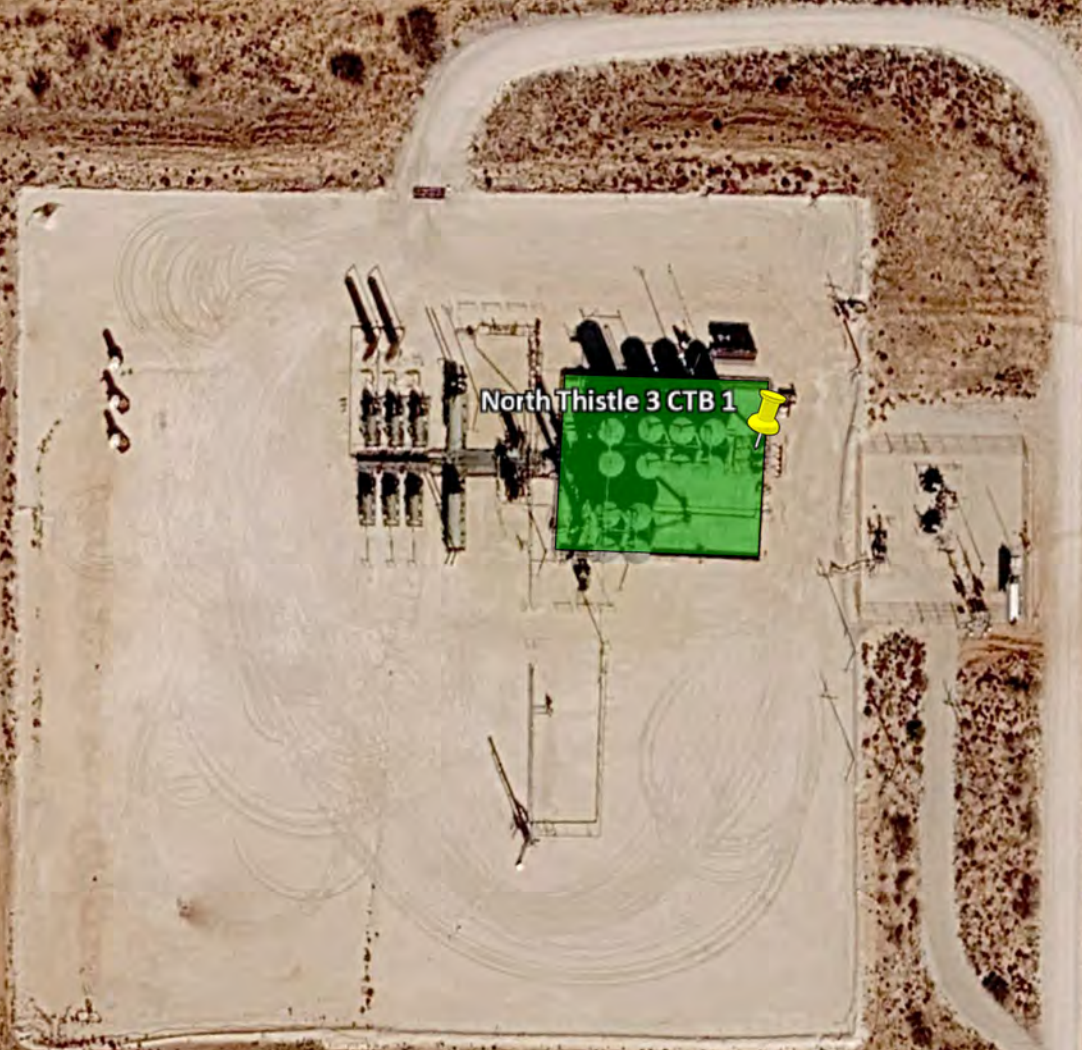
## North Thistle 3 CTB 1

Containment Area: Approx 12,573 sq ft

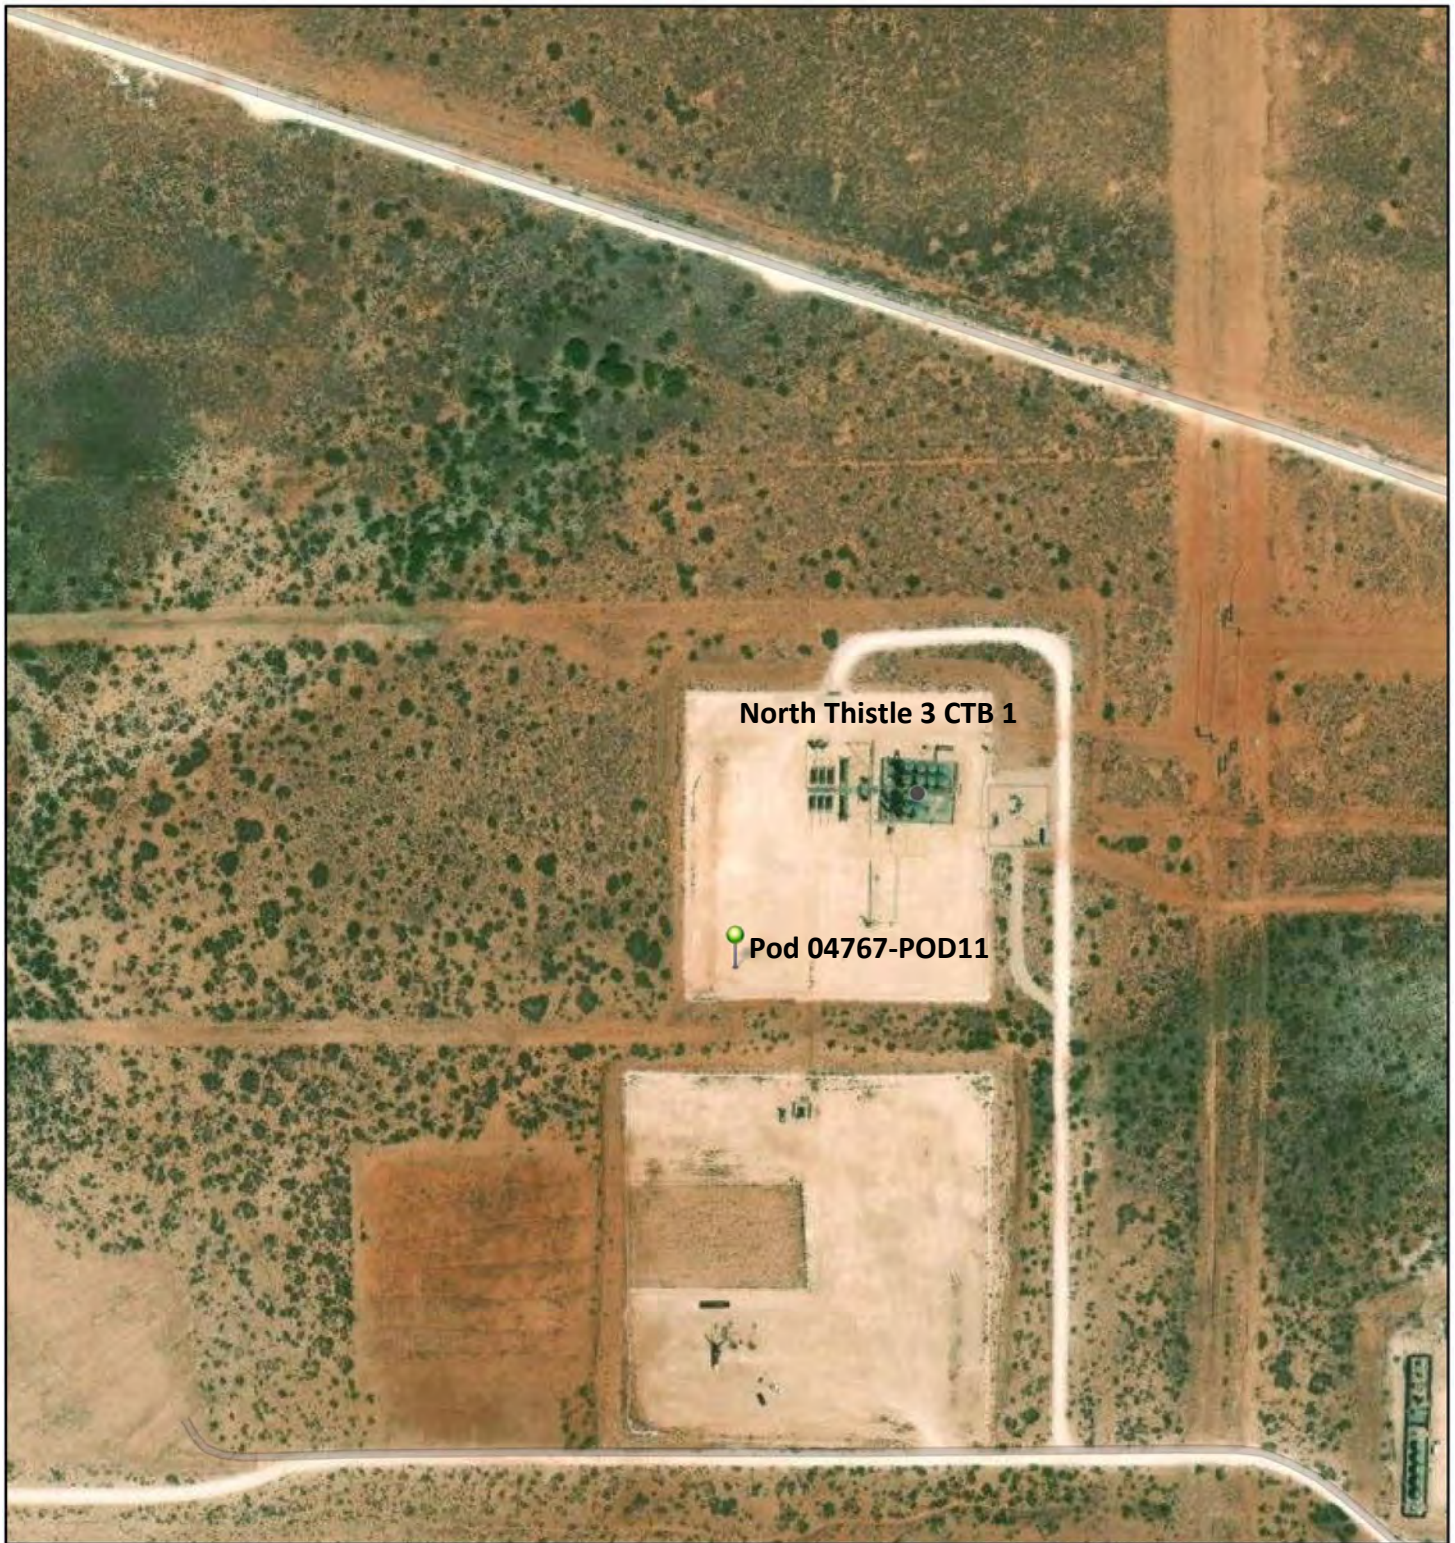
# North Thistle 3 CTB 1 - Nearest Pod for DTGW Determination

Based on New Mexico Office of the State Engineer (NMOSE) records, the nearest Point of Diversion (POD) C-04767-POD1 is located at the Site and consists of a temporary borehole advanced to a depth of approximately 55 feet below ground surface (bgs), with no groundwater encountered. The nearest domestic well used for stock watering purposes, NMOSE C-03582-POD1, is 1.43 miles southeast of the Site.

OSE Pod 04797-P OD 1 **Pod Located on Site**
-

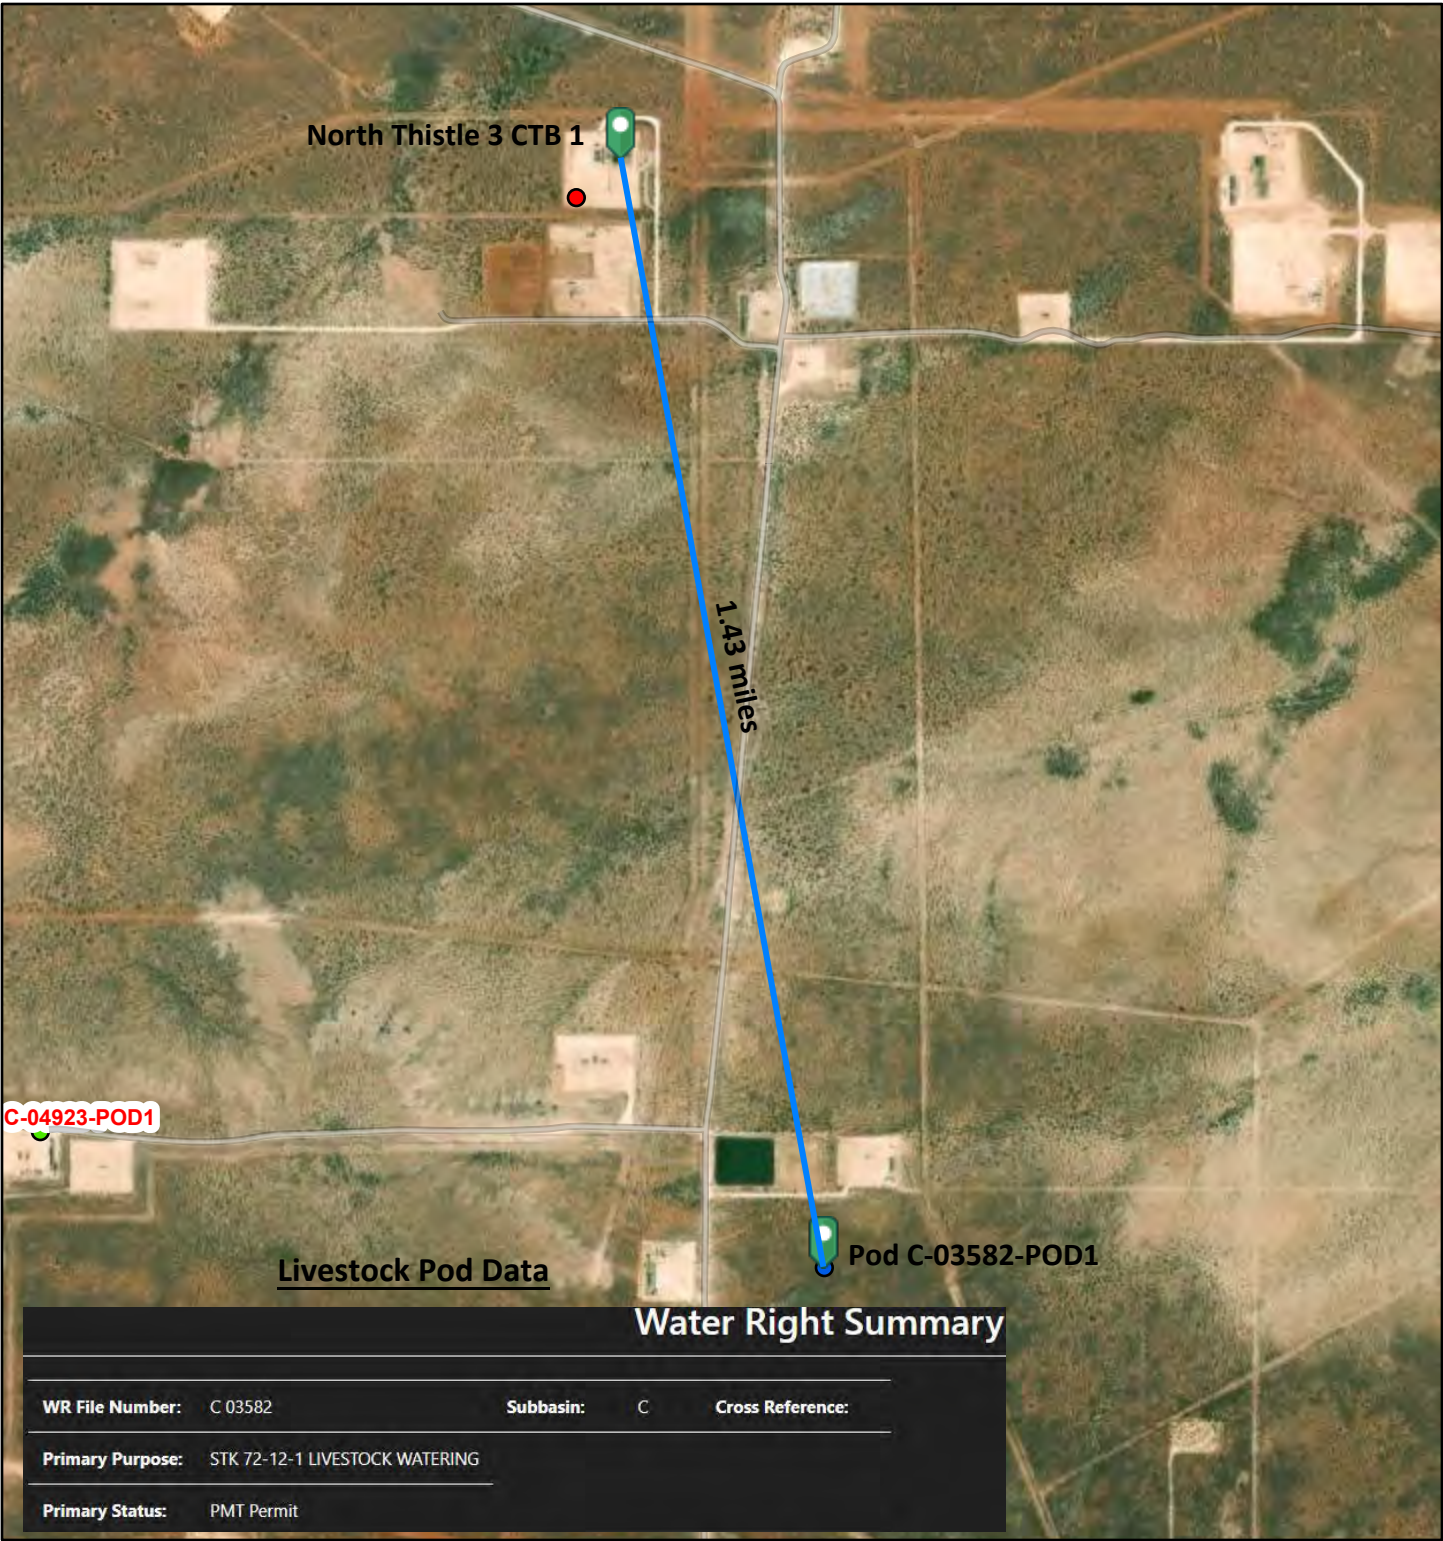
# North Thistle 3 CTB 1 - Nearest Domestic Well Map

Nearest Domestic Pod  
C-03582-Pod1  
Use  
Livestock Watering  
Distance  
1.43 miles
