## REVISED CLOSURE REQUEST

Spunky BUK State Com 1H  
Incident Number nAPP2609728018  
SLO Lease Number: VB-1766-0001  
Eddy County, New Mexico  
Unit D, Section 02, T26S, R26E  
32.078485, -104.270667

September 16, 2026

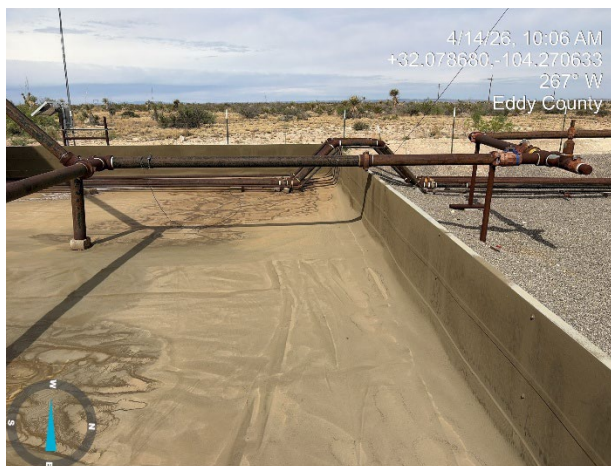
tear closer to the tank and BS26-02 was advanced at the tear closer to the containment sidewall – with an additional scaled figure depicting both breach locations included in the revised submittal. Regarding the Google Earth satellite imagery from April 26, 2026, EOG respectfully submits that the apparent discoloration on the north side of the tank battery is attributable to darker gravel material added to the northern bermed area, as evidenced by 2019 historical imagery and the below Site photo from liner inspection activities.

EOG believes the contrast observed in the more recent imagery does not represent hydrocarbon staining or a surface release; furthermore the incident addressed in this report is laterally delineated to the north by borehole BS26-06, to the south by BS26-04, to the west by BS26-05, and to the east by BS26-03 and EOG does not believe additional grab sampling on the north, west, or south sides of the containment is warranted based on the existing delineation data. EOG acknowledges that the area associated with borehole BS26-01 was inadvertently excluded from the original excavation scope. Although the Site was acquired by COG, EOG agreed to complete additional excavation of the liner breach in accordance with the above denial.

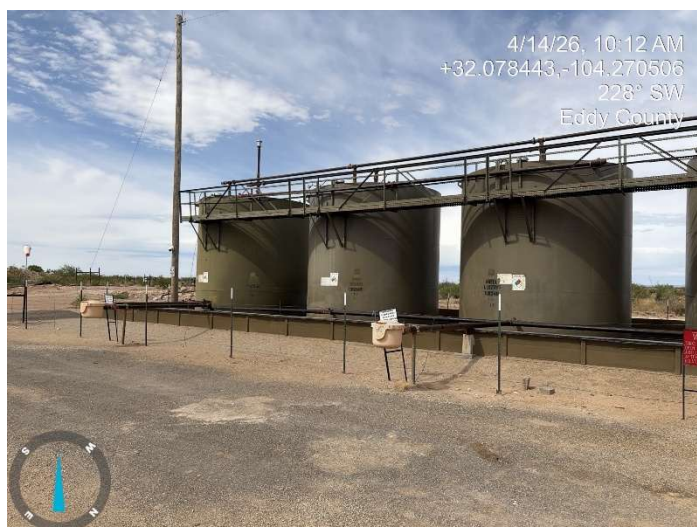
Photograph: 2

Description: Containment overview

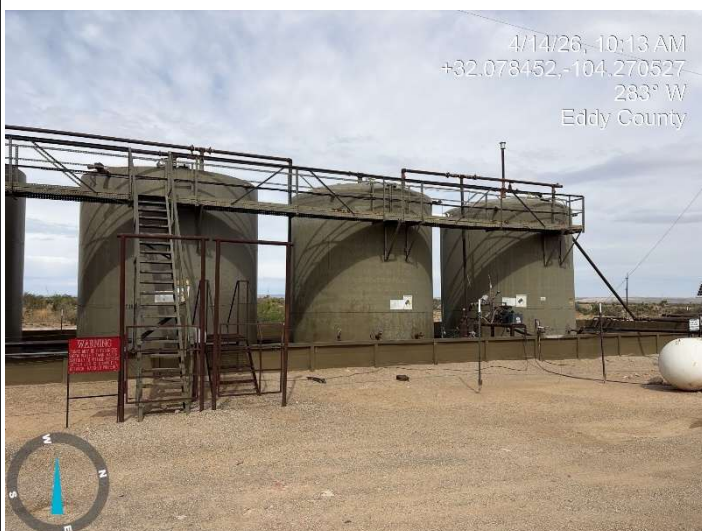
Photograph: 3

Description: Containment overview

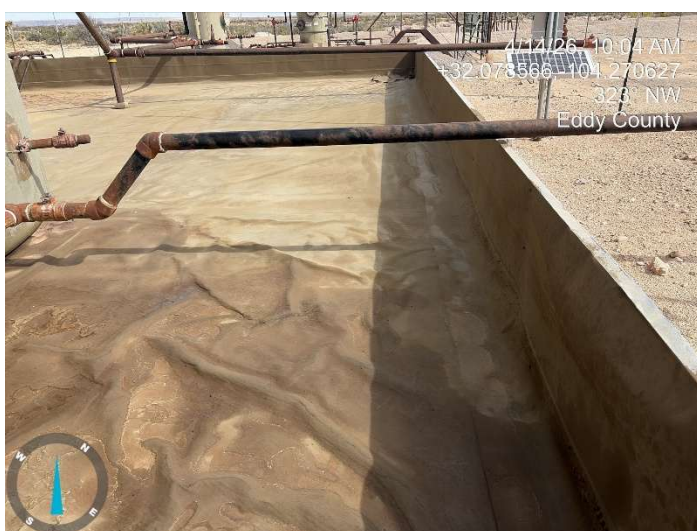
Photograph: 4

Description: Liner inspection activities

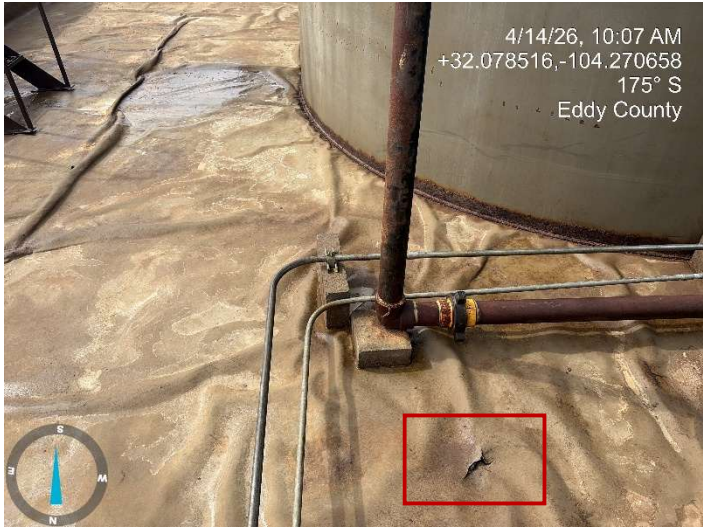
| Photograph: 7<br>Date: 4/14/2026<br>Description: Liner inspection activities | Photograph: 8<br>Date: 4/14/2026<br>Description: Location of tear identified in the floor of the lined containment (BS26-01) |

- 2) On pg. 4 you say: "One borehole, BS26-01, was advanced via hand auger at the location of the tear in the liner floor." As you can see in the second photo on pg. 30, this was located inside the metal lines that surround the tank, within a foot or so of the tank. This appears to be the breach shown in Photo 8. This area does not appear to be addressed in the remediation that occurred in the photographs shown on pg. 35.

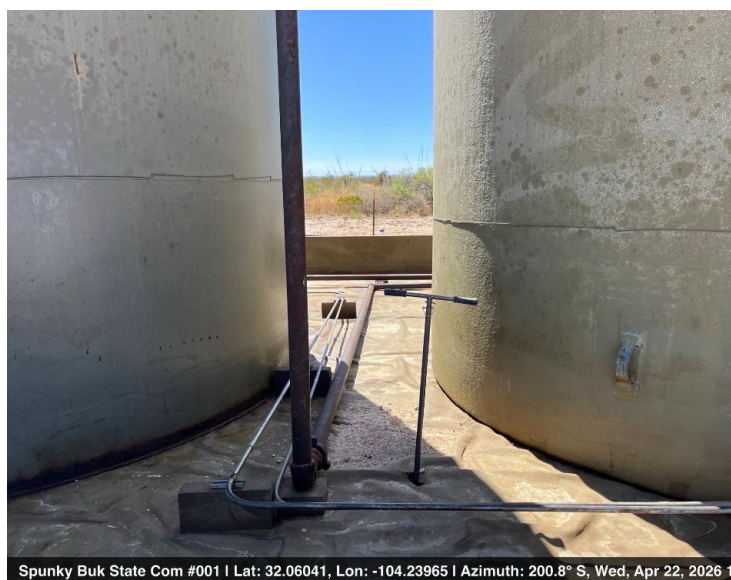
Date: 4/22/2026  
Time: 14:59  
Notes: BH26-01 collected at 0', 1', and 2' bgs.  
Latitude: 32.06040555555555  
Longitude: -104.23964722222222  
Direction: S

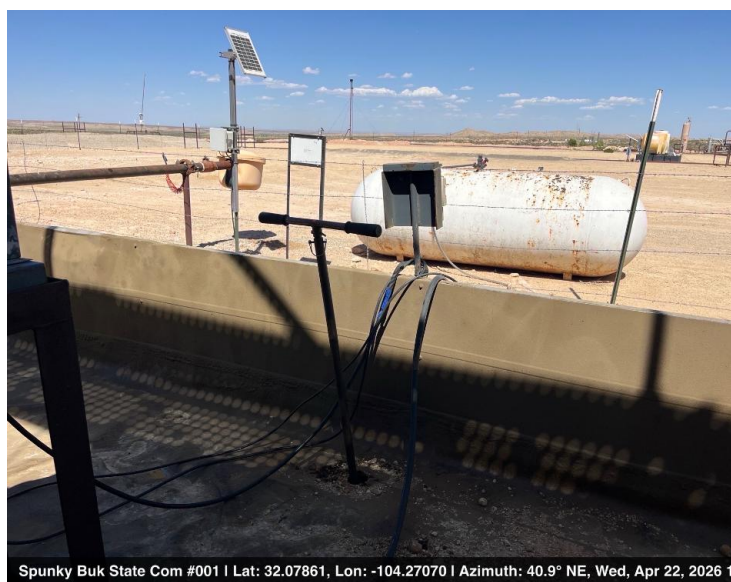
Date: 4/22/2026  
Time: 15:00  
Notes: BH26-02 collected at 0', 1', and 2' bgs.  
Latitude: 32.07860833333335  
Longitude: -104.27069722222222  
Direction: NE

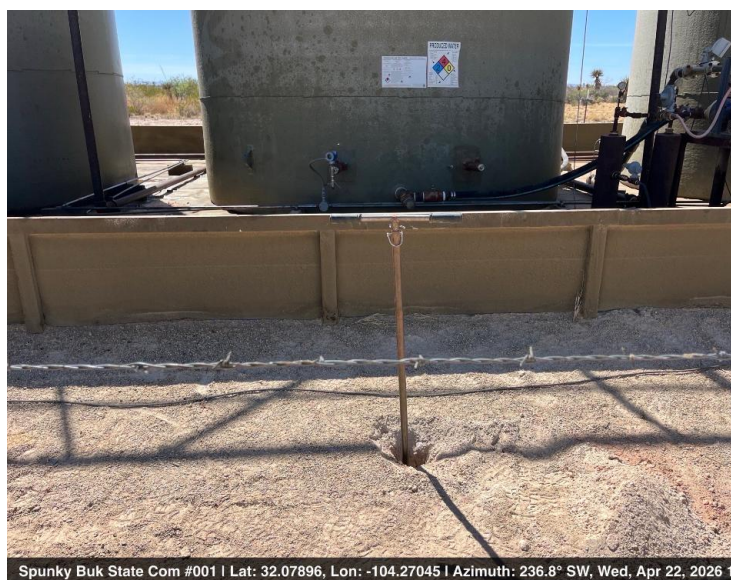
Date: 4/22/2026  
Time: 15:02  
Notes: BH26-03 collected at 0' and 2' bgs  
Latitude: 32.07895555555556  
Longitude: -104.27044722222222  
Direction: SW

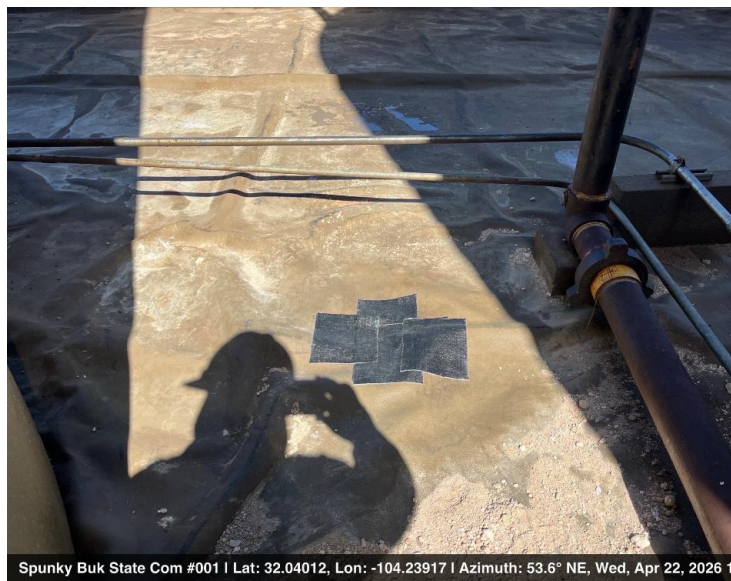
Date: 4/22/2026  
Time: 15:49  
Notes: BH26-01 liner tear was patched  
Latitude: 32.04011666666666  
Longitude: -104.23916666666666  
Direction: NE

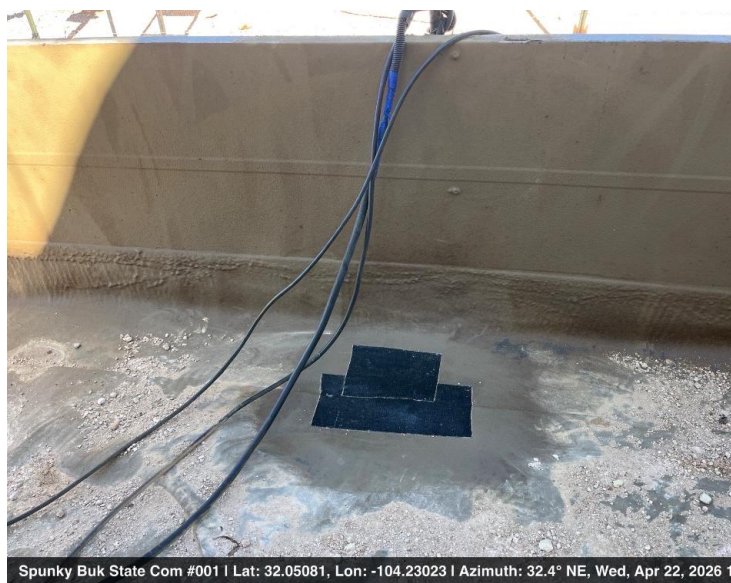
Date: 4/22/2026  
Time: 15:49  
Notes: BH26-02 liner tear was patched  
Latitude: 32.05080833333333  
Longitude: -104.230225  
Direction: NE

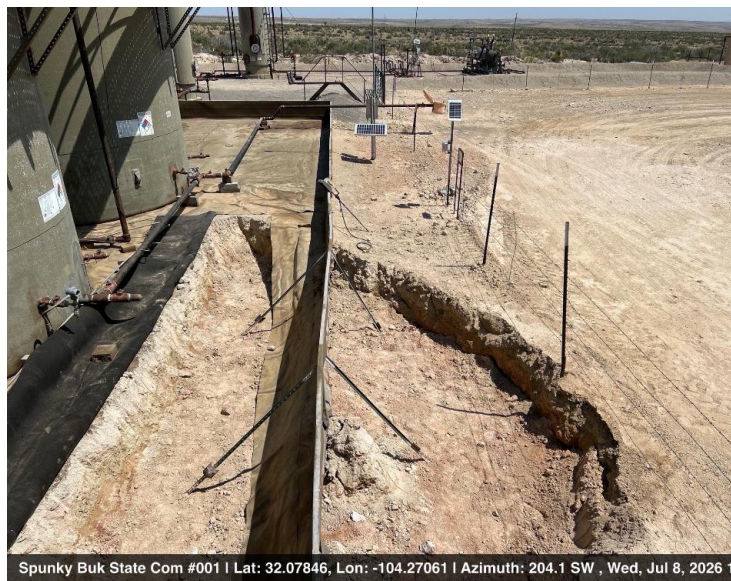
Date: 7/8/2026  
Time: 11:08  
Notes: On steps east of tanks facing north over excavation to 2.25 feet bgs.  
Latitude: 32.07846388888889  
Longitude: -104.27061388888889  
Direction: S

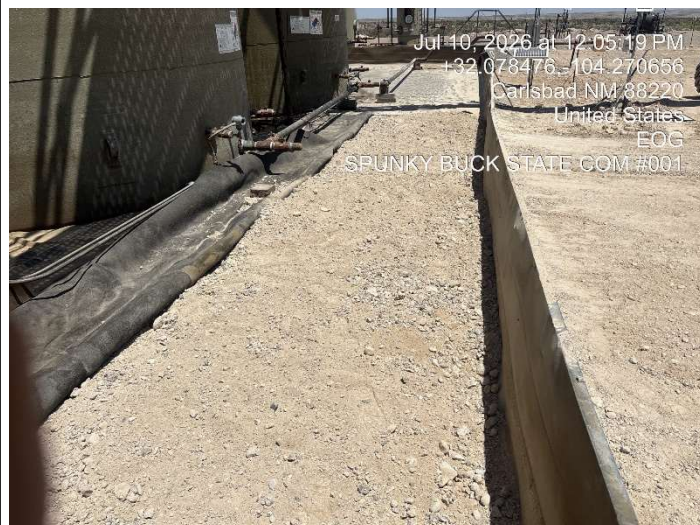
**Photograph: 1**                      **Date: 7/10/2026**

**Description: Backfilled excavation prior to liner repair**

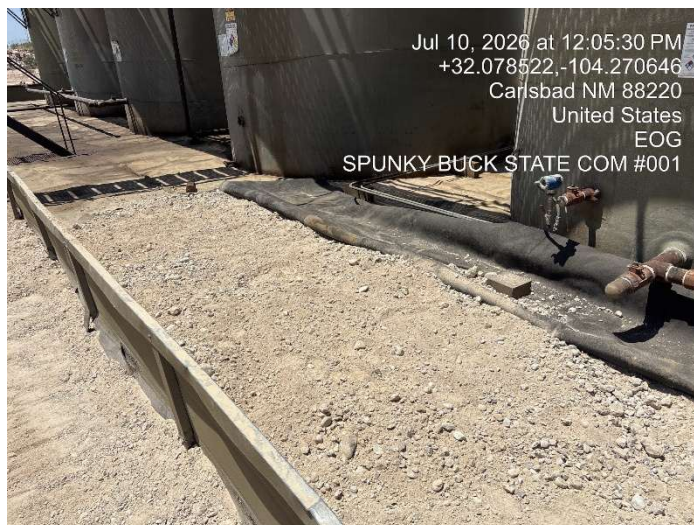
**Photograph: 2**                      **Date: 7/10/2026**

**Description: Backfilled excavation prior to liner repair**

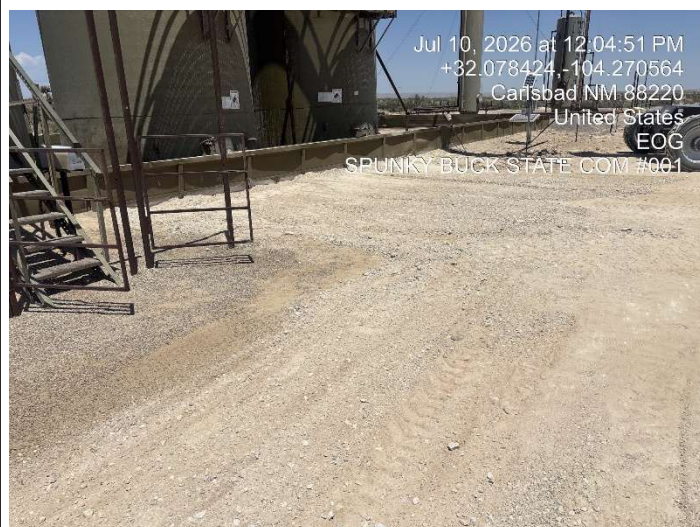
**Photograph: 3**                      **Date: 7/10/2026**

**Description: Backfilled excavation**

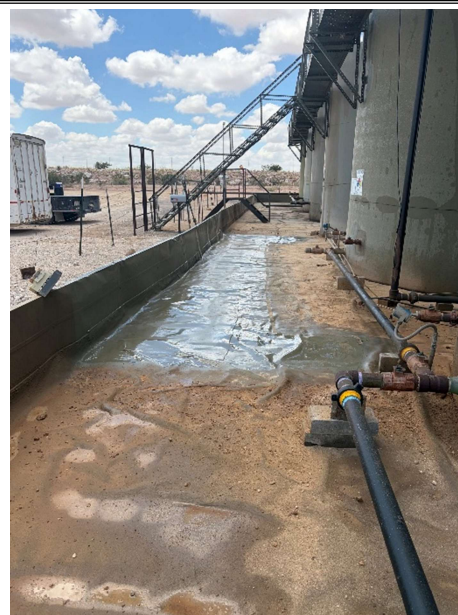
**Photograph: 4**                      **Date: 7/11/2026**

**Description: Repaired liner**

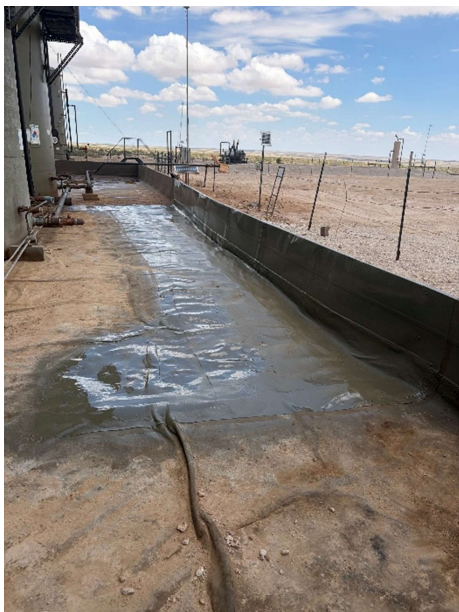
Photograph: 5 Date: 7/11/2026

Description: Repaired liner

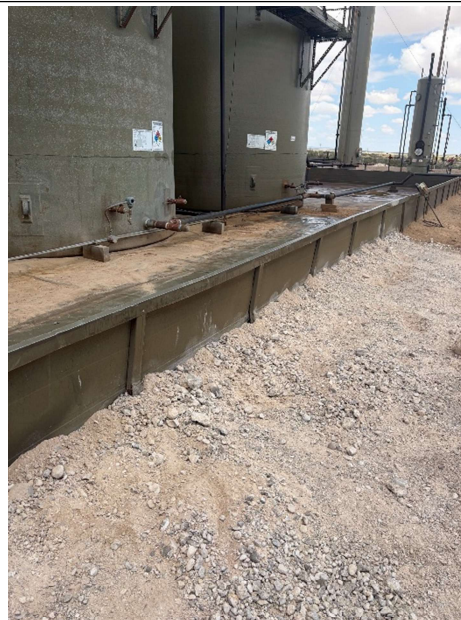
Photograph: 6 Date: 7/11/2026

Description: Repaired containment

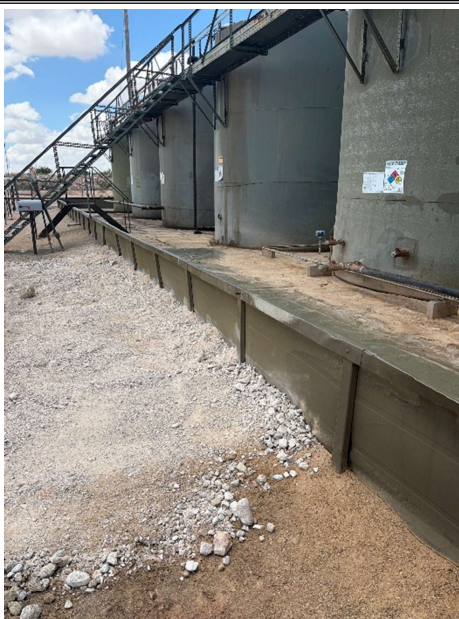
Photograph: 7 Date: 7/11/2026

Description: Repaired containment

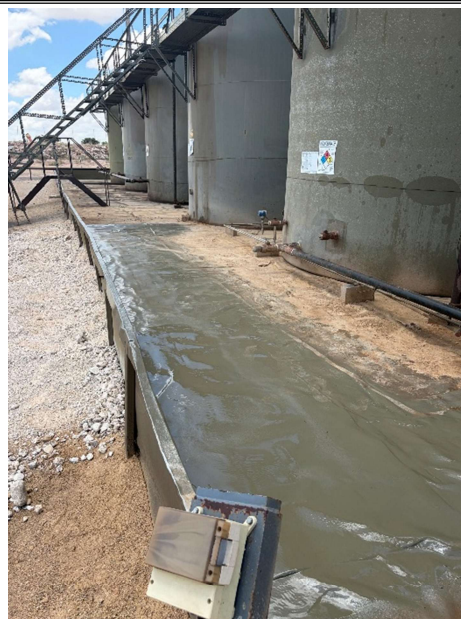
Photograph: 8 Date: 7/11/2026

Description: Repaired containment

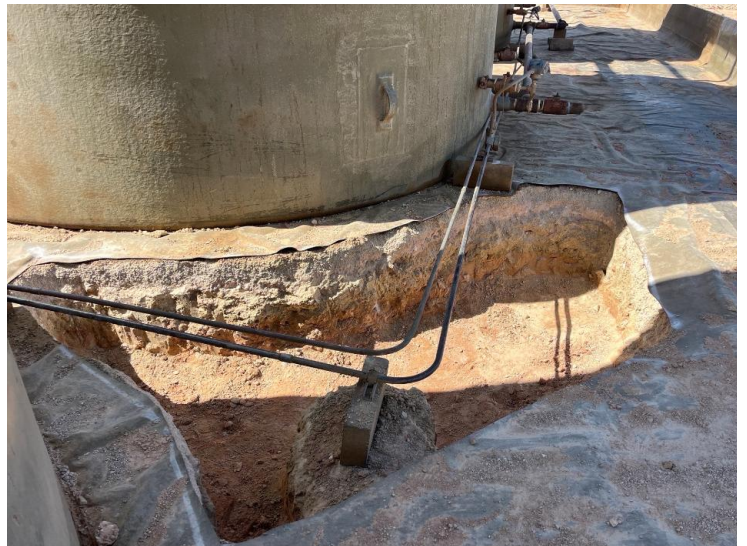
Date: 8/21/2026  
Time: 15:36  
Notes: South end of 2.25' excavation facing north. Area where BS26-04 and WS26-03 were collected  
Latitude: 32.07846674748963  
Longitude: -104.27059728232103  
Direction: N

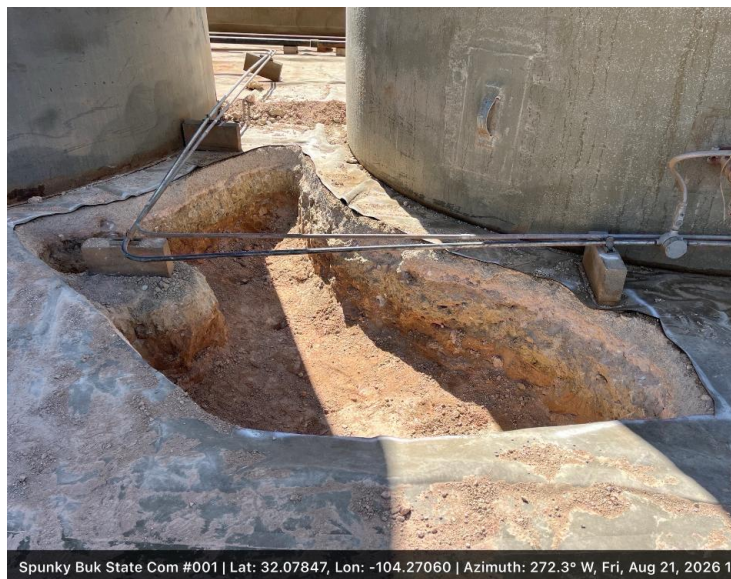
Date: 8/21/2026  
Time: 15:36  
Notes: East side of 2.25' excavation facing west. Area where BS26-04 and WS26-03 were collected  
Latitude: 32.07846674748963  
Longitude: -104.27059728232103  
Direction: W

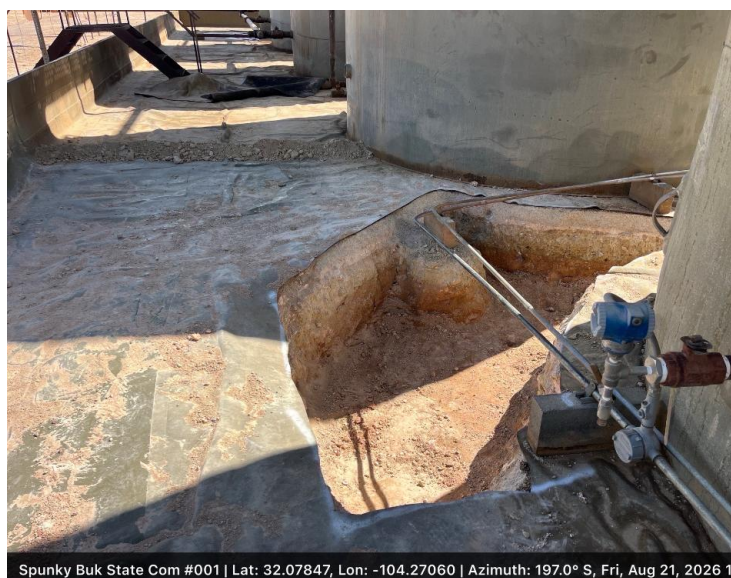
Date: 8/21/2026  
Time: 15:37  
Notes: North end of 2.25' excavation facing south. Area where BS26-04 and WS26-03 were collected  
Latitude: 32.07846674748963  
Longitude: -104.27059728232103  
Direction: S

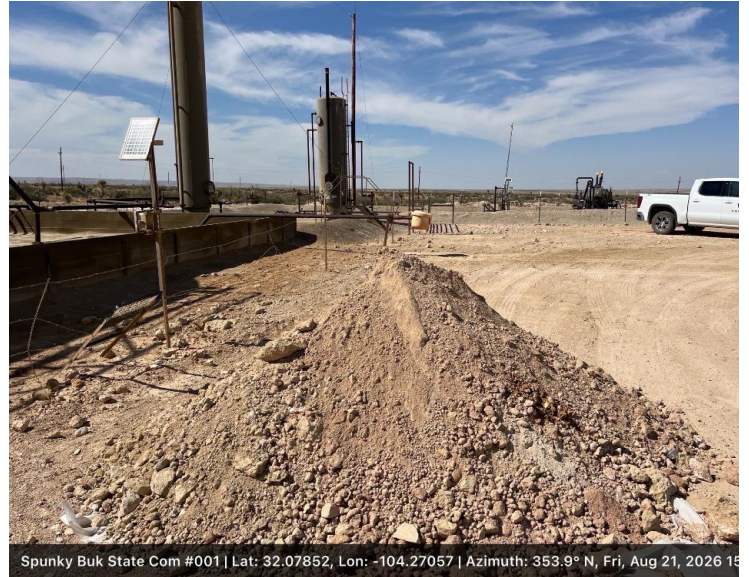
Date: 8/21/2026  
Time: 15:44  
Notes: Removed material placed on liner  
Latitude: 32.07852222222226  
Longitude: -104.27056944444445  
Direction: N

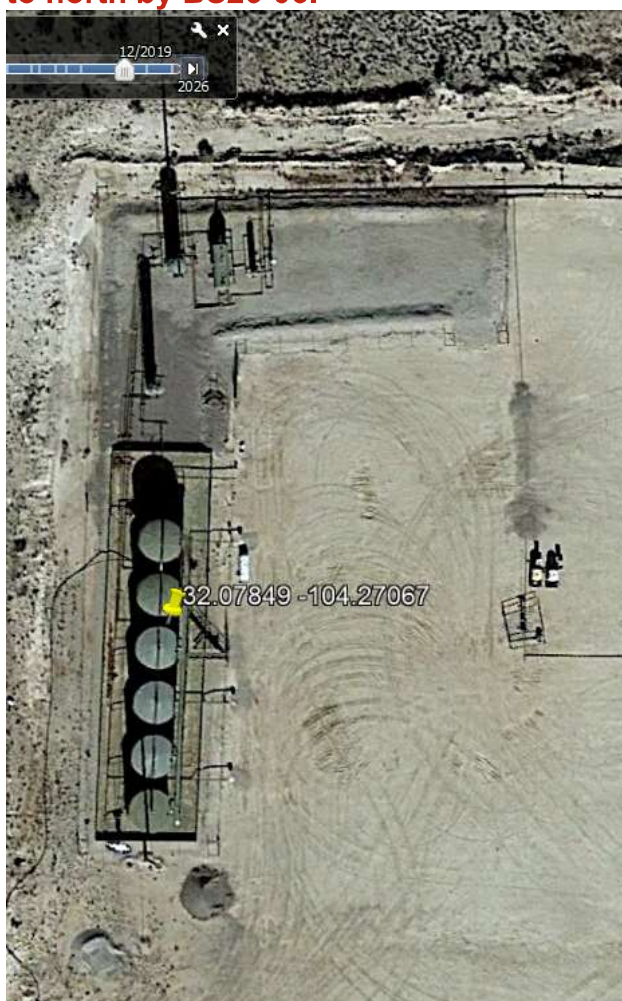
- **Based on the 2019 imagery, a darker gravel was added to the northern bermed area. EOG believes that the contrast on the camera used for updated imagery is distorting colors. The incident discussed in this report is laterally delineated to north by BS26-06.**

- EOG agrees, BS26-01 was missed in the original excavation. We will go back to site and complete remediation of that area to the maximum extent possible. Based on the area, we may not fully be able to cut a 5' x 5' area but will cut as close as we can to equipment.

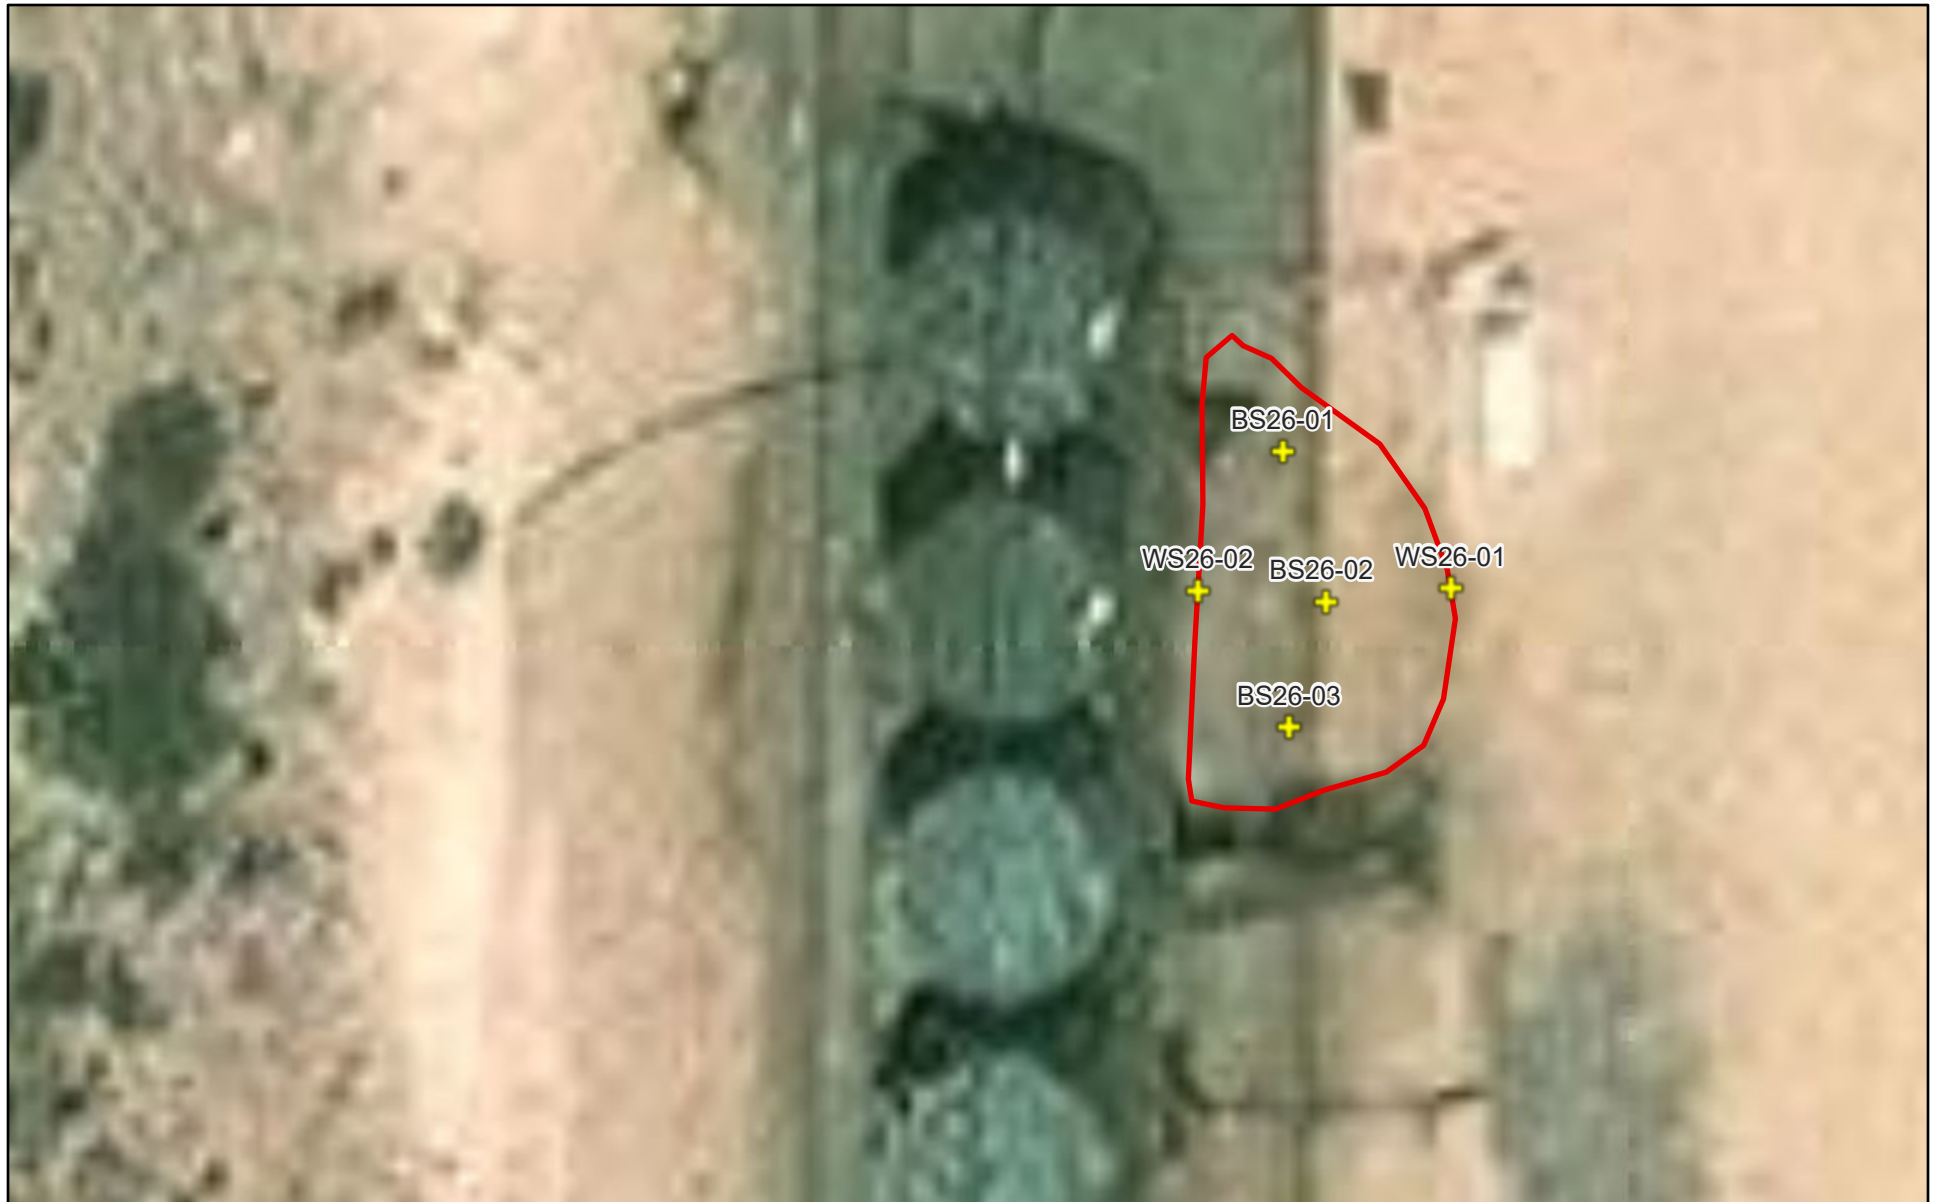
## Excavation Soil Sample Locations

World\_Boundaries\_and\_Places  
Confirmation Soil Sample  
+ Confirmation Sample

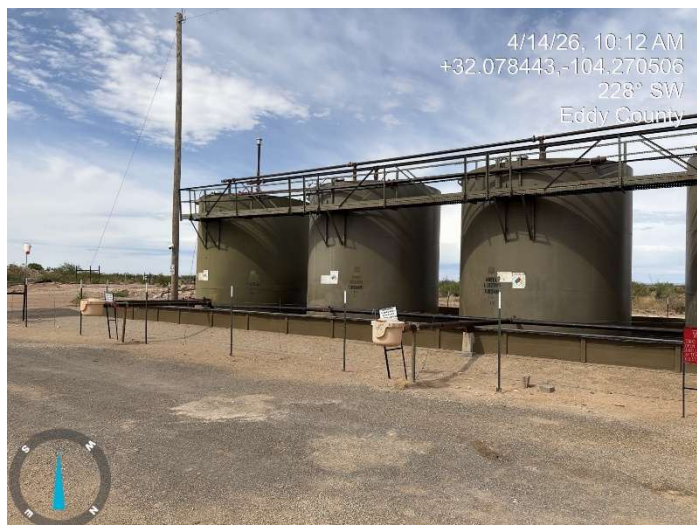
Photograph: 2

Description: Containment overview

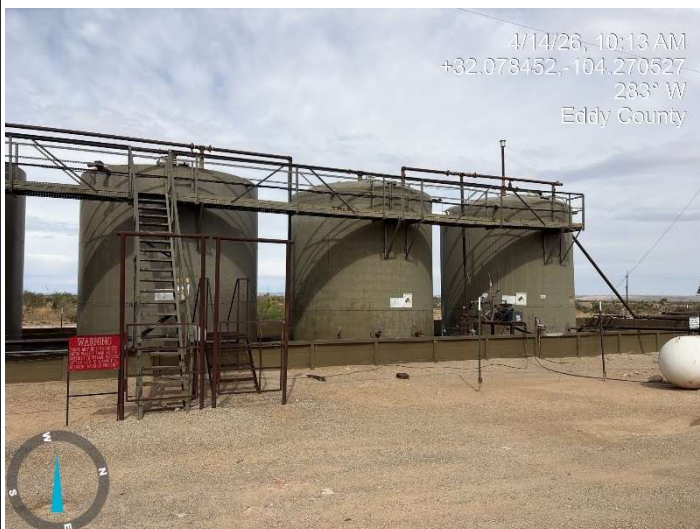
Photograph: 3

Description: Containment overview

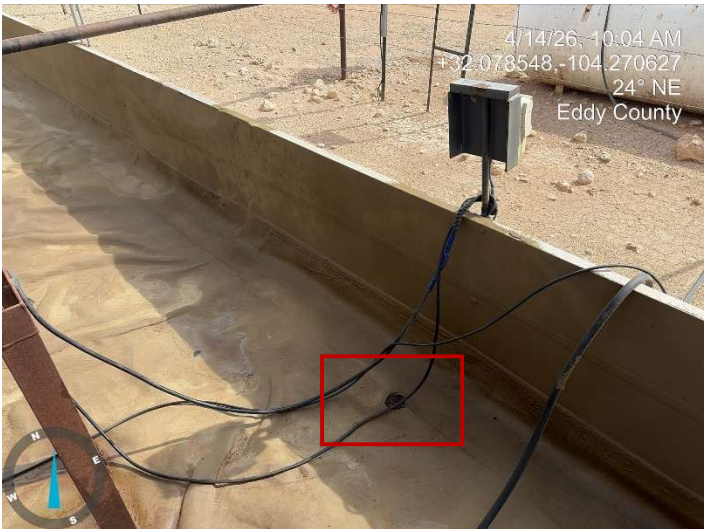
| Photograph: 5<br>Date: 4/14/2026<br>Description: Liner inspection activities | Photograph: 6<br>Date: 4/14/2026<br>Description: Location of hole identified in the floor of the lined containment |

- 3) Photo 6 of the liner inspection shows a hole closer to the containment side. How many breaches were found? The location of all breaches found during the liner inspection should be clearly marked on a scaled sitemap. Submit this within an updated remediation closure report.

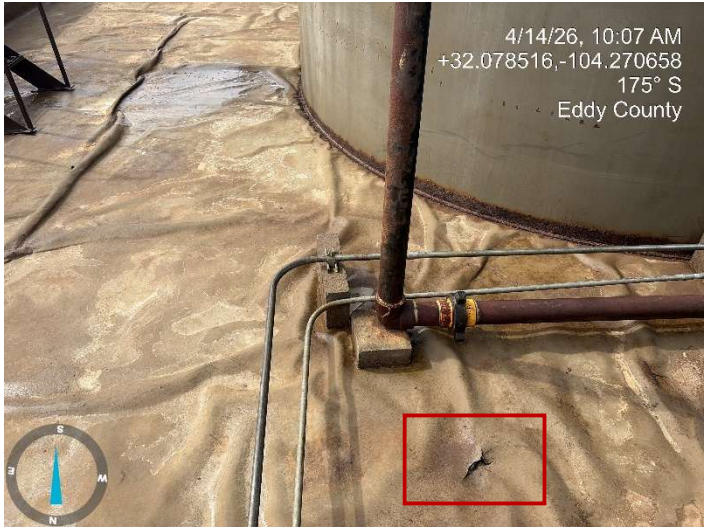
| Photograph: 7<br>Date: 4/14/2026<br>Description: Liner inspection activities | Photograph: 8<br>Date: 4/14/2026<br>Description: Location of tear identified in the floor of the lined containment |

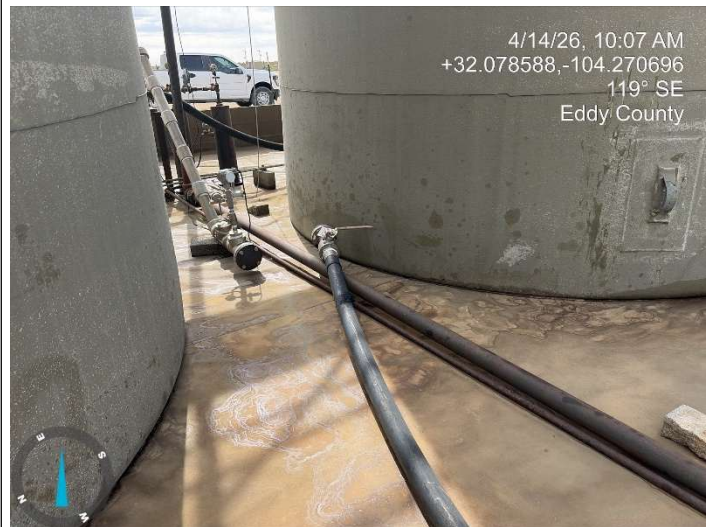
Photograph: 16

Description: Liner inspection activities

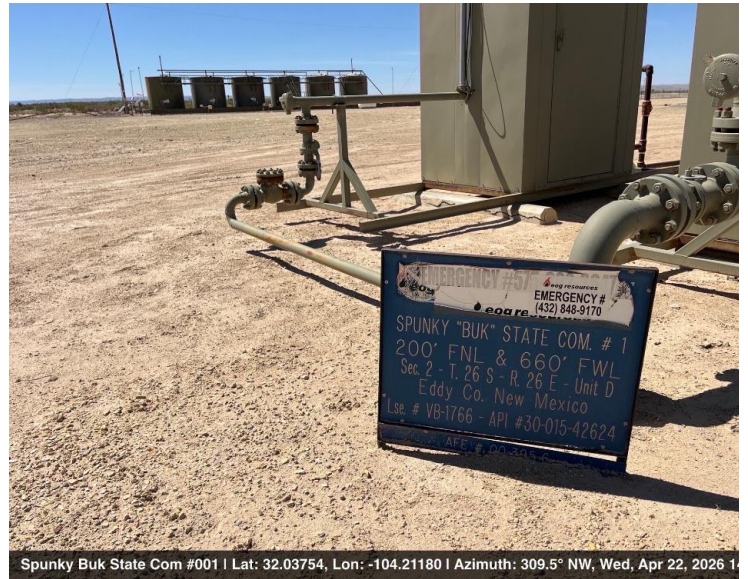
Date: 4/22/2026  
Time: 14:59  
Notes: BH26-01 collected at 0', 1', and 2' bgs.  
Latitude: 32.06040555555555  
Longitude: -104.23964722222222  
Direction: S

- **Remediation closure denied for the following reasons:**
- **1) Delineation samples are marked as BH samples on Figure 4 however the same samples are named with a BS prefix on Table I. Sampling nomenclature should be consistent throughout so as to eliminate confusion. Update.**
  - **Will update in revised report, should all be BS samples**

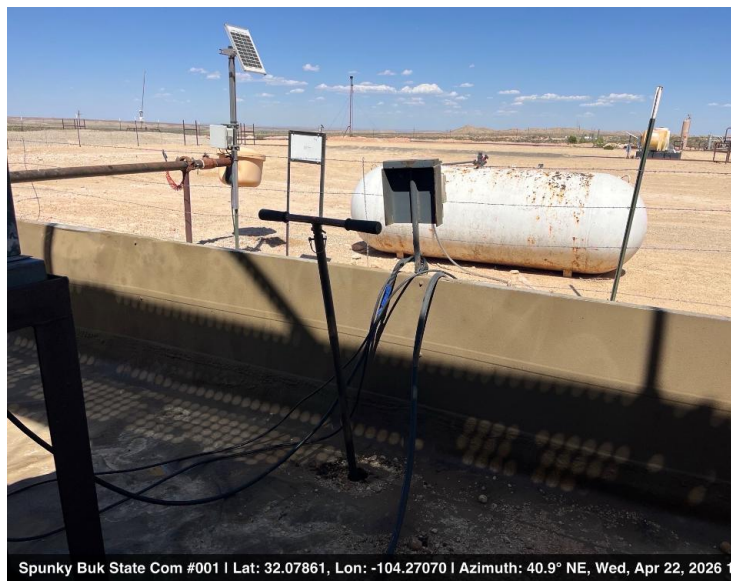
Date: 4/22/2026  
Time: 15:00  
Notes: BH26-02 collected at 0', 1', and 2' bgs.  
Latitude: 32.07860833333335  
Longitude: -104.27069722222222  
Direction: NE

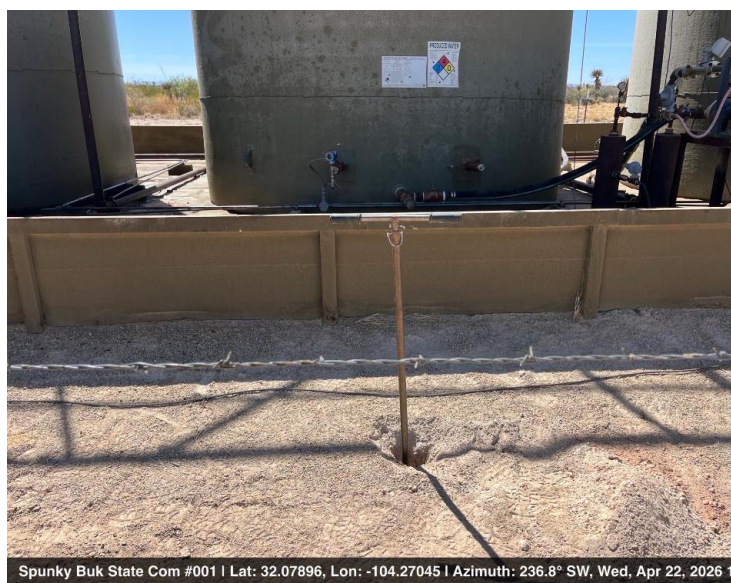
Date: 4/22/2026  
Time: 15:02  
Notes: BH26-03 collected at 0' and 2' bgs  
Latitude: 32.07895555555556  
Longitude: -104.27044722222222  
Direction: SW

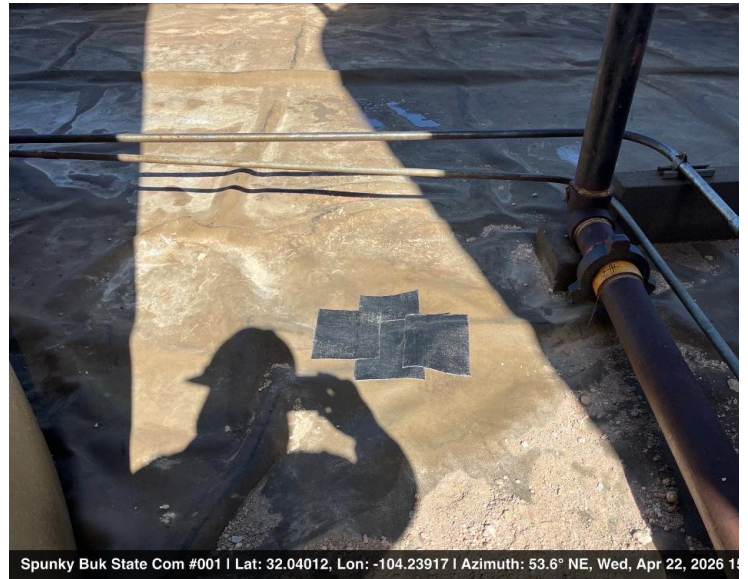
Date: 4/22/2026  
Time: 15:49  
Notes: BH26-01 liner tear was patched  
Latitude: 32.04011666666666  
Longitude: -104.23916666666666  
Direction: NE

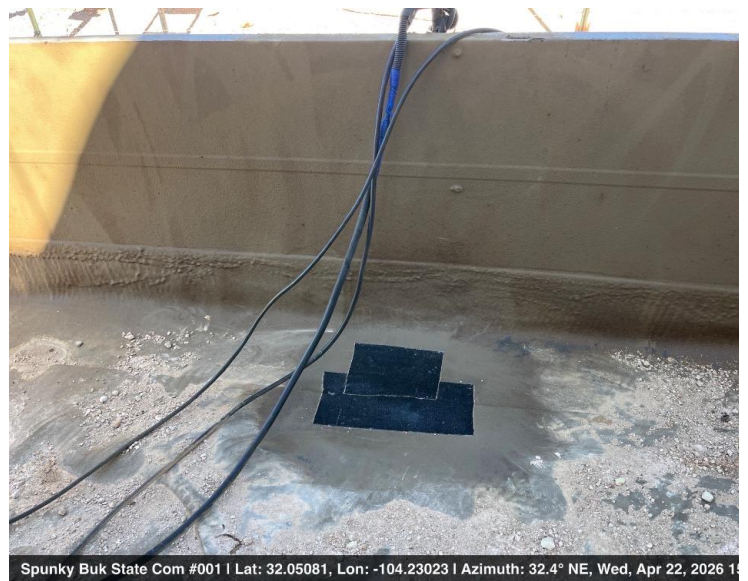
Date: 4/22/2026  
Time: 15:49  
Notes: BH26-02 liner tear was patched  
Latitude: 32.05080833333333  
Longitude: -104.230225  
Direction: NE

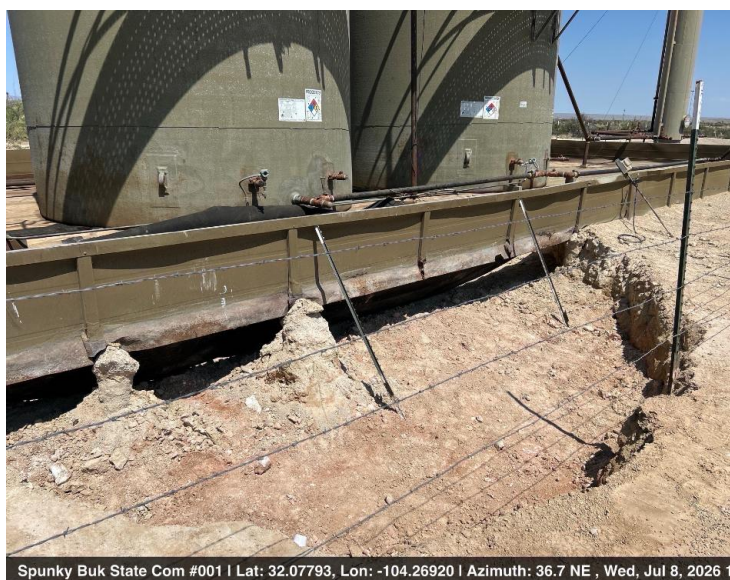
Date: 7/8/2026  
Time: 11:07  
Notes: East of containment facing northwest.  
Latitude: 32.07792777777778  
Longitude: -104.26920277777778  
Direction: NE

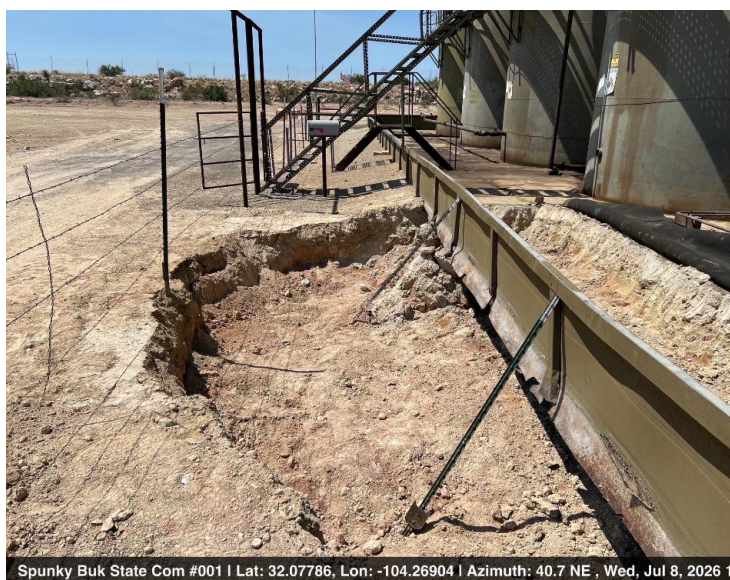
Date: 7/8/2026  
Time: 11:07  
Notes: East of containment facing south.  
Latitude: 32.07785555555556  
Longitude: -104.26904444444445  
Direction: NE

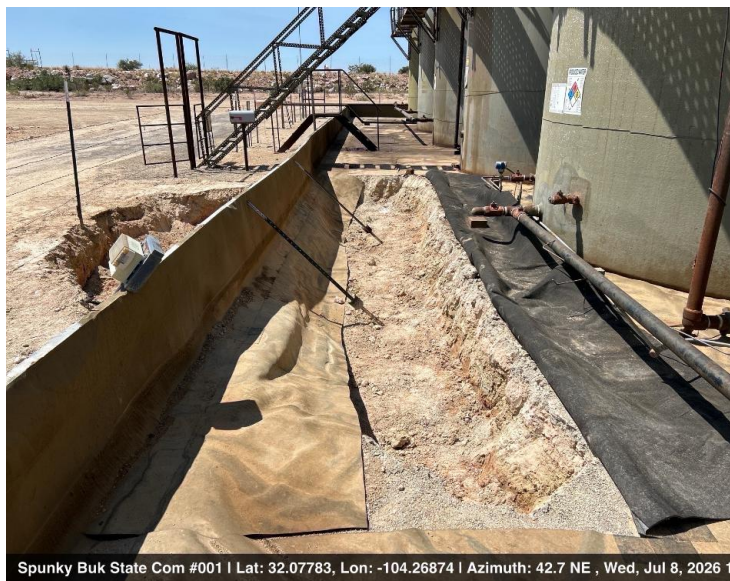
Date: 7/8/2026  
Time: 11:07  
Notes: East of tanks facing south.  
Latitude: 32.077827777777784  
Longitude: -104.26873888888889  
Direction: NE

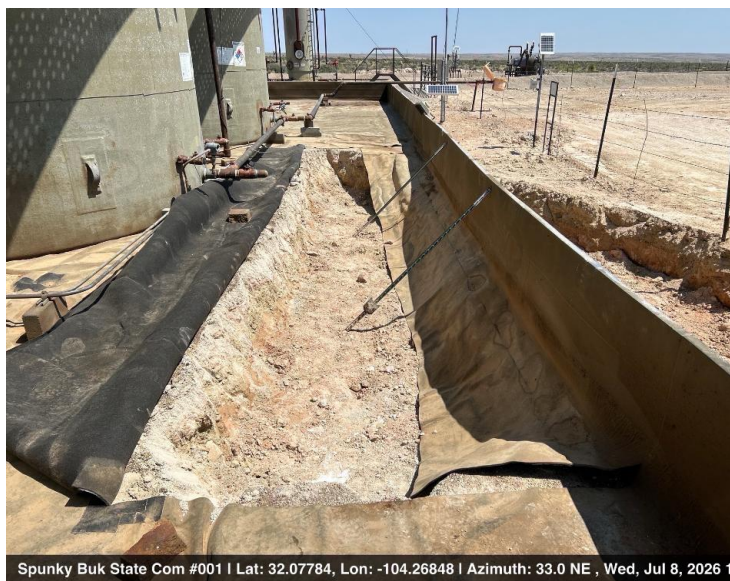
Date: 7/8/2026  
Time: 11:07  
Notes: East of tanks facing north.  
Latitude: 32.077836111111111  
Longitude: -104.26847777777778  
Direction: NE

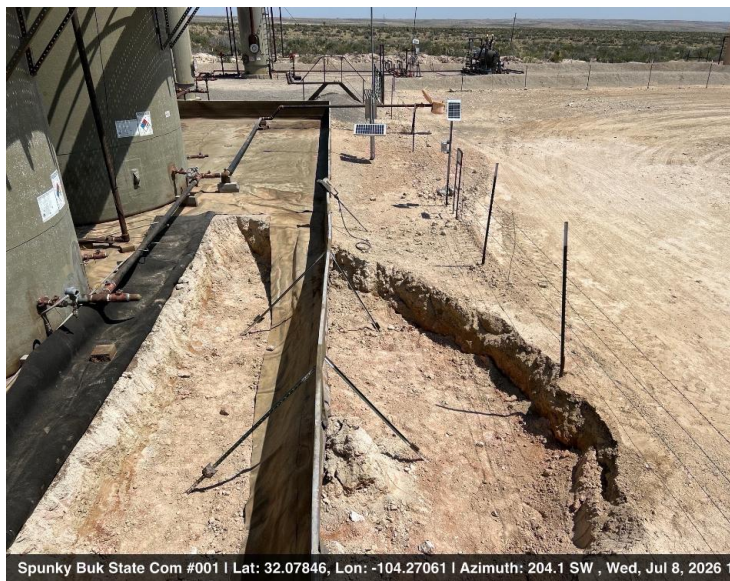
Date: 7/8/2026  
Time: 11:08  
Notes: On steps east of tanks facing north over excavation to 2.25 feet bgs.  
Latitude: 32.07846388888889  
Longitude: -104.27061388888889  
Direction: S

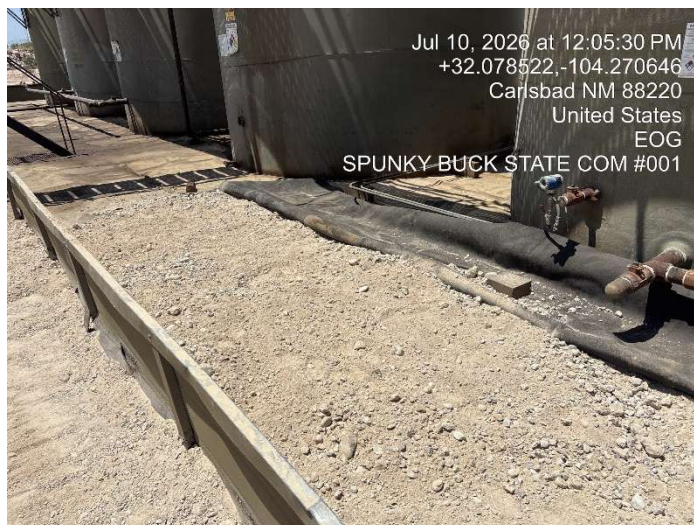
Photograph: 2

Description: Backfilled excavation prior to  
liner repair

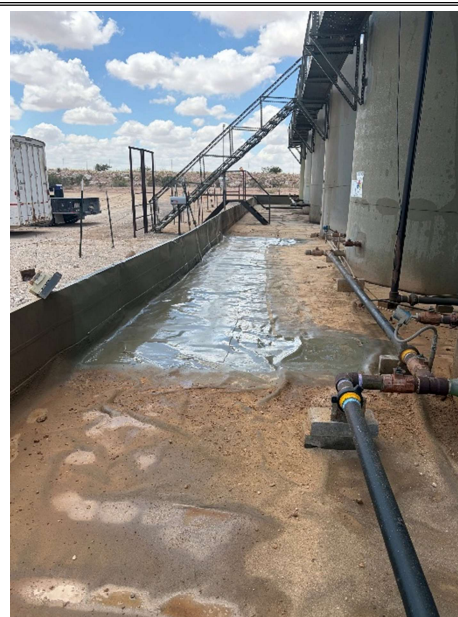
Photograph: 4

Description: Backfilled excavation

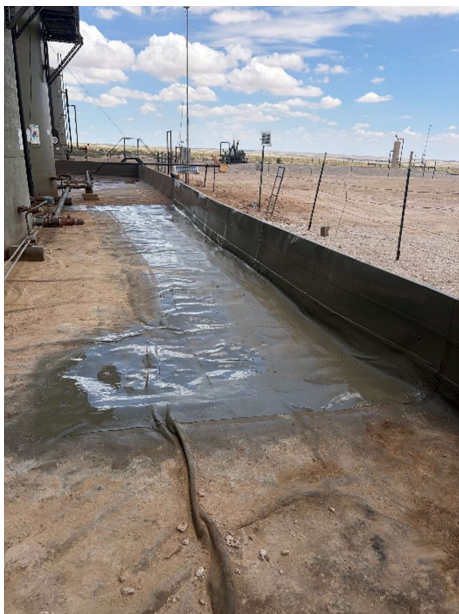
Photograph: 5

Description: Repaired liner

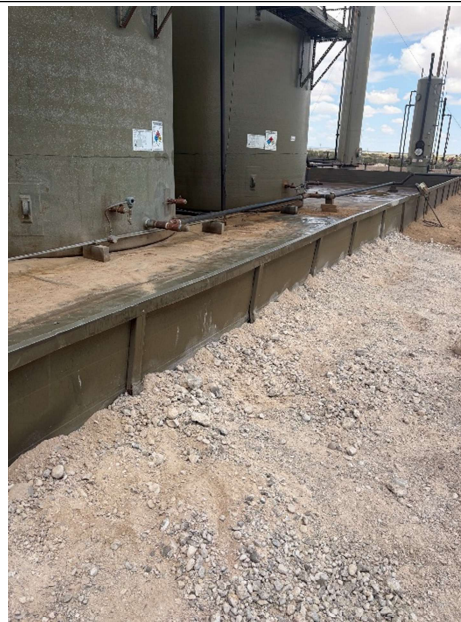
Photograph: 6

Description: Repaired containment

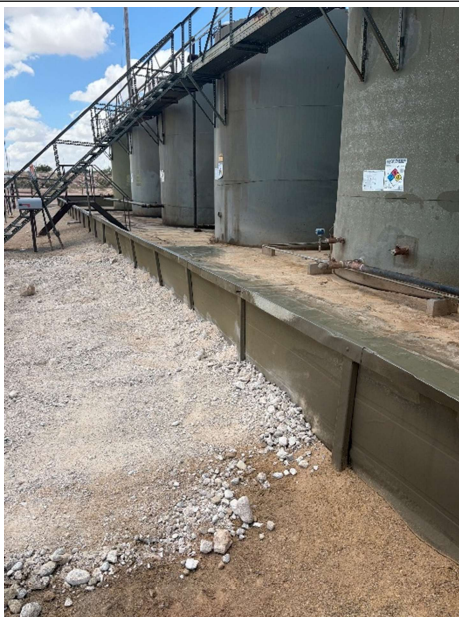
Photograph: 7

Description: Repaired containment
