Proposed Alternative Method Permit or Closure Plan Application

1.
Operator: Harvest Four Corners OGRID # 373888
Address: 1755 Arroyo Dr., Bloomfield, NM 87413
Facility or well name: Wilmer Canyon 2
API Number: 3004523459 OCD Permit Number: _____
U/L or Qtr/Qtr C Section 25 Township 32N Range 8W County: San Juan
Center of Proposed Design: Latitude 36.958071 Longitude -107.629684 NAD83
Surface Owner: ☒ Federal ☐ State ☐ Private ☐ Tribal Trust or Indian Allotment

**RE: Below Grade Tank Closure Report
Wilmer Canyon #2
API #3004523459
San Juan County, New Mexico**

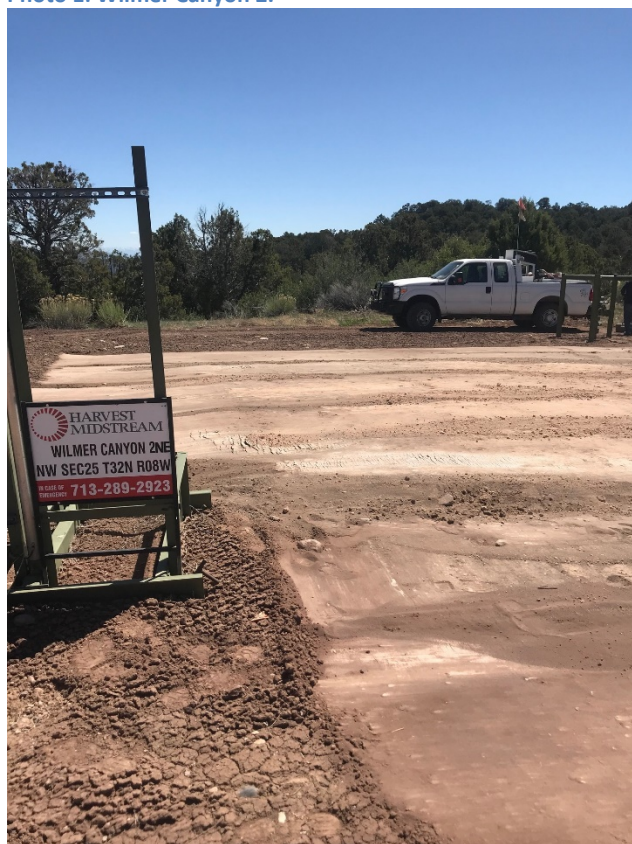
Photo 1: Wilmer Canyon 2.

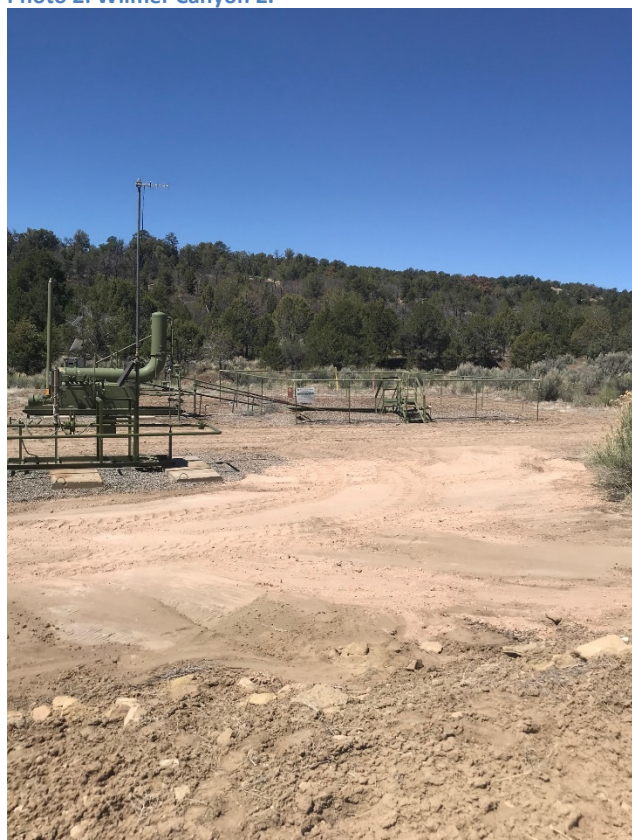
Photo 2: Wilmer Canyon 2.
