RE: Notice of Proposed Below-Grade Tank (BGT) Closure

BELOW-GRADE TANK CLOSURE PLAN

McCulley LS 004- Tank ID: B

<u>API #: 30045</u>07439 Unit Letter K, Section 14, T28N, R09W

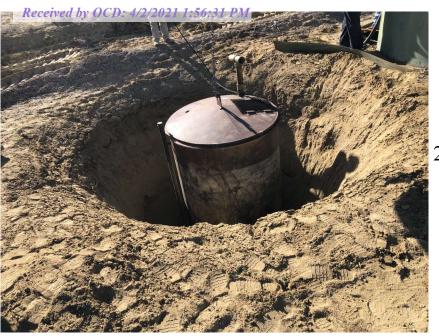
21 bbl tank prior to removal

SIMCOE shall remove the BGT and dispose of it in a NMOCD approved facility or recycle, reuse, or reclaim it in a manner that the NMOCD approves. If a liner is present and must be disposed of it will be cleaned by scraping any soils or other attached materials on the liner to a de minimus amount and disposed at a permitted solid waste facility, pursuant to Subparagraph (m) of Paragraph (1) of Subsection C of 19.15.35.8 NMAC. Documentation as to the final disposition of the removed BGT will be provided in the final closure report. **The BGT was transported for recycling.**

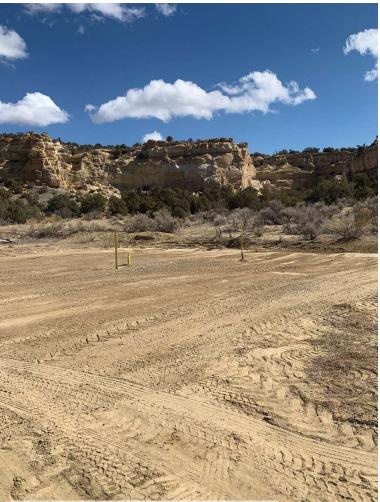
3 Point composite Sample locations

Soils beneath the BGT were sampled for TPH, BTEX, and chloride. All test parameters were below the stated limits. A field and laboratory reports are attached.

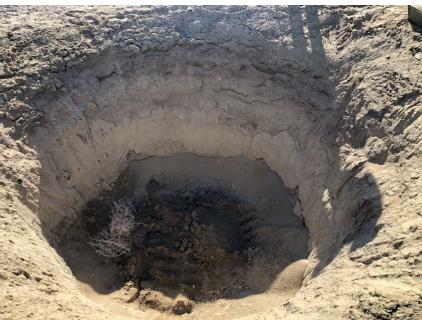
Backfilled area of former 21 bbl tank

Sampling results reveal no evidence of a release had occurred. BGT area has been backfilled with clean, earthen material.
