Pit, Closed-Loc	<u>op System, Belo</u>	w-Grade Tank, or
Proposed Alternative M	Method Permit or	Closure Plan Application

## Rincon Unit 91 API # 30-039-06627

Enduring Resources, LLC BGT Closure Report Rincon Unit 91 30-039-06627

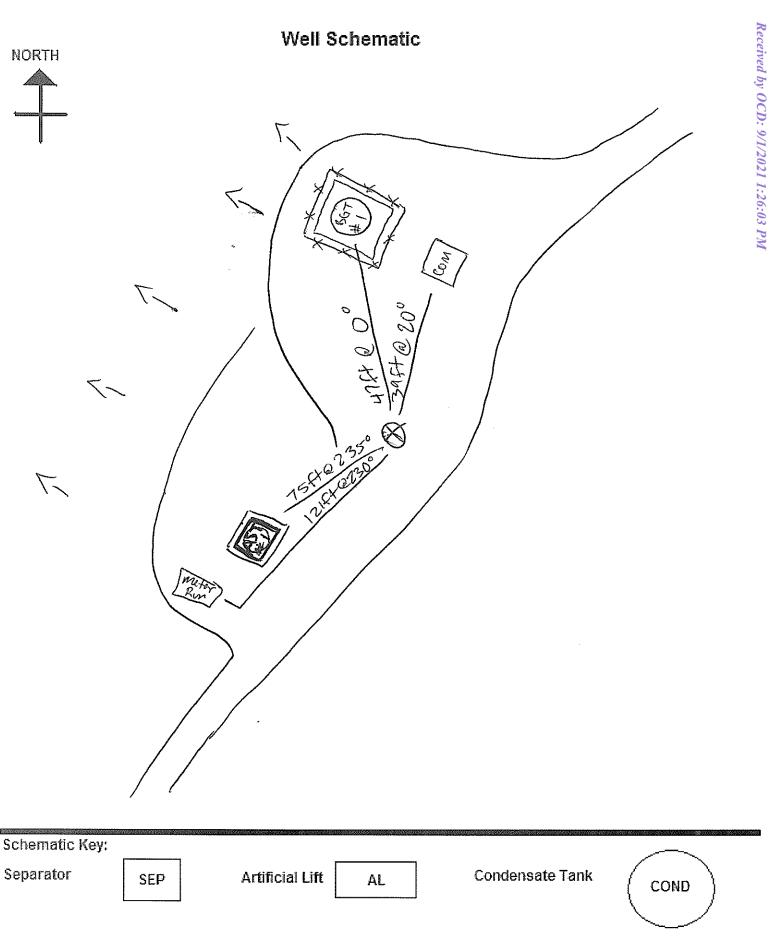
Compressor	сом	Meter Run	METER RUN		
Dehydrator	DEH	Well Head	0	Water Tank	WATER

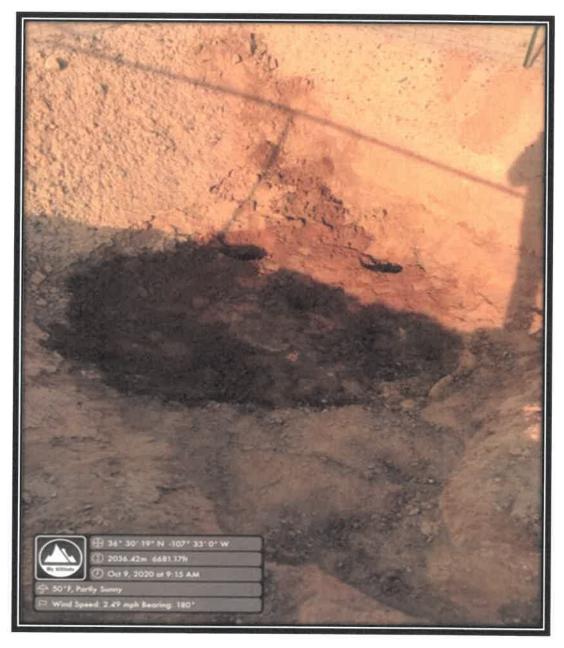
Photo: Under BGT

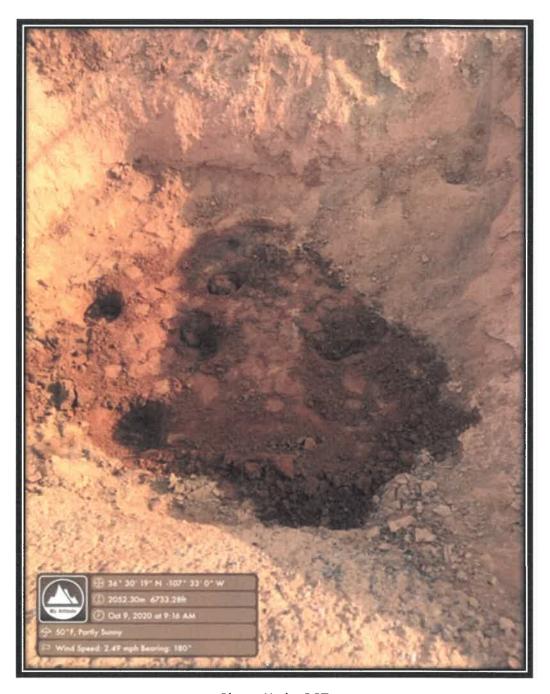
Photo: Under BGT

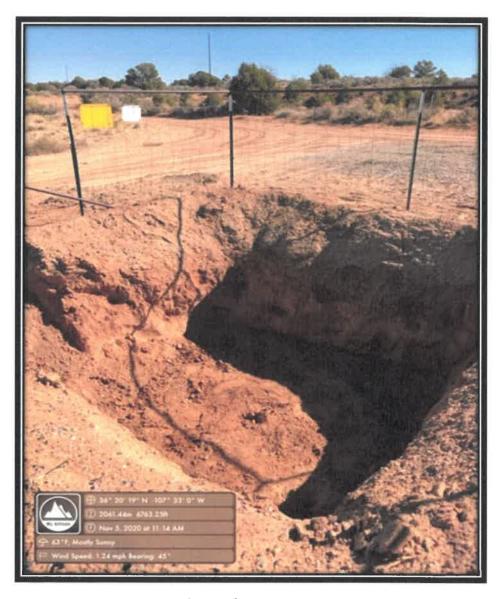
Photo: After excavation

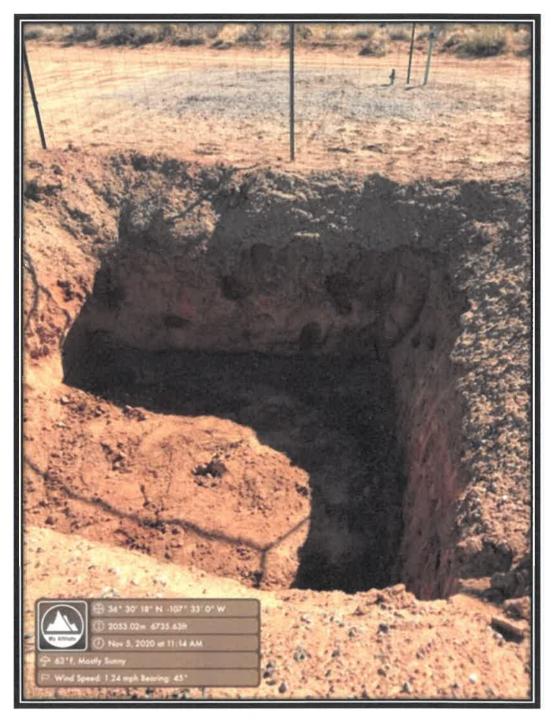
Photo: After Excavation

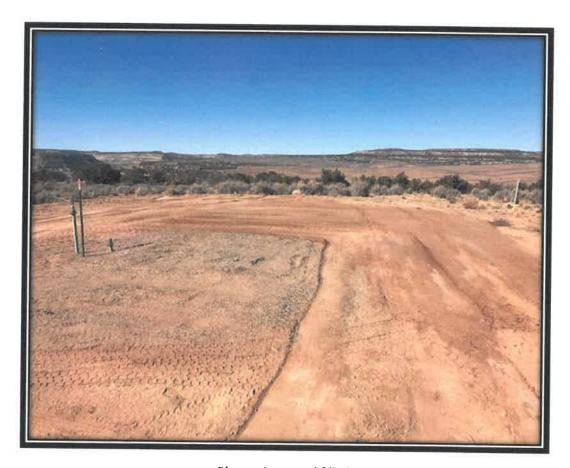
Photo: Area Backfilled

Excavated area was backfilled and recontoured to meet NMOCD specifications; see attached *Photo Page*.

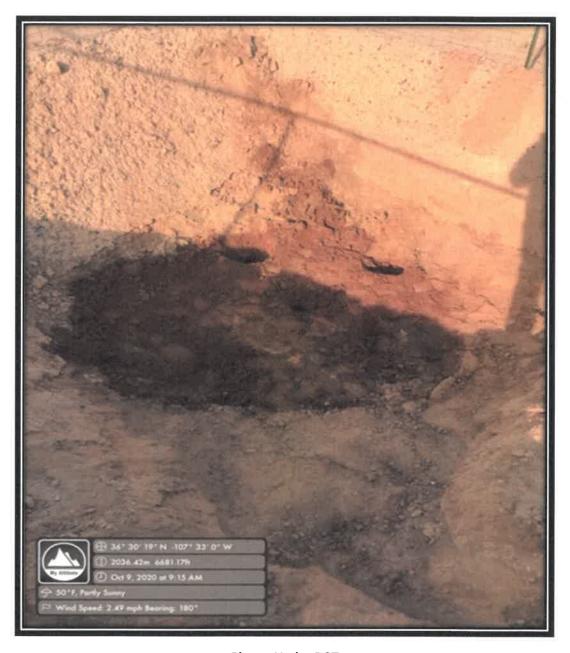
Photo: Under BGT

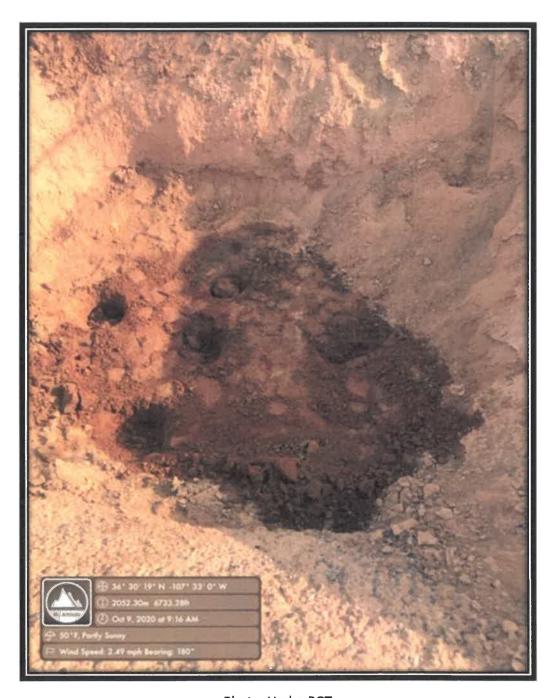
Photo: Under BGT

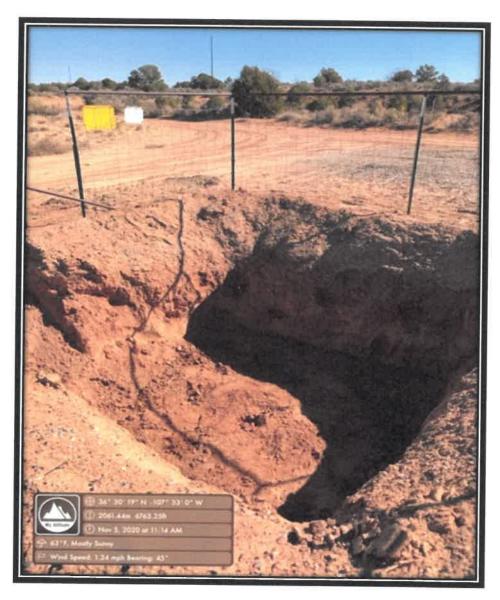
Photo: After excavation

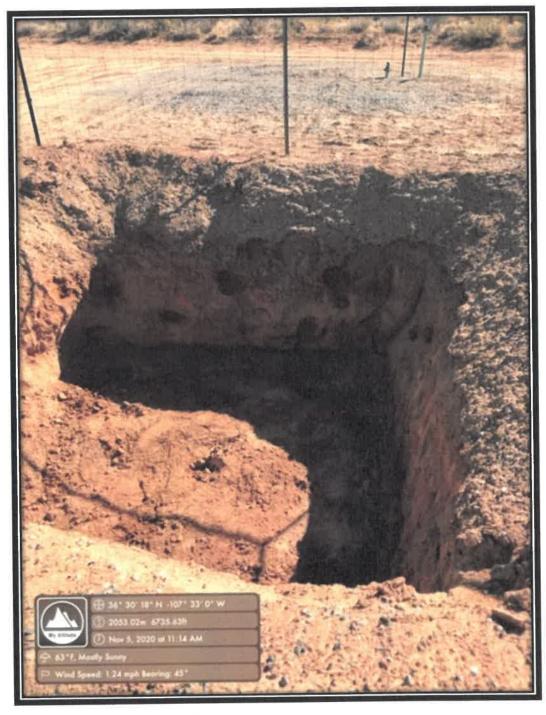
Photo: After Excavation

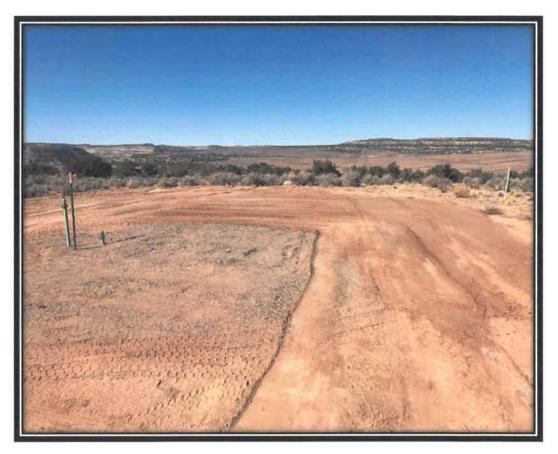
Photo: Area Backfilled
