Pit, Below-Grade Tank, or Proposed Alternative Method Permit or Closure Plan Application

Hilcorp Energy Company San Juan Basin Below Grade Tank Closure Report

Lease Name: Tiger 6 BGT 2 API No.: 30-045-29581

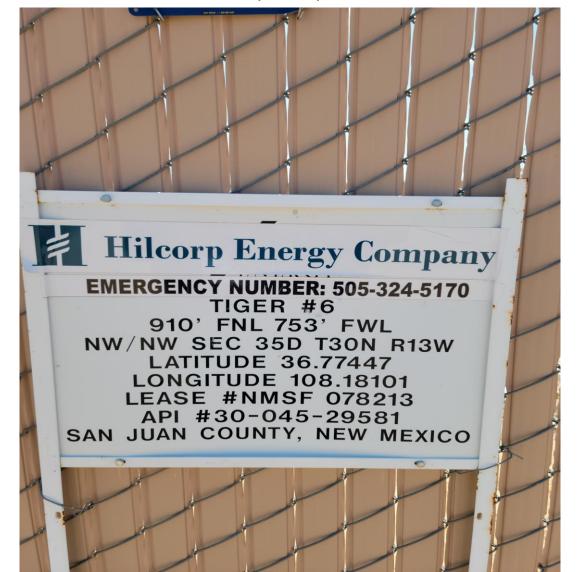
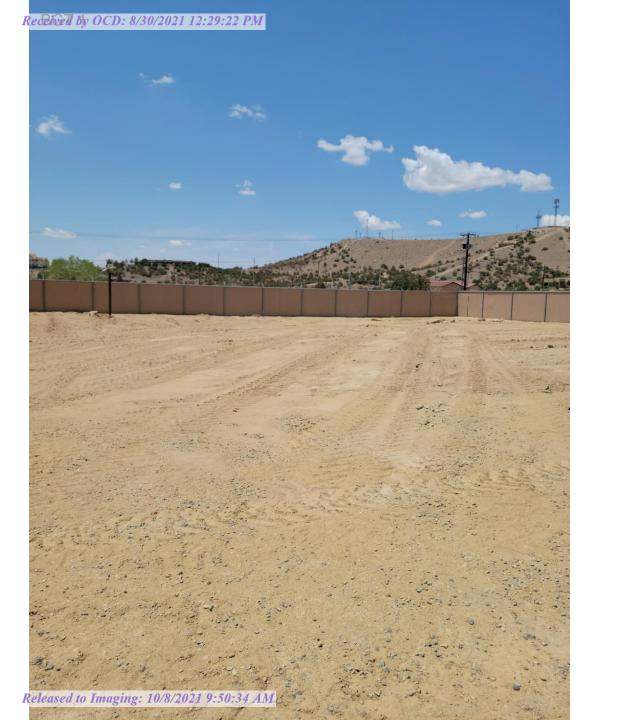
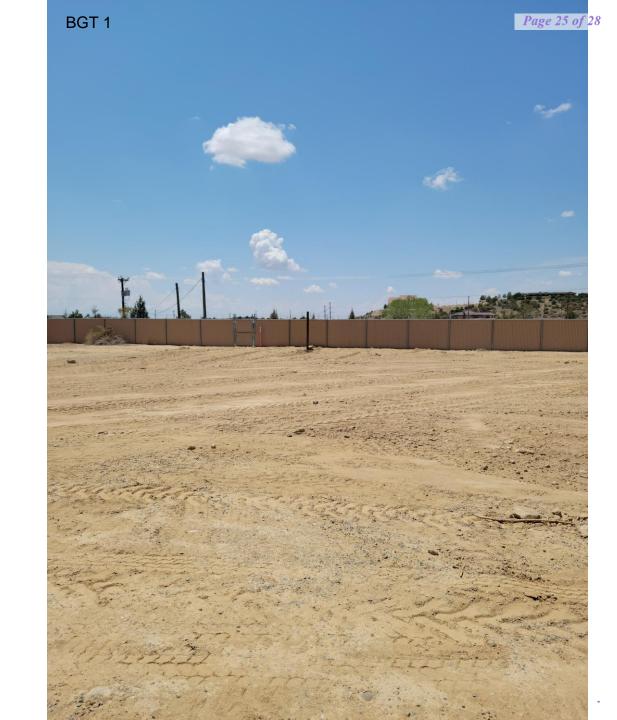
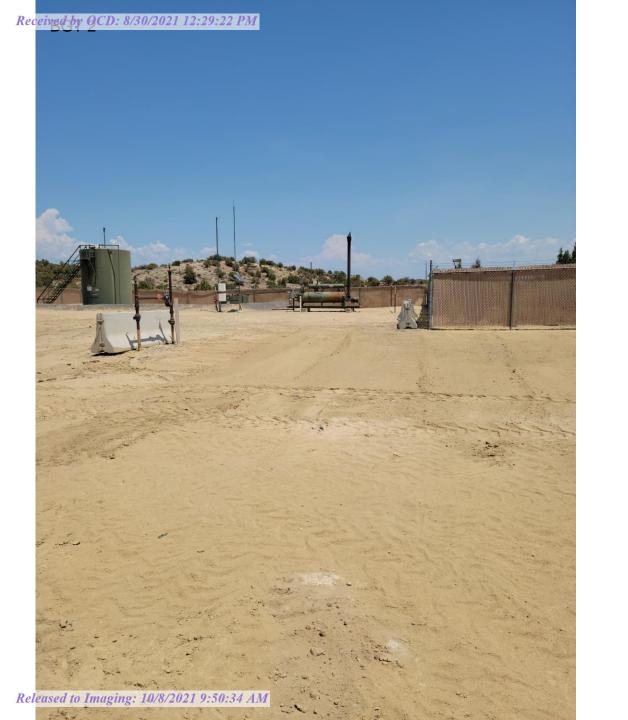
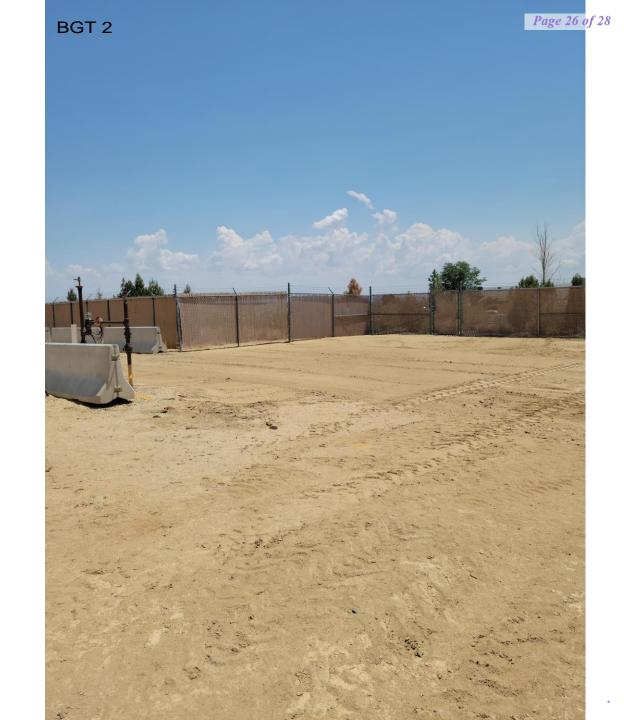
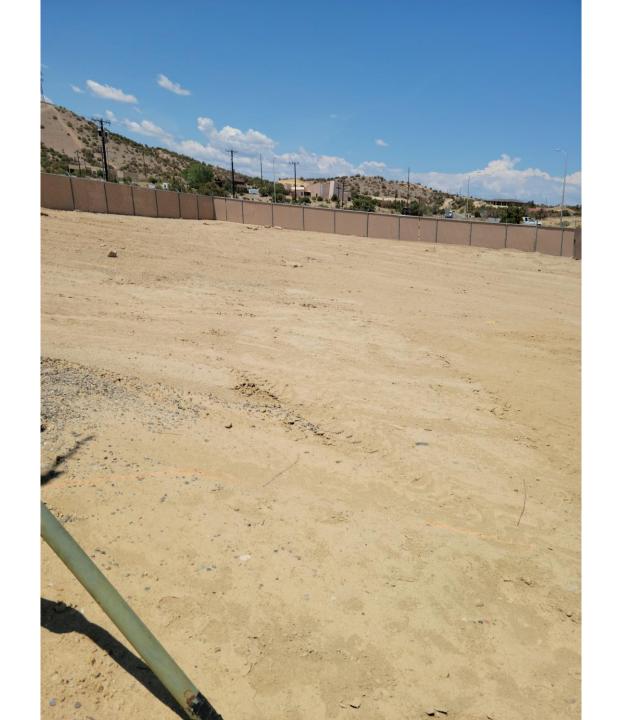
Tiger #6 07/19/21

Pit Closure Pictures.

The below-grade tank area passed all requirements of Paragraph (4) of Subsection E of 19.15.17.13 NMAC and was backfilled with compacted, non-waste containing, earthen material.

The below-grade tank area was re-contoured to match fit, shape, line, form and texture of the surrounding area. Re-shaping including drainage control, to prevent ponding and erosion. Natural drainages were unimpeded and water bars and/or silt traps were placed in areas where needed to prevent erosion on a large scale. Final recontour has a uniform appearance with smooth surface, fitting the natural landscape.

The below-grade tank area was backfilled and more than four feet of cover was achieved and the cover included one foot of suitable material to establish vegetation at the site.
