Pit, Below-Grade Tank, or
Proposed Alternative Method Permit or Closure Plan Application

Hilcorp Energy Company
San Juan Basin
Below Grade Tank Closure Report

Lease Name: Scott 1E

API No.: 3004525085

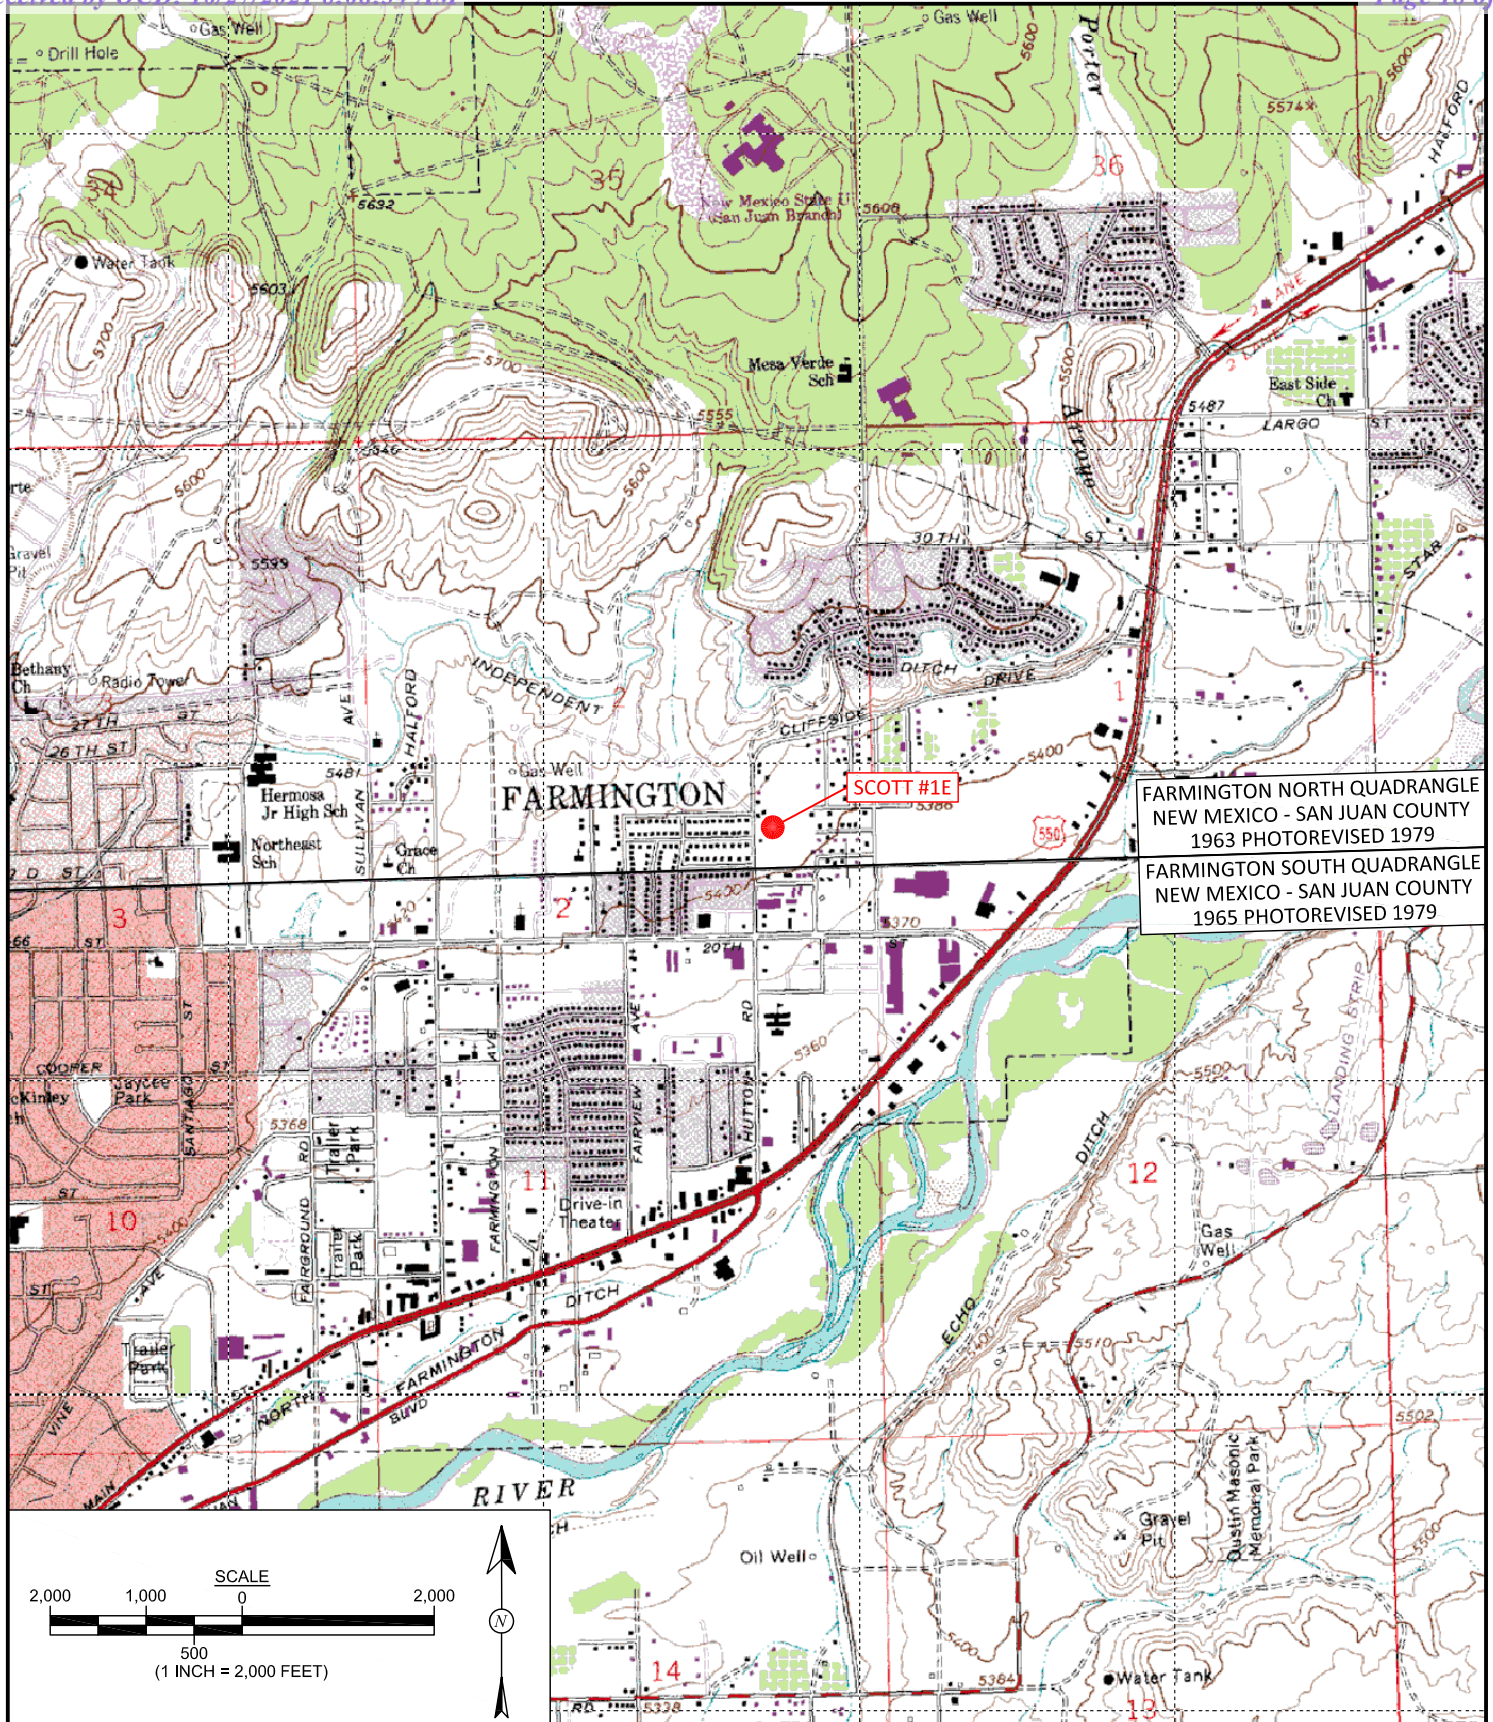
FARMINGTON NORTH QUADRANGLE
NEW MEXICO - SAN JUAN COUNTY
1963 PHOTOREVISED 1979

FARMINGTON SOUTH QUADRANGLE
NEW MEXICO - SAN JUAN COUNTY
1965 PHOTOREVISED 1979

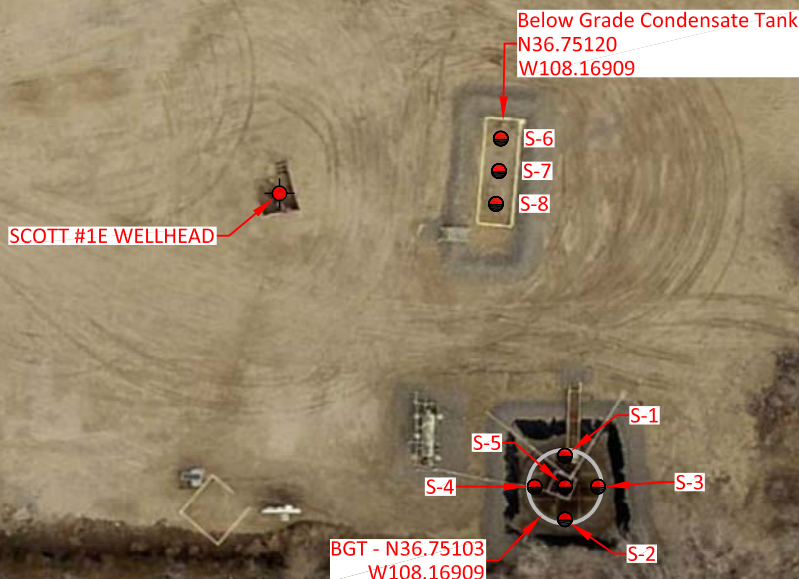
Sample ID	Date	Benzene (mg/kg)	Total BTEX (mg/kg)	TPH - GRO (mg/kg)	TPH - DRO (mg/kg)	Chlorides (mg/kg)
NMOCD ACTION LEVEL		0.2	50	100		250
SC-1	9/18/13	<0.050	<0.25	<5.0	29	<30
SC-2	9/19/13	<0.050	<0.25	<5.0	<10	39

AERIAL SOURCE: © 2012 PICTOMETRY INTERNATIONAL CORP. ONLINE, AERIAL DATE: MARCH 4, 2013.
