Pit, Below-Grade Tank, or
Proposed Alternative Method Permit or Closure Plan Application

1.
Operator: Harvest Four Corners OGRID # 373888
Address: 1755 Arroyo Dr., Bloomfield, NM 87413
Facility or well name: Whitley #7E
API Number: 30-045-26463 OCD Permit Number: _____
U/L or Qtr/Qtr F Section 9 Township 27N Range 9N County: San Juan
Center of Proposed Design: Latitude 36.59234 Longitude -107.79759 NAD83
Surface Owner: ☒ Federal ☐ State ☐ Private ☐ Tribal Trust or Indian Allotment

**RE: Below Grade Tank Closure Report
Whitley #7E
API #3004526463
San Juan County, New Mexico**

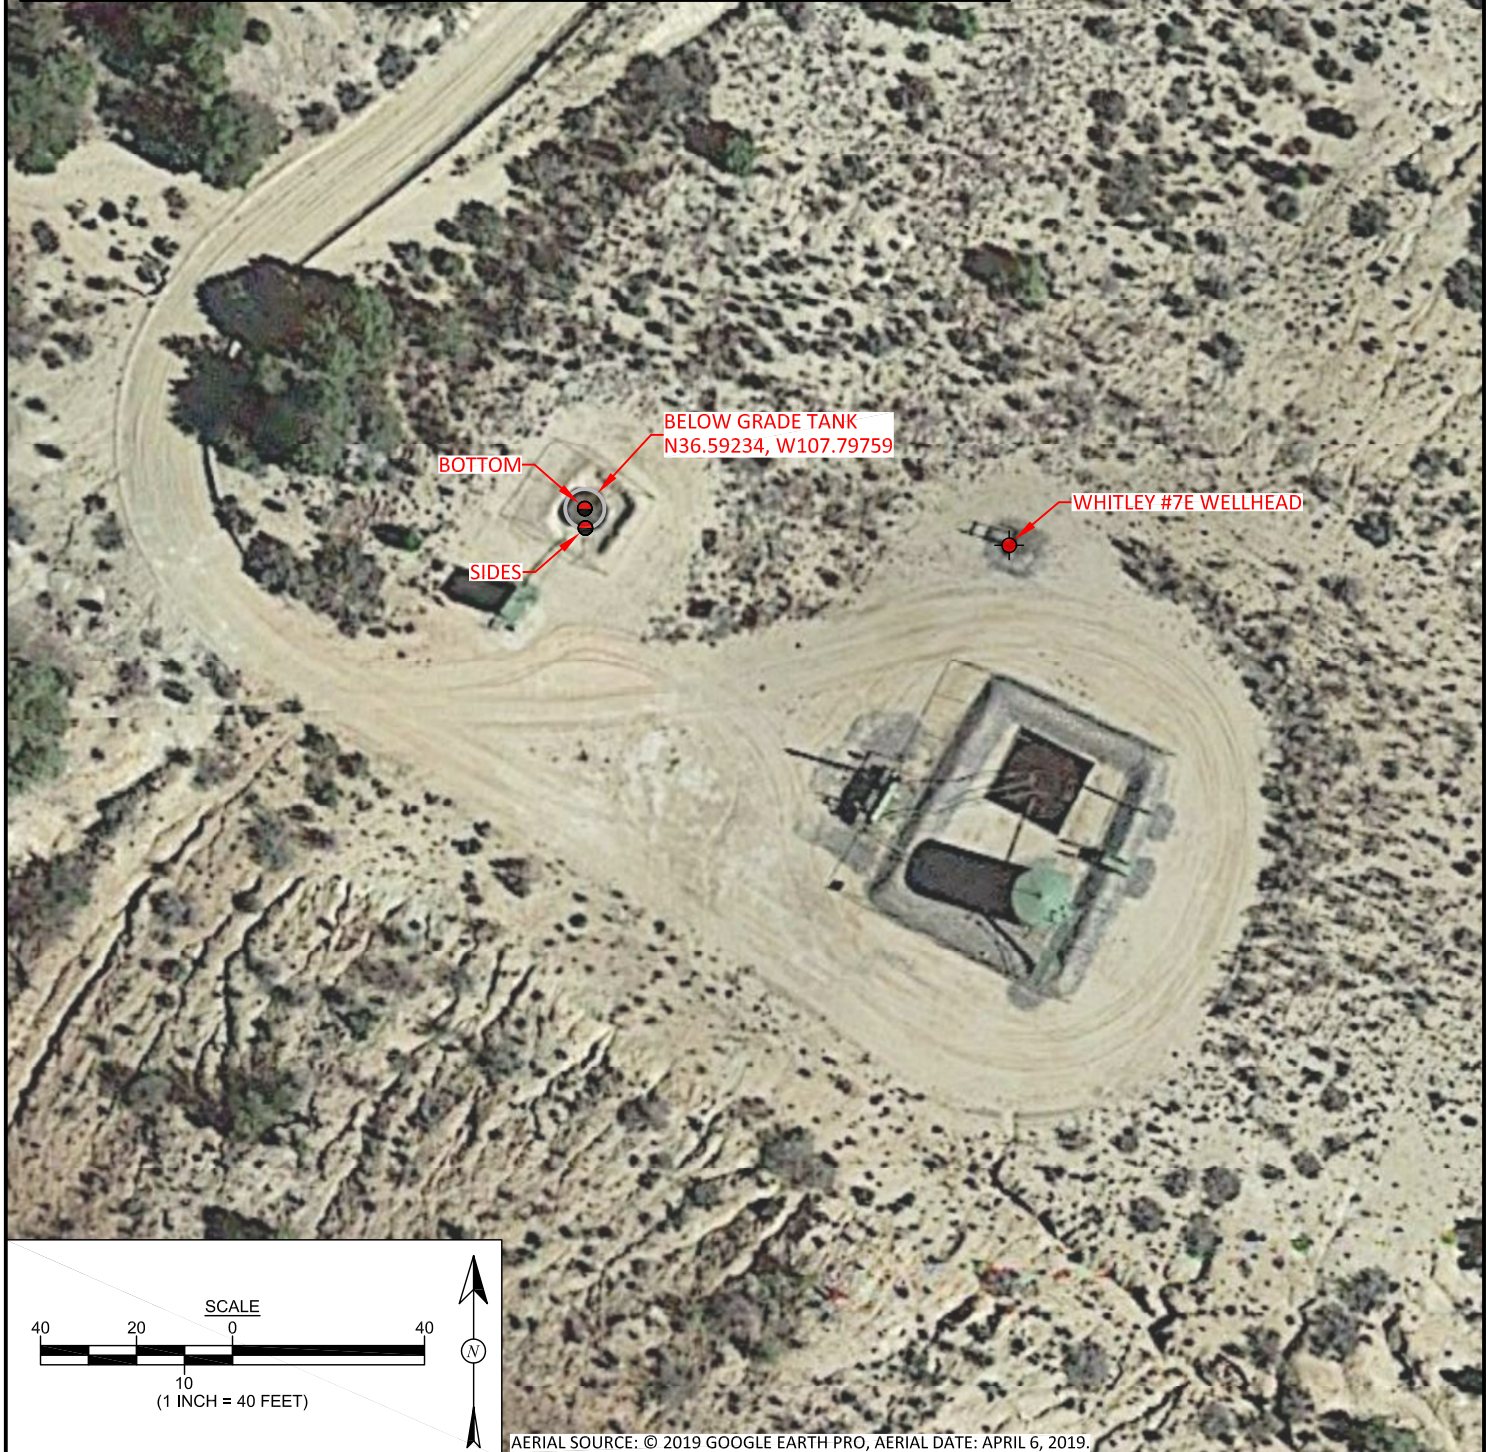
Figure 2. Aerial Site Map

SAMPLE LOCATIONS

Laboratory analytical results are summarized in Table 1 and presented on Figure 2. The laboratory analytical report is attached.

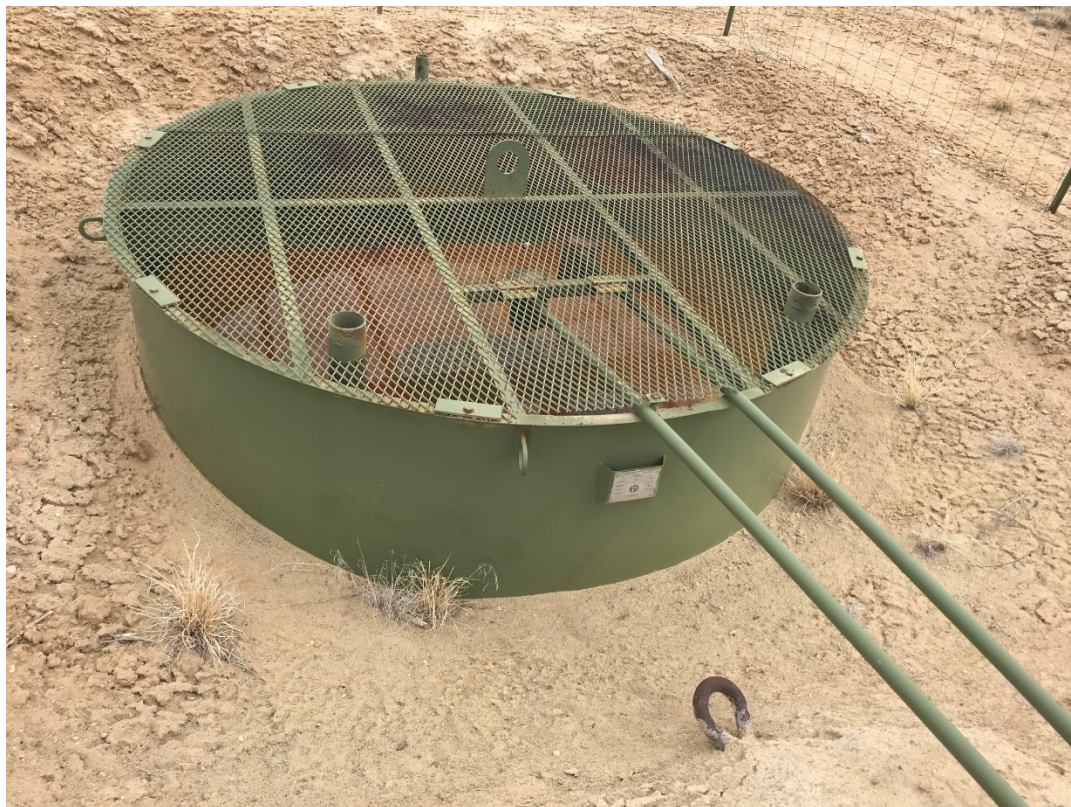
Photo 1: Whitley #7E – Removed Harvest BGT.

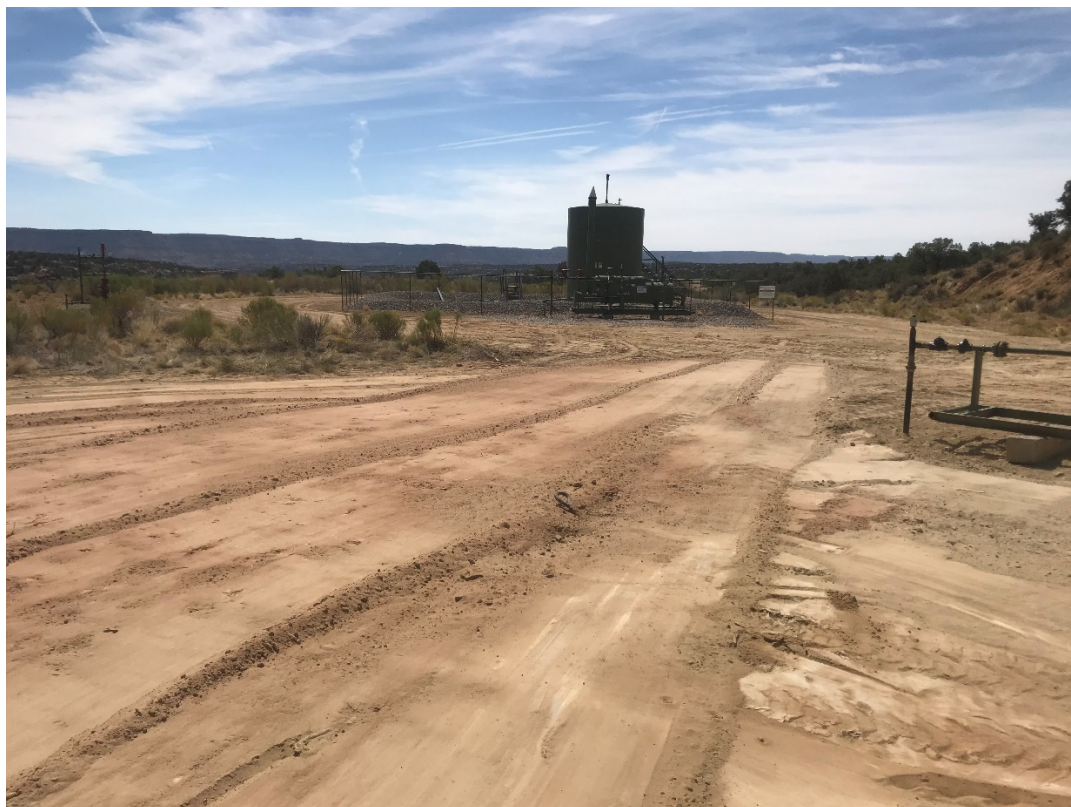
Photo 2: Whitley #7E after BGT removal backfill. View is toward Hilcorp well.

Based on BGT laboratory analytical results for benzene, total BTEX, TPH, and chloride for the BGT removed from the location, the site was backfilled with clean soil. No further work is recommended at Whitley #7E for the Harvest BGT Closure.

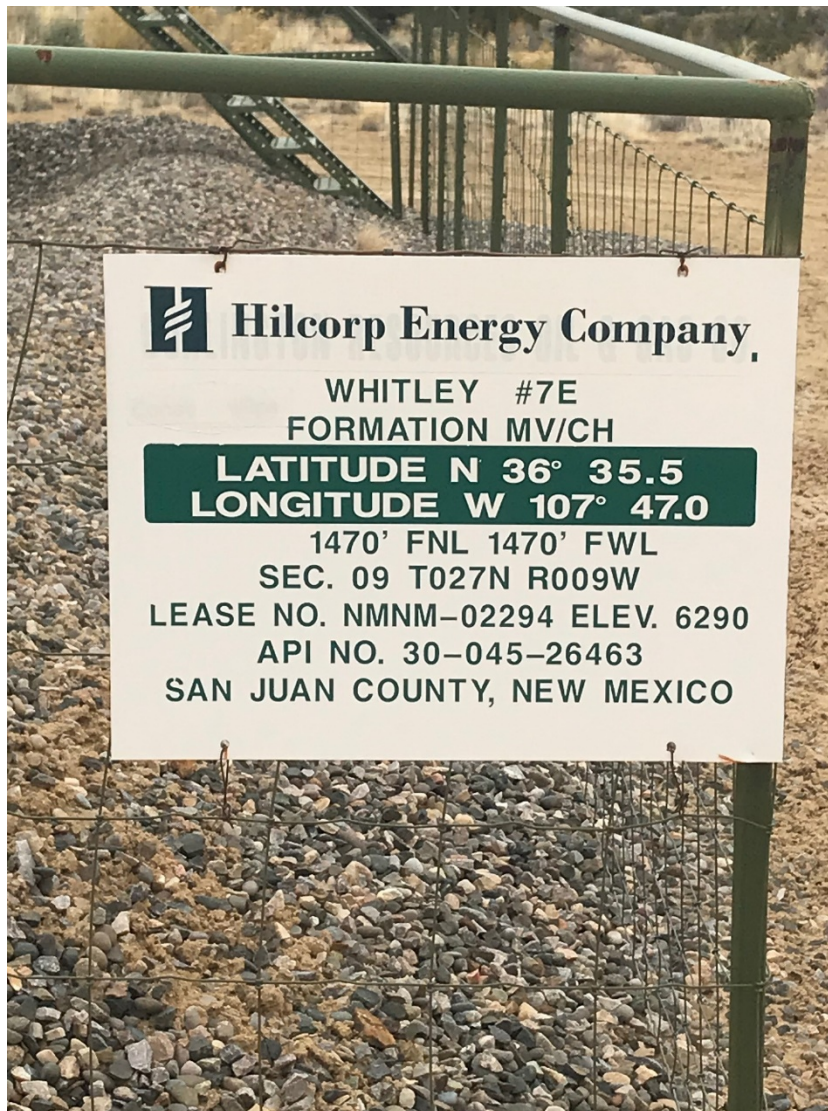
Photo 3: Whitley #7E signage
