Pit, Below-Grade Tank, or  
Proposed Alternative Method Permit or Closure Plan Application

1.  
Operator: Enduring Resources, LLC OGRID #: 372286  
Address: 200 Energy Court, Farmington, New Mexico 87401  
Facility or well name: Marshall A 3  
API Number: 30-045-06536 OCD Permit Number: \_\_\_\_\_  
U/L or Qtr/Qtr G Section 15 Township 27N Range 9W County: San Juan  
Center of Proposed Design: Latitude 36.578597 Longitude -107.772393 NAD83  
Surface Owner: ☐ Federal ☐ State ☐ Private ☒ Tribal Trust or Indian Allotment

Enduring Resources, LLC  
BGT Closure Report  
Marshall A 3  
30-045-06536

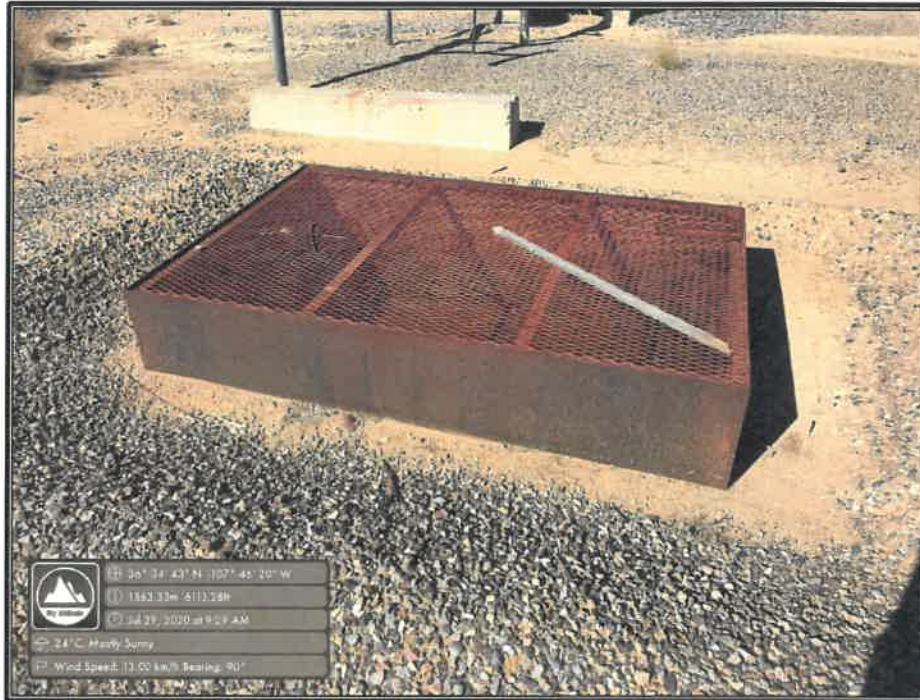
PHOTO 1: Visual Confirmation of Release Occurring During BGT Removal

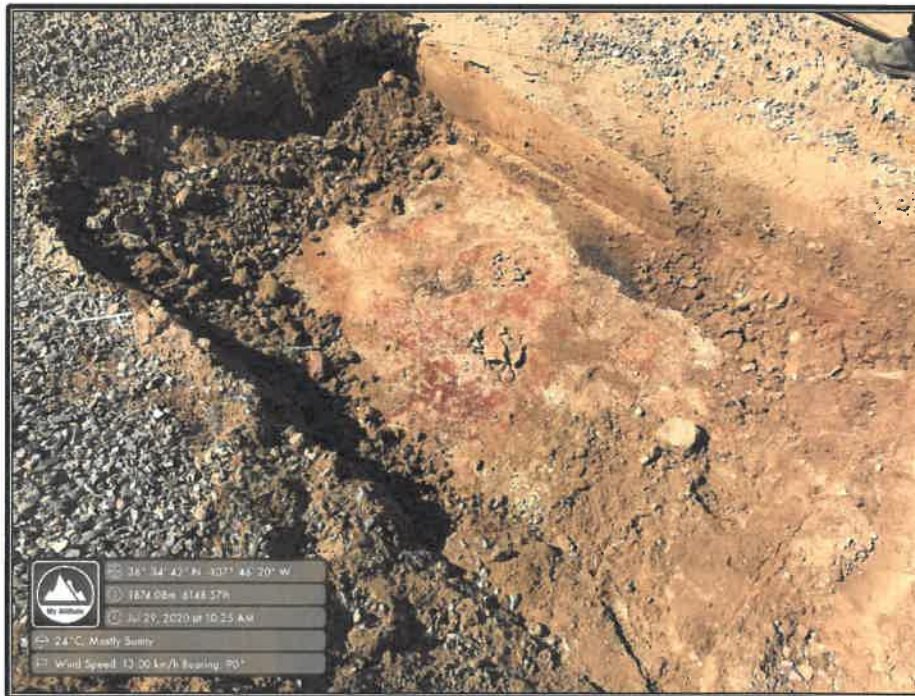
PHOTO 2: Former BGT Location after Removal (7/29/2020)

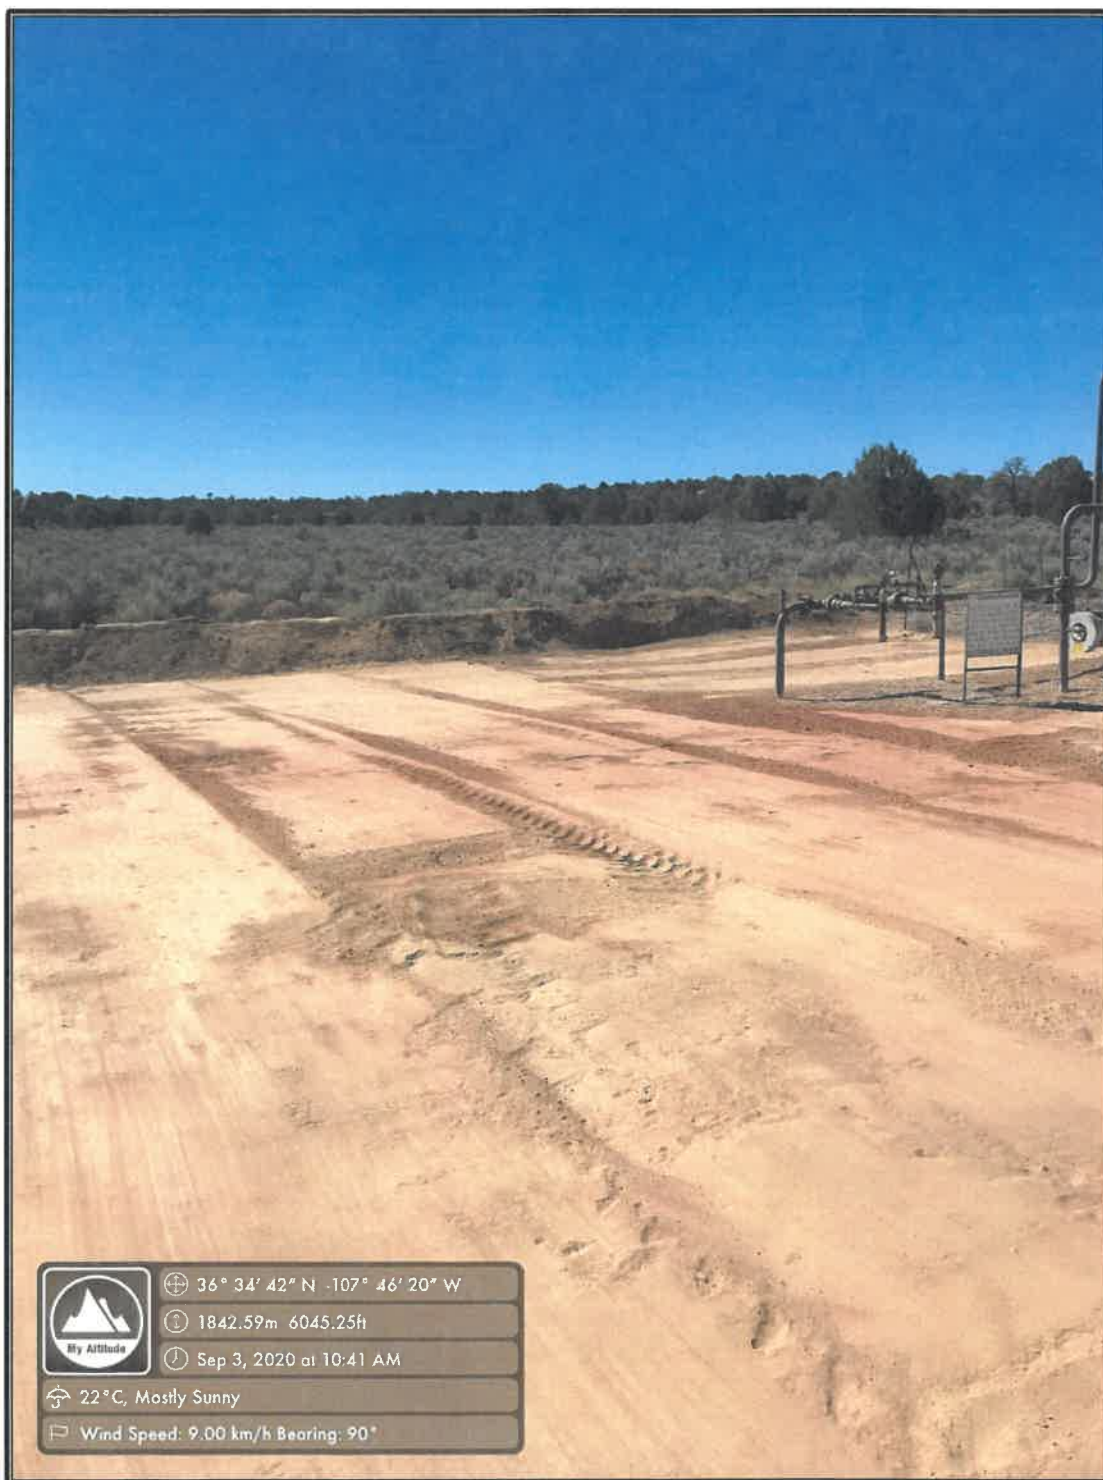
PHOTO 3: BGT Area after Backfill

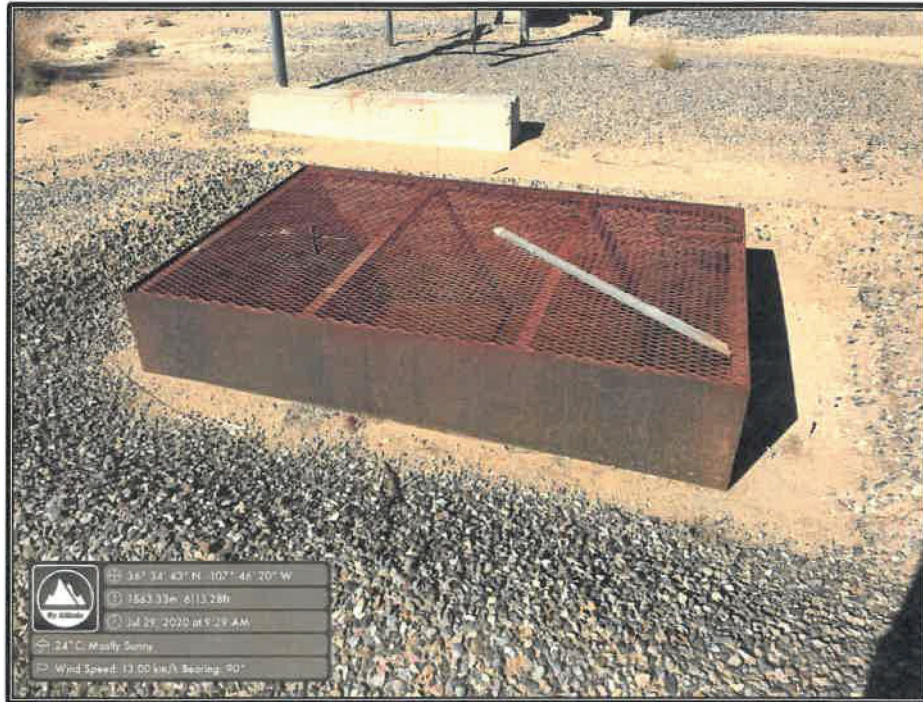
PHOTO 1: Visual Confirmation of Release Occurring During BGT Removal

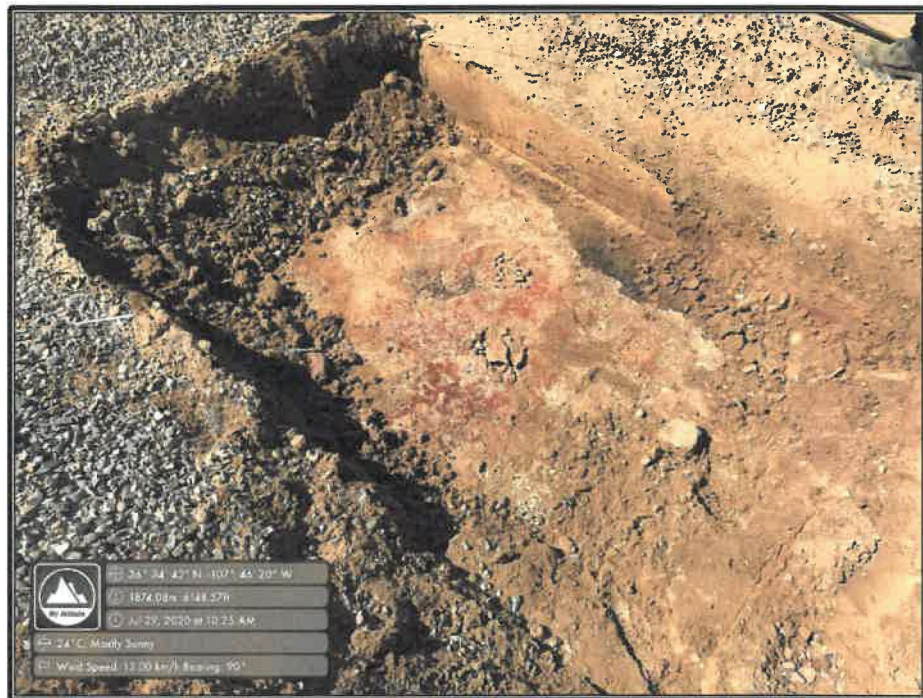
PHOTO 2: Former BGT Location after Removal (7/29/2020)

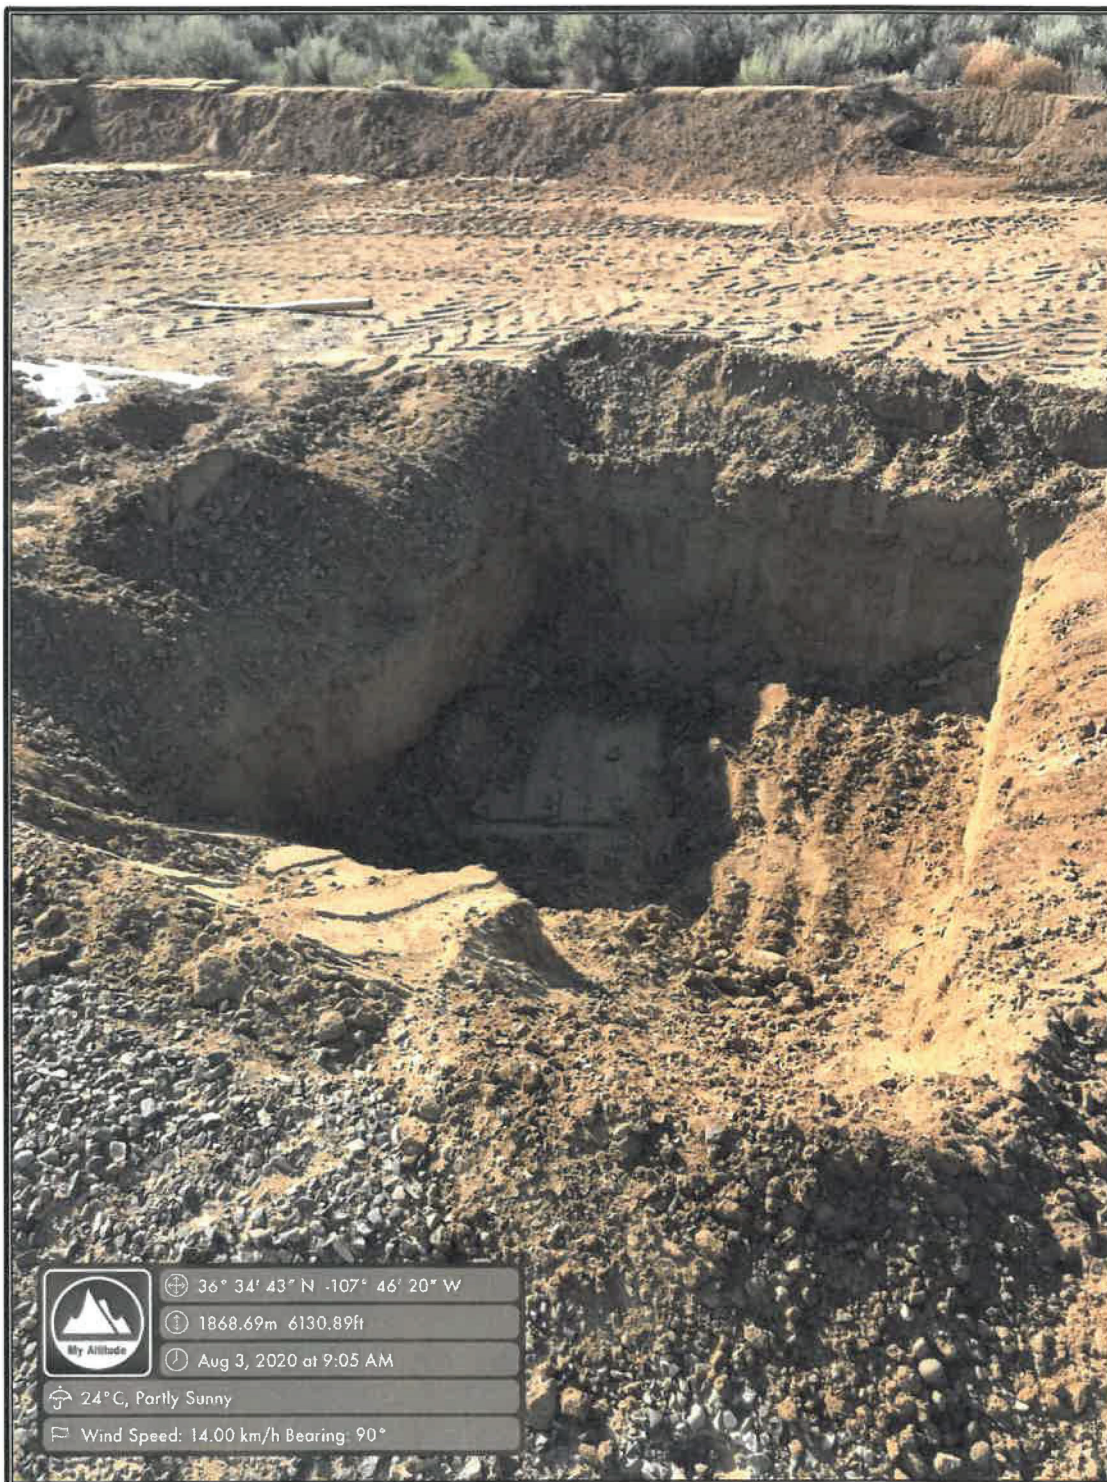
PHOTO 3: Excavated Area (8/3/2020)

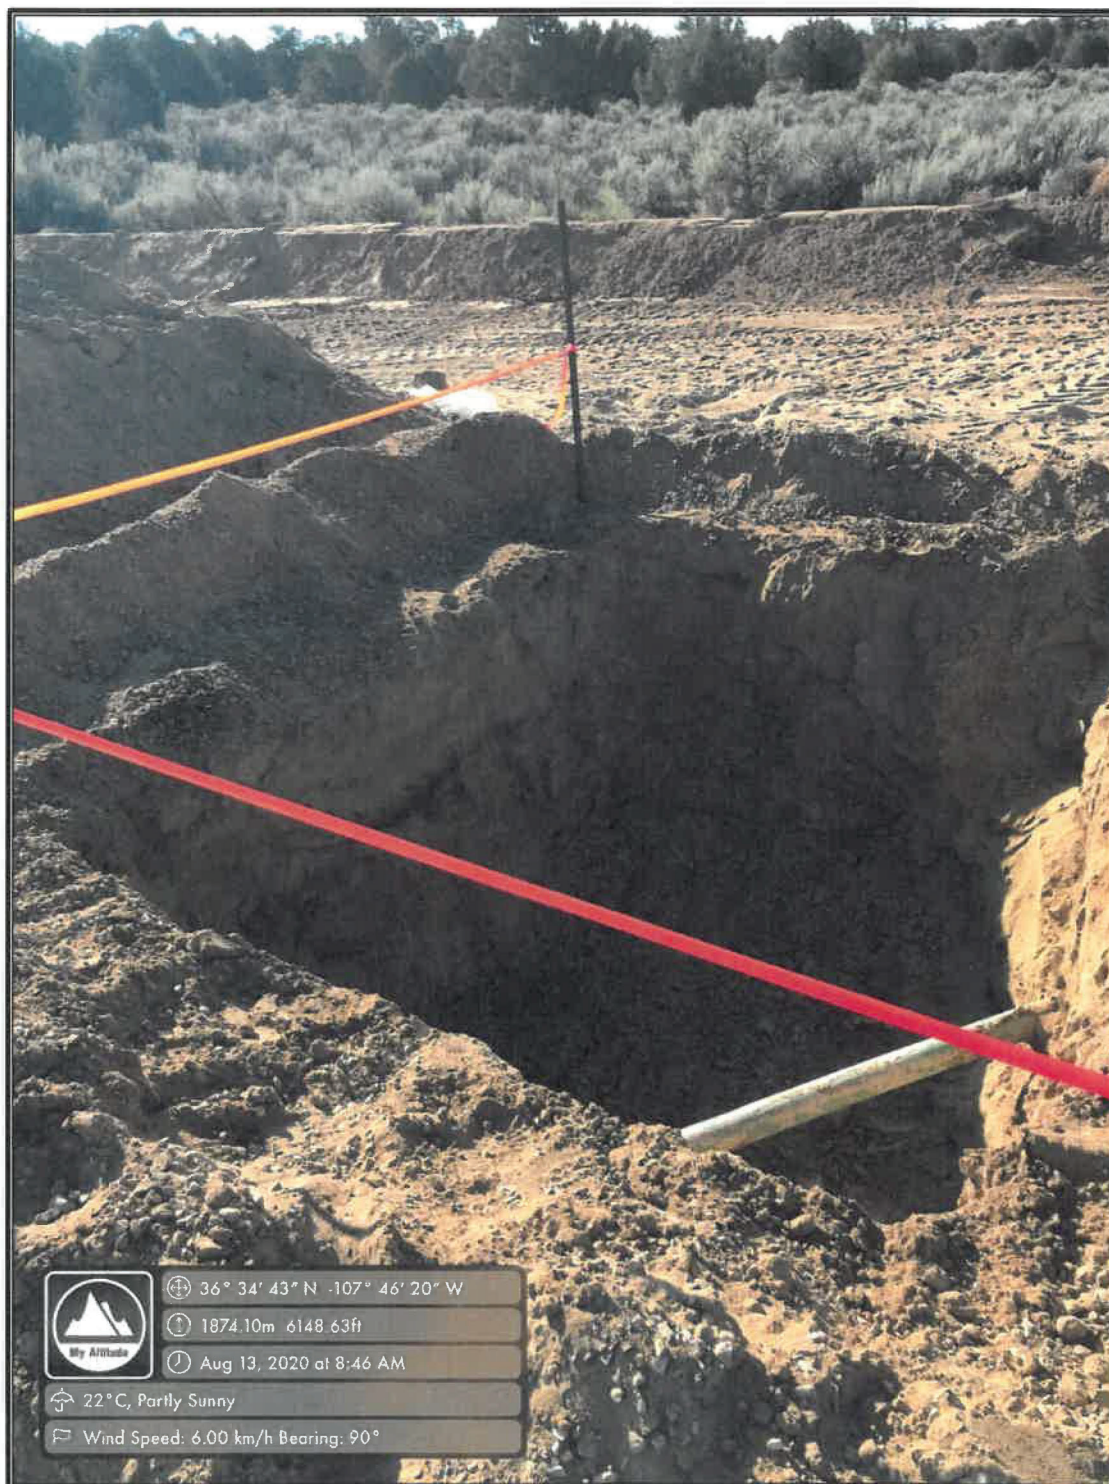
PHOTO 4: Excavated Area (8/13/2020)

Two of the samples from the Marshall A 3 failed the 100 ppm TPH standard for this location. The South Wall and the Bottom at 5' below ground surface. Additional excavation will take place on these areas on Monday, August 24, and sampling will occur on Tuesday August 25<sup>th</sup> at 9 AM. Thank you for your time in regards to this matter. Sample results are included for your reference.

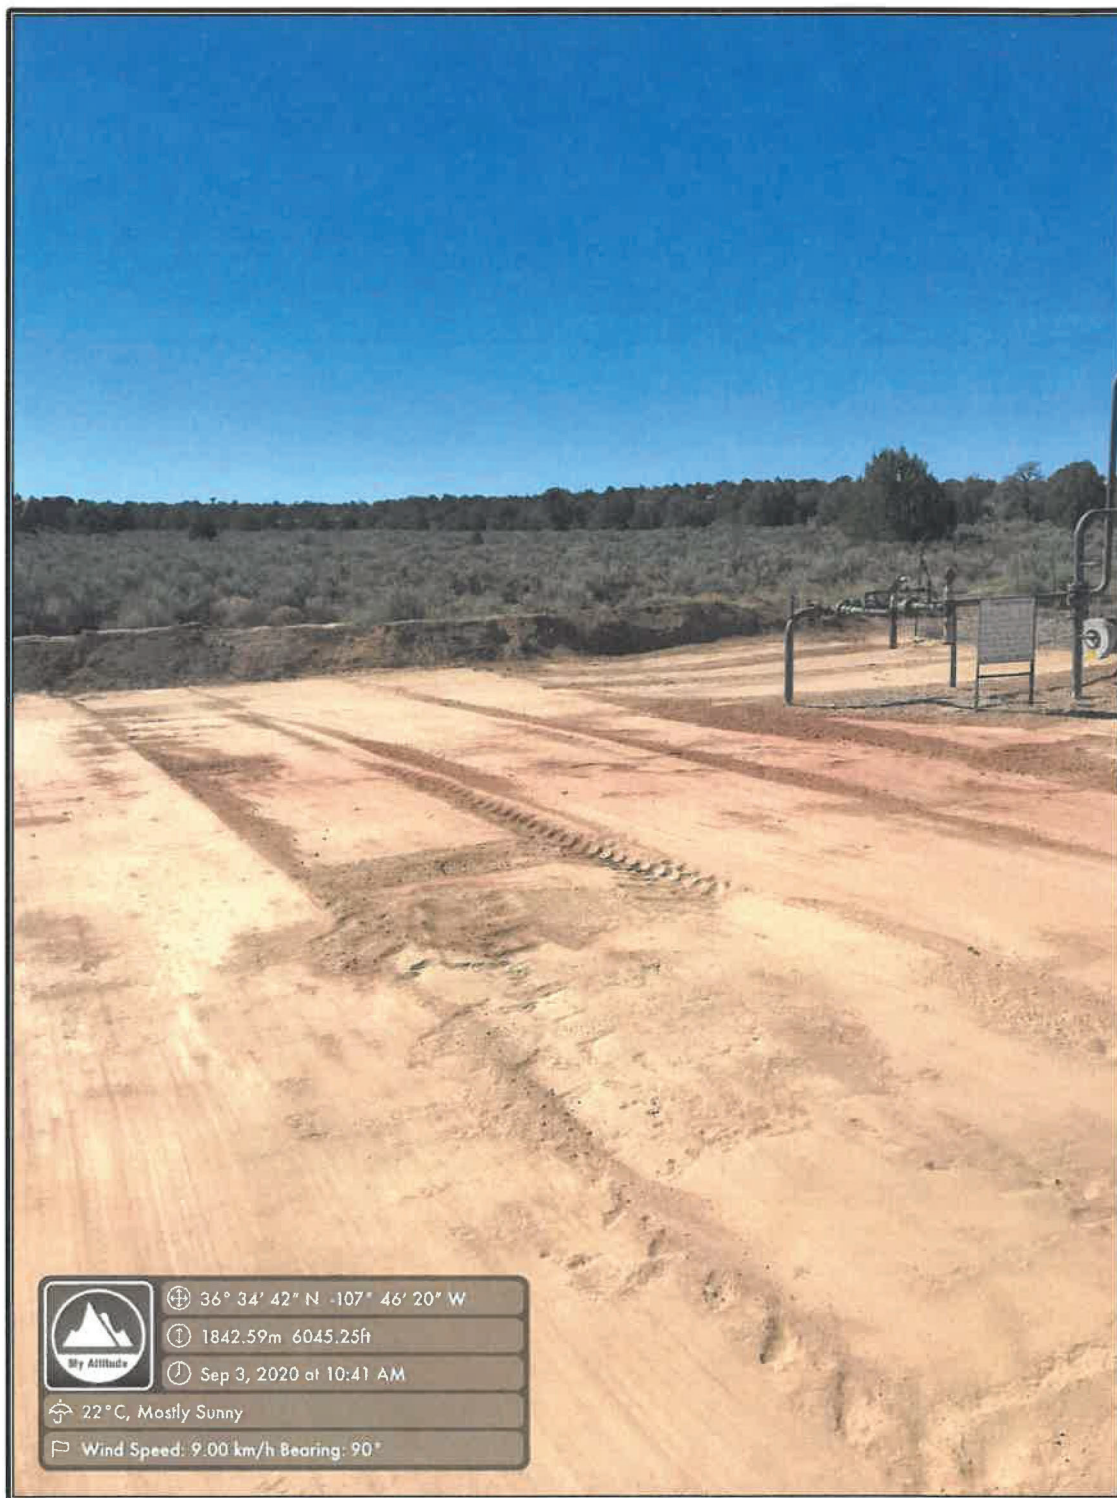
PHOTO 5: BGT Area after Backfill
