Pit, Below-Grade Tank, or  
Proposed Alternative Method Permit or Closure Plan Application

**Hilcorp Energy Company  
San Juan Basin  
Below Grade Tank Closure Report**

**Lease Name: San Juan 29-7 Unit 112M**

**API No.: 30-039-22398**

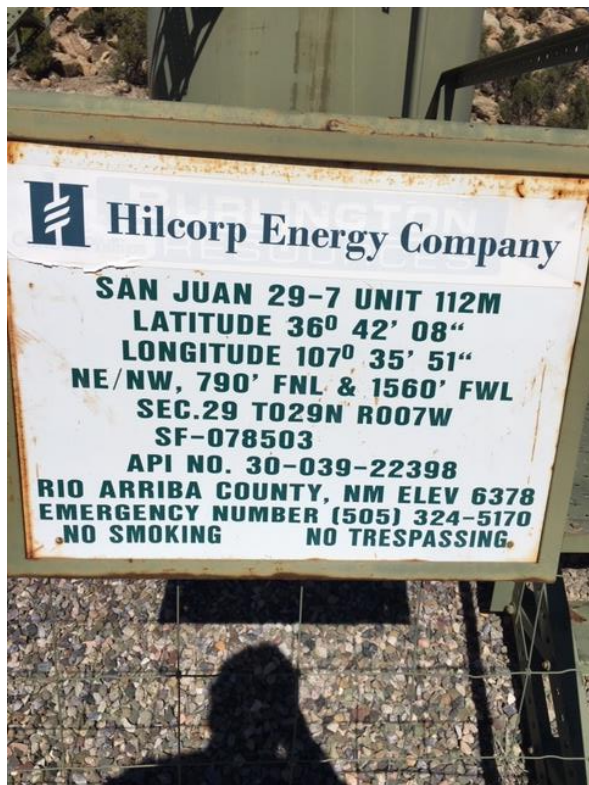
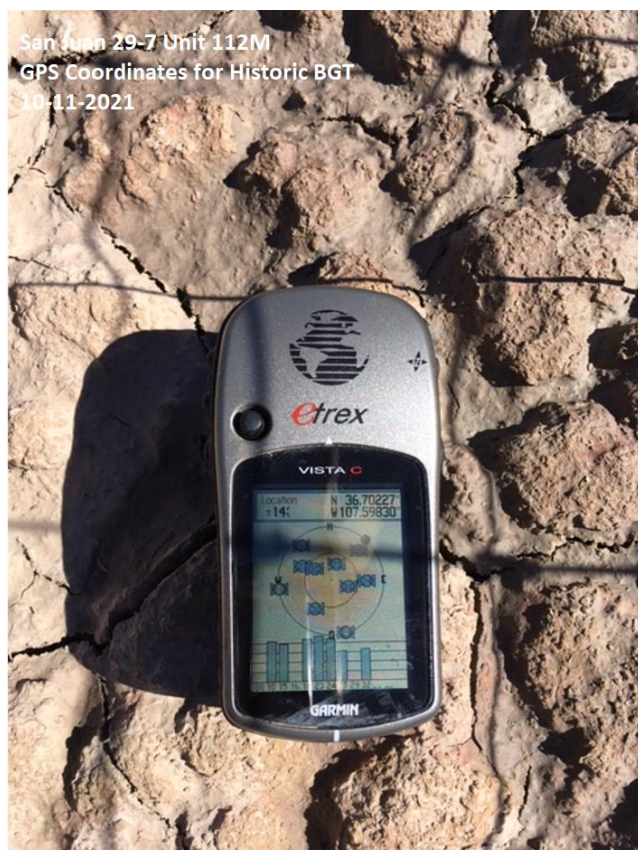
30-039-22398

BGT Closure Photos – Unable to auger down 8' due to auger refusal. After soil remediation the Final C-141 will be filled with Back fill photos.
