Pit, Below-Grade Tank, or  
Proposed Alternative Method Permit or Closure Plan Application

Hilcorp Energy Company  
San Juan Basin  
Below Grade Tank Closure Report

Lease Name: Masden Gas Com 1E

API No.: 3004524003

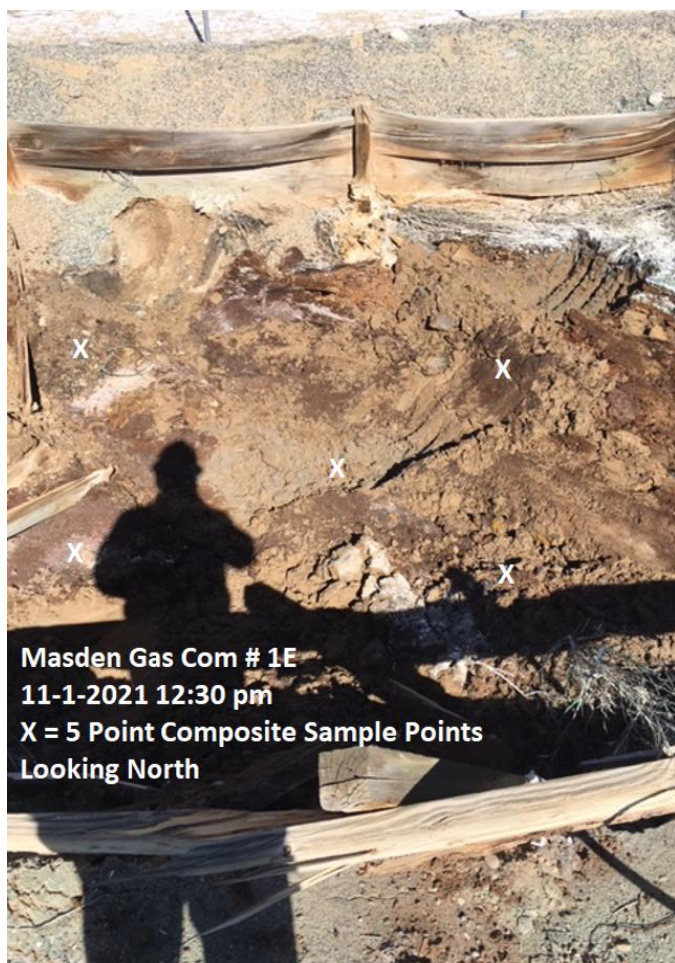
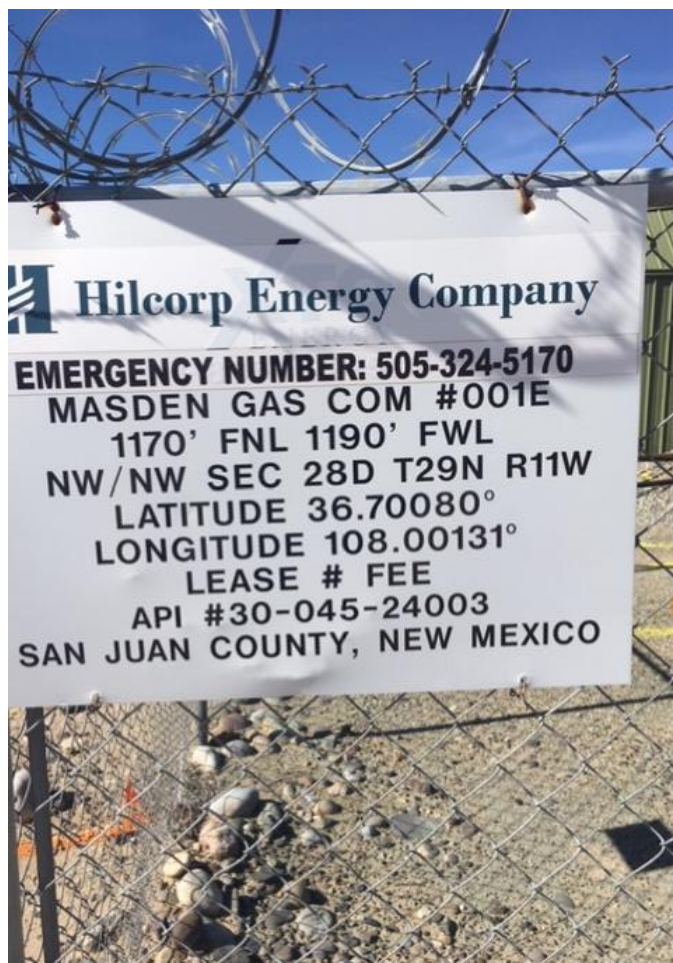
Masden Gas Com # 1E  
11-1-2021 12:30 pm  
X = 5 Point Composite Sample Points  
Looking North

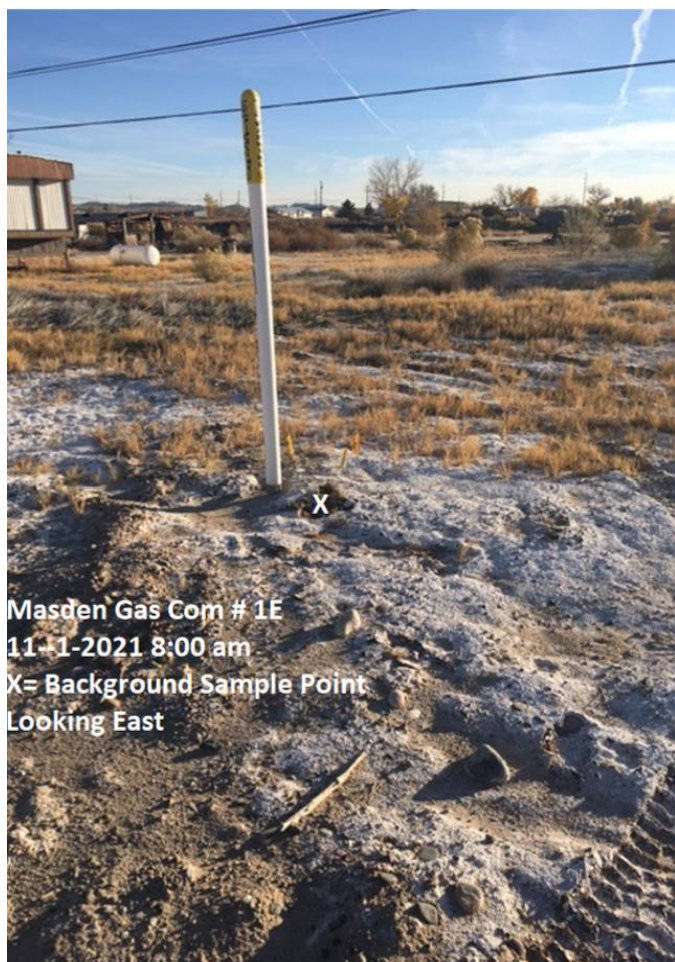
Masden Gas Com # 1E  
11-1-2021 8:00 am  
X= Background Sample Point  
Looking East

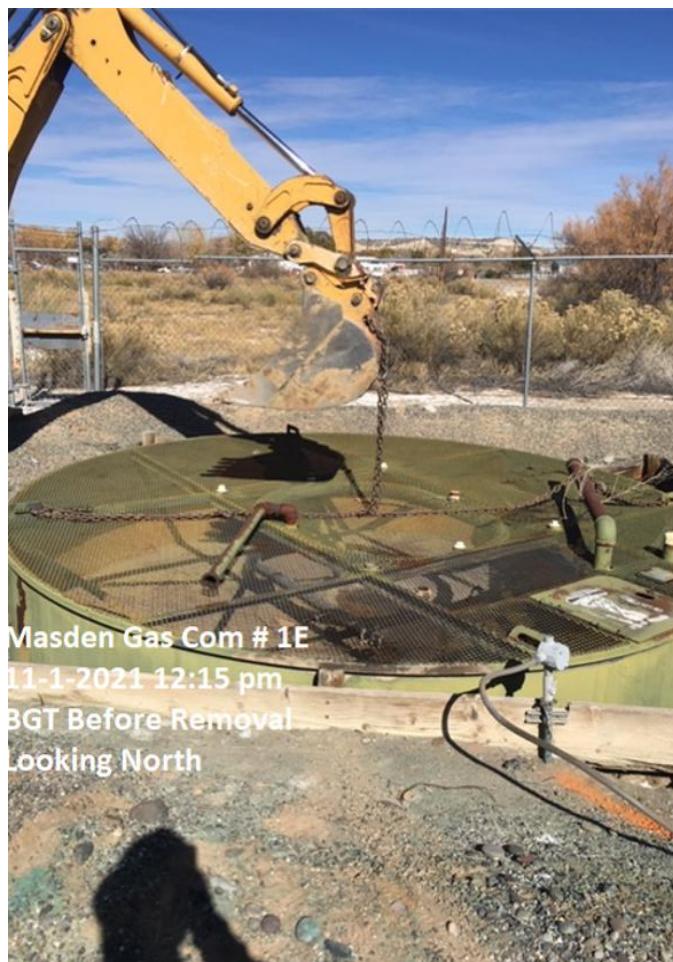
Masden Gas Com # 1E  
11-1-2021 12:15 pm  
BGT Before Removal  
Looking North
