Pit, Below-Grade Tank, or
Proposed Alternative Method Permit or Closure Plan Application

Hilcorp Energy Company
San Juan Basin
Below Grade Tank Closure Report

Lease Name: Hartman 1R

API No.: 3004530686

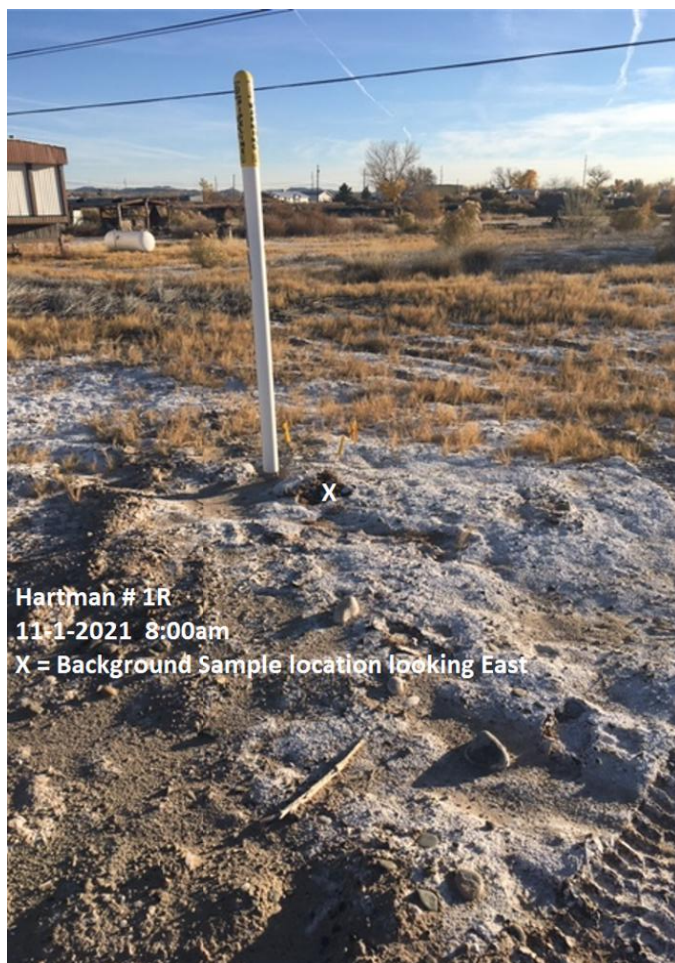
Hartman # 1R
11-1-2021 8:00am
X = Background Sample location looking East

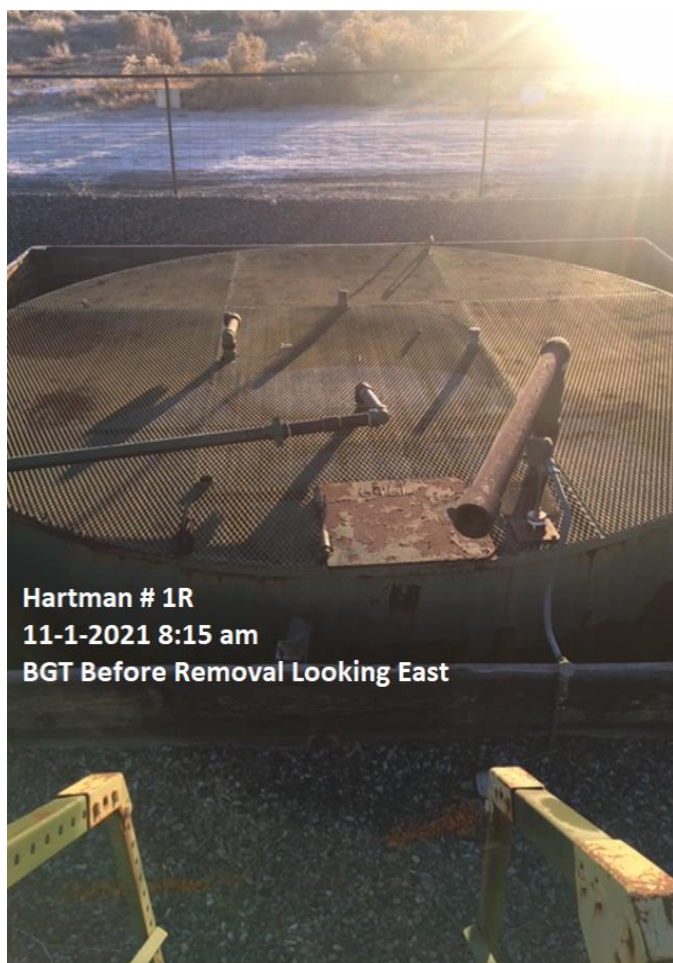
Hartman # 1R
11-1-2021 8:15 am
BGT Before Removal Looking East

The below-grade tank was disposed of in a division-approved manner.

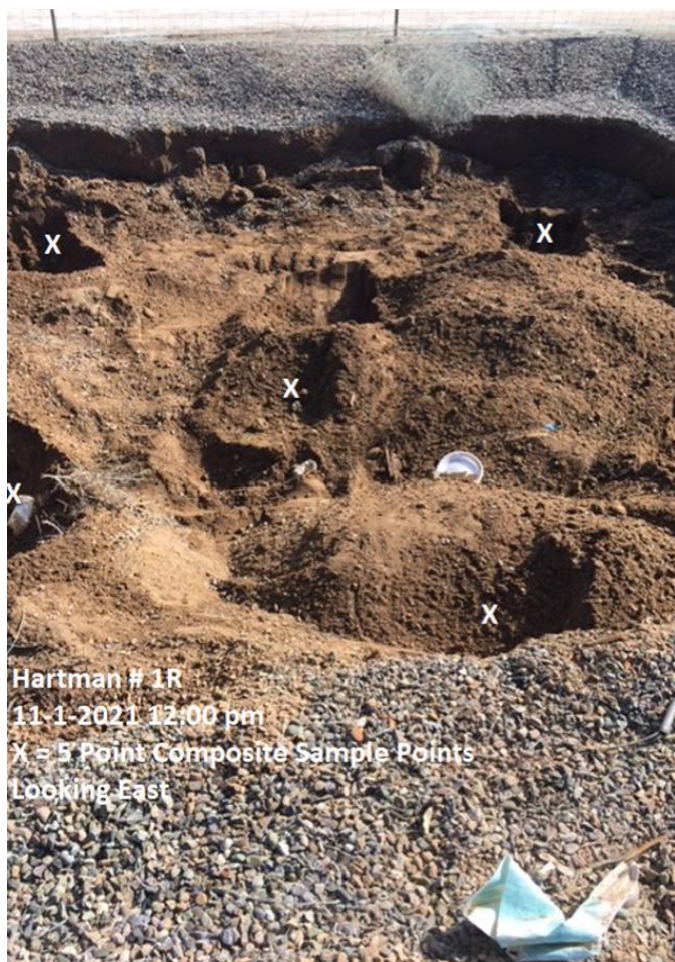
Hartman # 1R
11-1-2021 12:00 pm
X = 5 Point Composite Sample Points
Looking East

A five point composite sample was taken of the below-grade tank using sampling tools and all samples tested per Subsection B of 19.15.17.1 3(B)(1)(b). (Sample results attached). Form C-141 is attached.

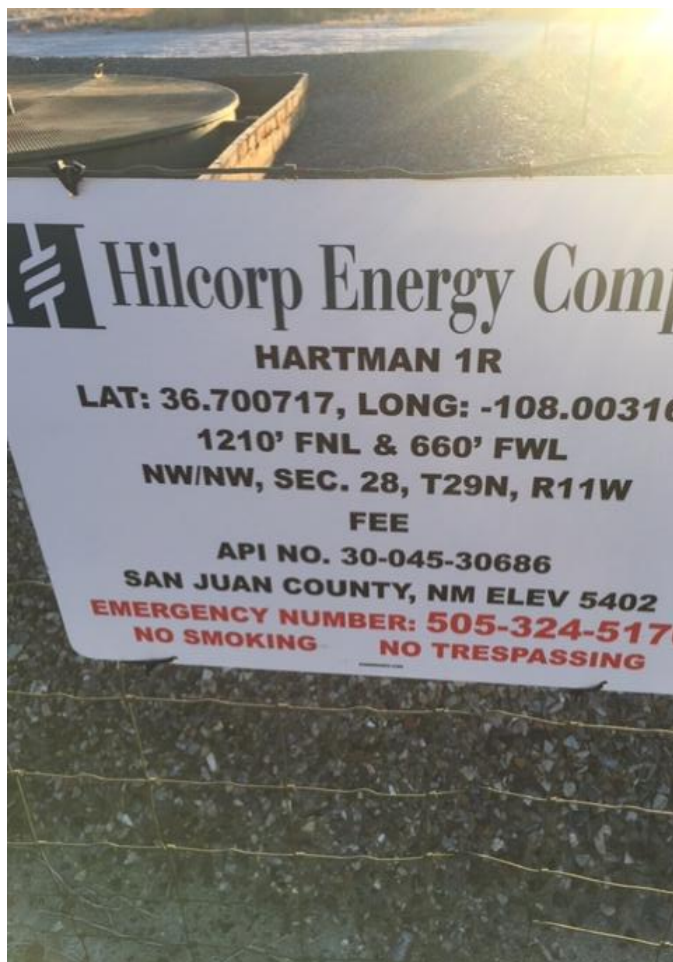
11/30/2021 West facing @ 10:15 am

The below-grade tank area passed all requirements of Paragraph (4) of Subsection E of 19.15.17.13 NMAC and was backfilled with compacted, non-waste containing, earthen material.
