Pit, Below-Grade Tank, or  
Proposed Alternative Method Permit or Closure Plan Application

Hilcorp Energy Company  
San Juan Basin  
Below Grade Tank Closure Report

Lease Name: P O Pipkin 1G

API No.: 3004533777

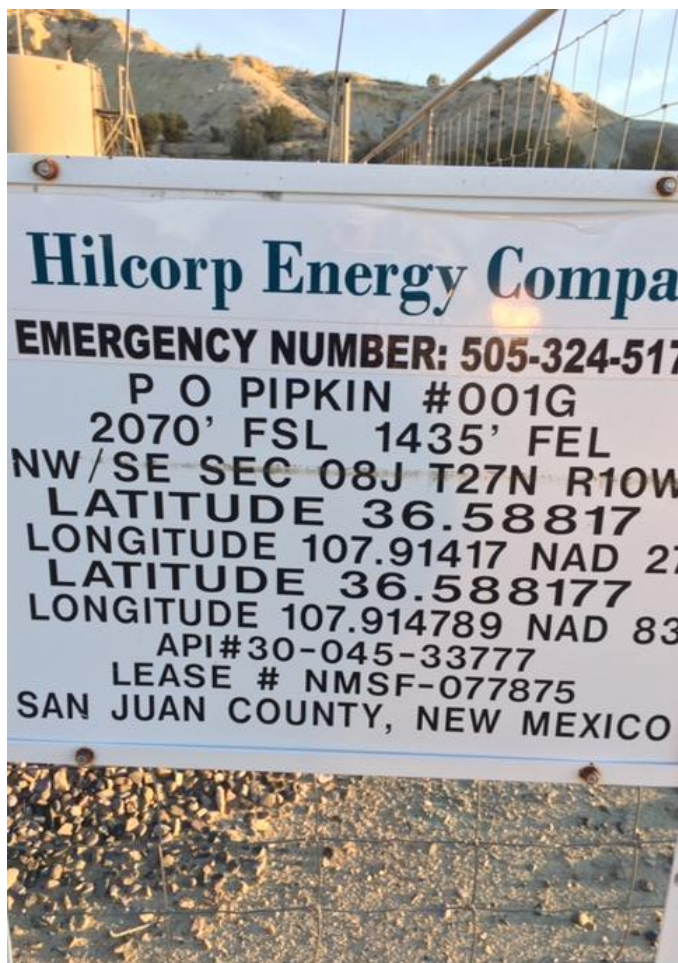
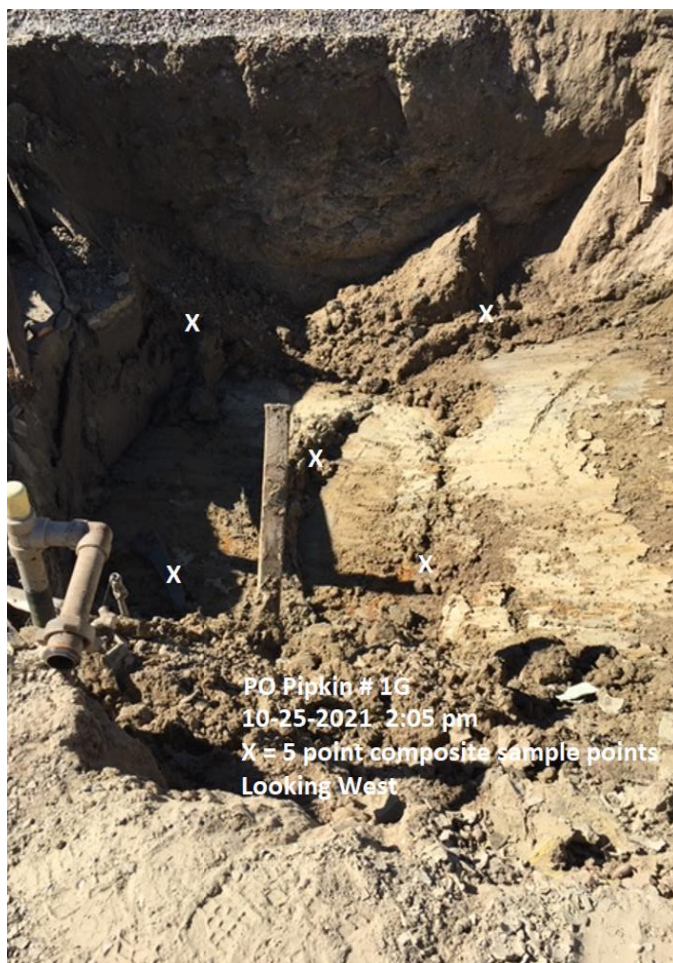
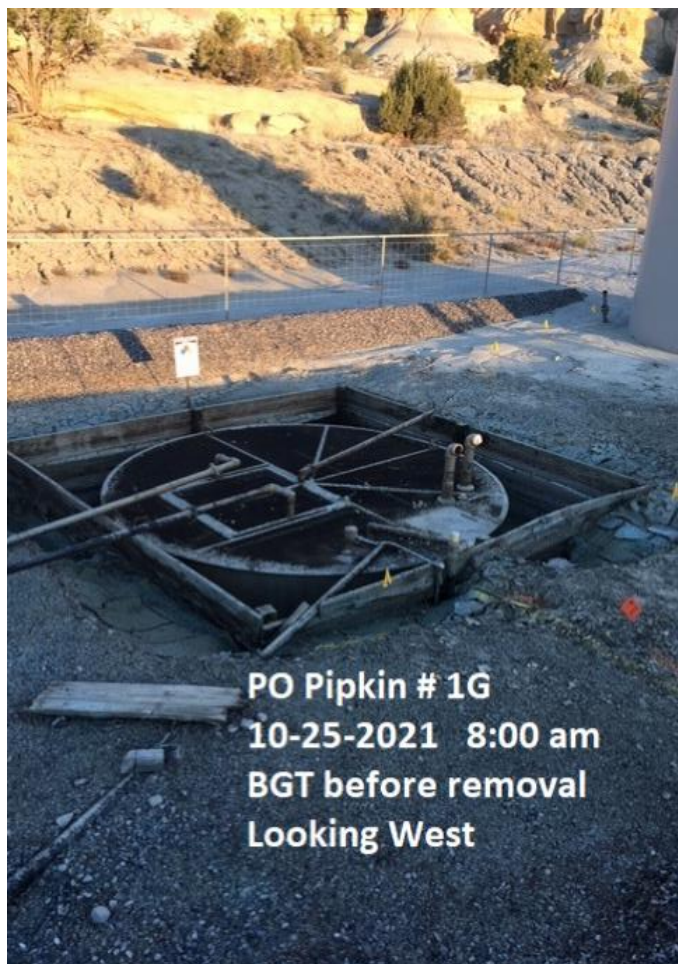
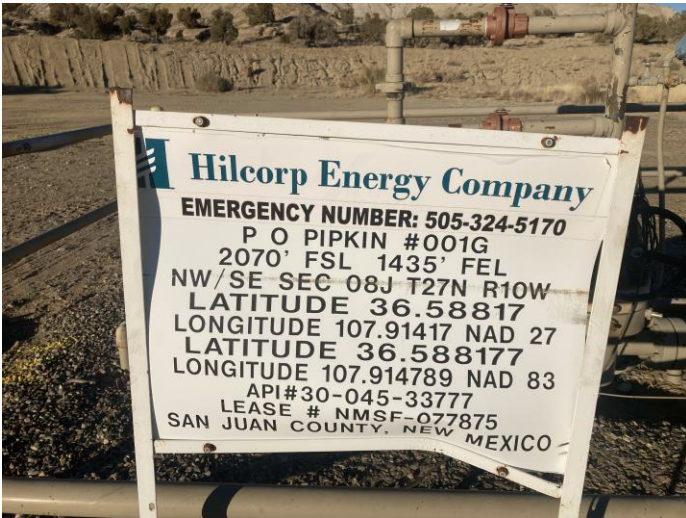
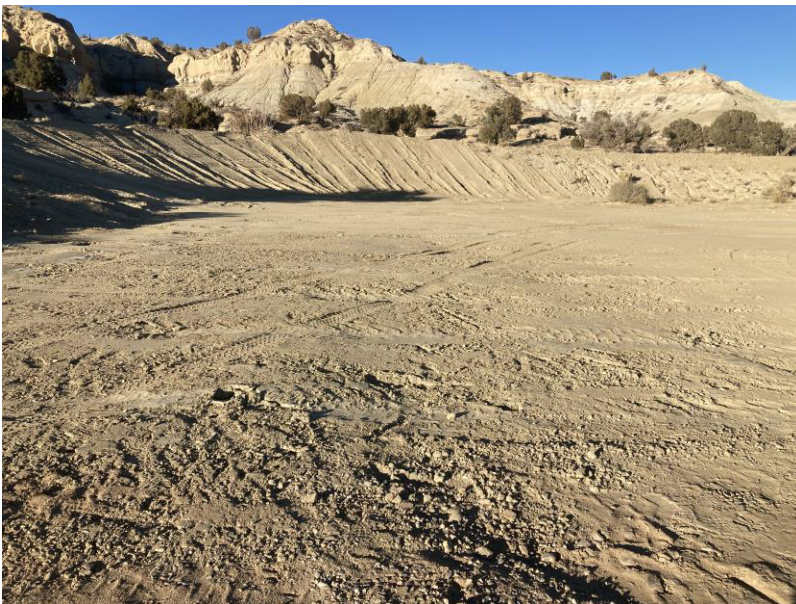
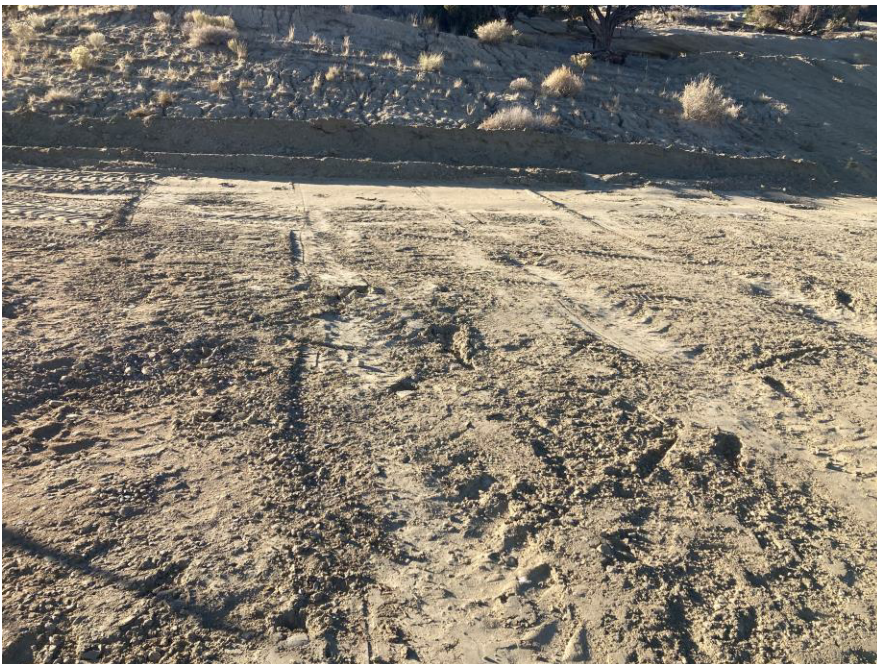
12/3/2021 Facing North @3:40 pm

The below-grade tank area passed all requirements of Paragraph (4) of Subsection E of 19.15.17.13 NMAC and was backfilled with compacted, non-waste containing, earthen material.
