Pit, Below-Grade Tank, or
Proposed Alternative Method Permit or Closure Plan Application

**RE: Below Grade Tank Closure Report
Gallegos Com #5
API #3004521306
San Juan County, New Mexico**

Animas Environmental Services, LLC (AES) is pleased to provide the final closure report for the 45-bbl below grade tank (BGT) under operational control of Harvest Four Corners (Harvest) at the Hilcorp Gallegos Com #5 (API #3004521306), located in San Juan County, New Mexico. Tank removal and closure sampling was completed by Harvest. This report is a revision of the original dated June 23, 2020.

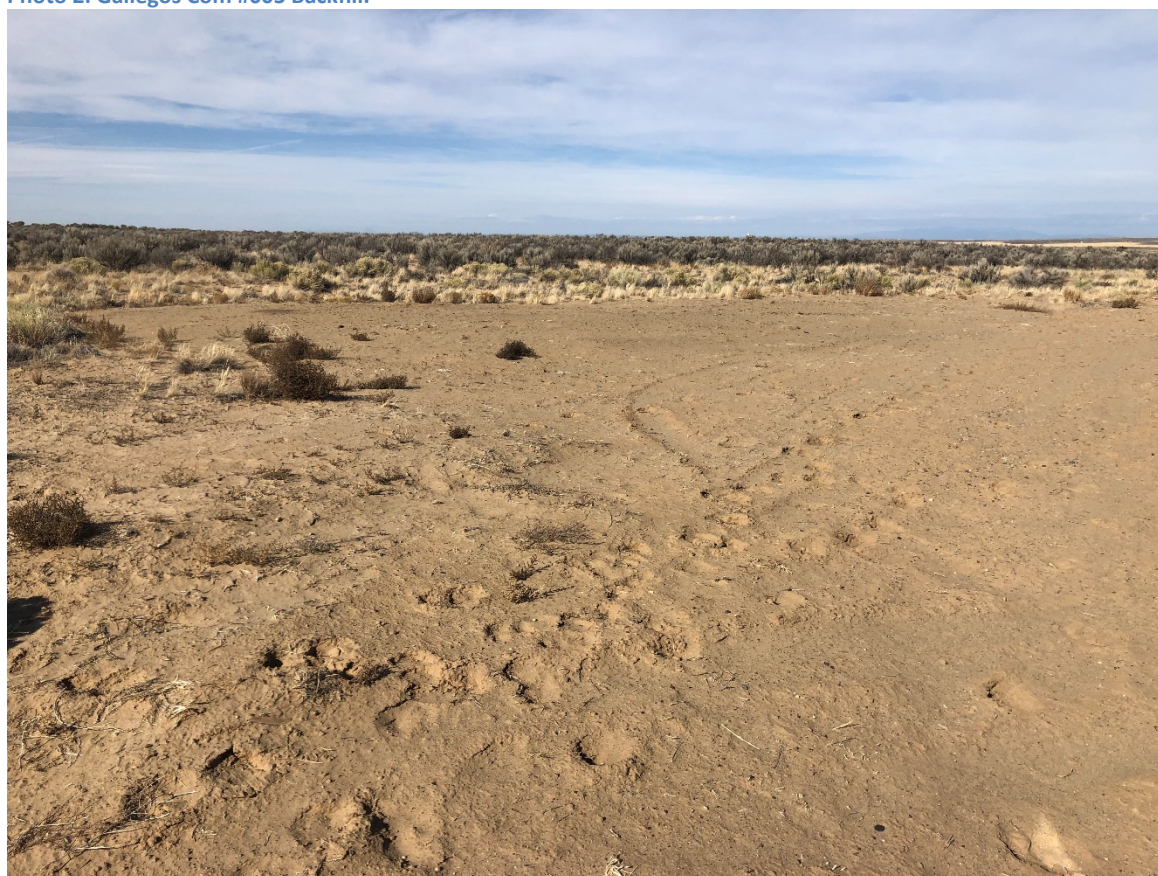
Photo 2: Gallegos Com #005 Backfill.

Based on BGT laboratory analytical results for benzene, total BTEX, TPH, and chloride at the location of the removed Harvest BGT, the site was backfilled with clean soil. No further work is recommended at Gallegos Com #5 for the Harvest BGT Closure.
