<u>Pit, Closed-</u>	<u>Loop System,</u>	<u>Below-Grade</u>	<u>Tank, or</u>
Proposed Alternativ	e Method Per	mit or Closure	Plan Application

#### SIMCOE LLC

Well Name: Gallegos Canyon Unit 235E
Well API# 30-045-26348
Unit Letter O, Section 13, T28N, R13W

#### BELOW-GRADE TANK CLOSURE PLAN

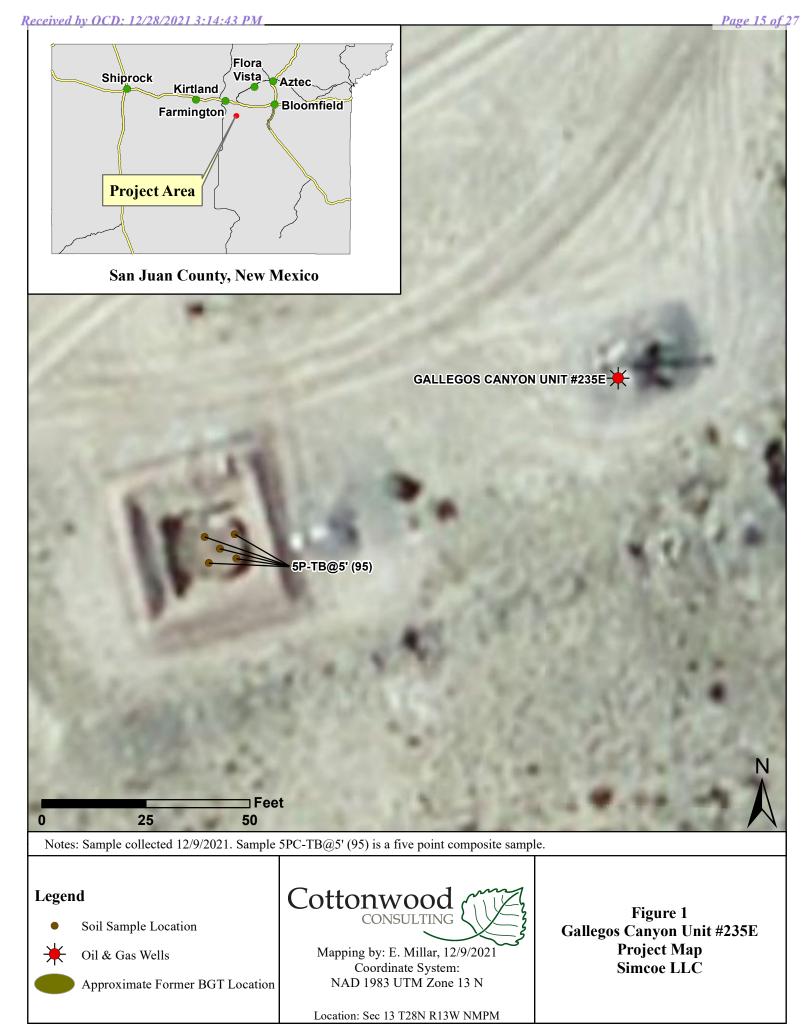
CLIENT: Simcoe LLC	COTTONWOO P.O. BOX 1653, I	OD CONSULTIN DURANGO, COI (0) 764-7356		API #:300 \cdot TANK ID (if applicble):		
FIELD REPORT:	(circle one): BGT CONFIRMATION		OTHER:	PAGE #:	of _	ı
SITE INFORMATION QUAD/UNIT: O SEC: 13 TWP:				DATE STARTED:	12/9/0	
1/4 -1/4/FOOTAGE:	LEASE 1	CONTACT: (1)	E / FEE / INDIAN	ENVIRONMENTAL SPECIALIST(S):	EM	<u> </u>
REFERENCE POINT		COORD.: 36°39'29.77	12" 108° 10' 4.51	a" GLELI	EV.: 564

2) 95 BBL & Steel tank	GPS COORD.:	1118 31,801- 1118	DISTANCE/BEA	RING FROM P&A: 100		
4)	GPS COORD.:			RING FROM P&A:		
SAMPLING DATA:  1) SAMPLE ID: 5 PC - TB @ 5 '( 9  2) SAMPLE ID:  3) SAMPLE ID:  4) SAMPLE ID:  5) SAMPLE ID:	SAMPLE DATE:	SAMPLE TIME: 1025 SAMPLE TIME: SAMPLE TIME: SAMPLE TIME:	LAB ANALYSIS: 8015 M LAB ANALYSIS: LAB ANALYSIS: LAB ANALYSIS: LAB ANALYSIS:	/b,80218,300		OVM EADING (ppm)
SOIL COLOR: Brown  SOIL COLOR: Brown  SOIL COLOR: Brown  COHESION (ALL OTHERS): (NON COHESIVE) SLIGHTLY COHESIVE / COHESIVE / HIGHLY COHESIVE  CONSISTENCY (NON COHESIVE SOILS): LOOSE) FIRM / DENSE / VERY DENSE MOISTURE: DRY / SLIGHTLY MOIST (MOIST) WET / SATURATED / SUPER SATURATED  SAMPLE TYPE: GRAB / COMPOSITE + # OF PTS.  DISCOLORATION/STAINING OBSERVED: YES (MO EXPLANATION-  DISCOLORATION/STAINING OBSERVED: YES (MO EXPLANATION-  SITE OBSERVATIONS: LOST INTEGRITY OF EQUIPMENT: YES / (MO EXPLANATION-  APPARENT EVIDENCE OF A RELEASE OBSERVED AND/OR OCCURRED: YES / (MO EXPLANATION:  EQUIPMENT SET OVER RECLAIMED AREA: YES) NO EXPLANATION-  Plan to 125 to 14 ST (2300 BB Ls) over reclaimed area: YES) NO EXPLANATION-  OTHER:

EXCAVATION DIMENSION ESTIMATION DEPTH TO GROUNDWATER: 750	N: <u> </u>			TIMATION (Cubic Ya	,	ppm
SITE SKETCH  Op by	BGT Located: off / on site	GCU 235 F	N TIME  OVM  TIME  PO  OTAT  ID  A	ermit date(s): 6/ CD Appr. date(s):  OVM = Organic ppm = parts ps	ppm DATE:  NOTE  (2 6/10 6/26/10 c Vapor Meter er million ible: Y / N) ible: Y / N	
BOTTOM; PBGTL = PREVIOUS BELOW-GRADE T NOT AVAILABLE; SW-SINGLE WALL; DW-DOL	ANK LOCATION; SPD = SAMPLE POINT DESIGN	NATION; R.W. = RETAINING WALL; NA- BOTTOM.	-NOT APPLICABLE OR M	lagnetic declinati	ion:	
NOTES:		ONSITE:	12/9/21

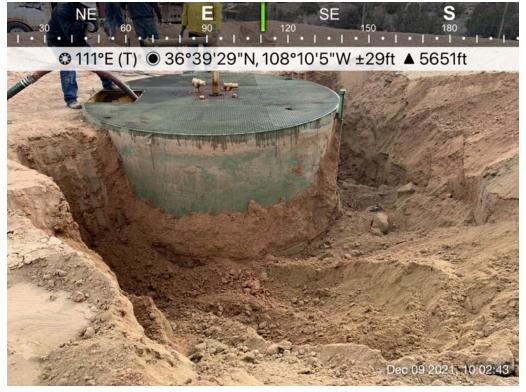
Photo 2: 95 bbls steel tank "A" during removal, 12/9/21.

The BGT was transported for recycling.
- Within six months of cessation of operations, SIMCOE shall remove any on-site equipment associated with a BGT unless the equipment is required for some other purpose.
   All equipment associated with the BGT has been removed.
- 6. SIMCOE shall test the soils beneath the BGT to determine whether a release has occurred. SIMCOE shall collect at a minimum: a five (5) point composite sample to include any obvious stained or wet soils, or other evidence of a release under the BGT. The composite sample shall be collected and analyzed as required for the constituents listed in Table I within Subparagraph (a) of Paragraph (3) of Subsection C of 19.15.17.13 NMAC (see Table 1 below).

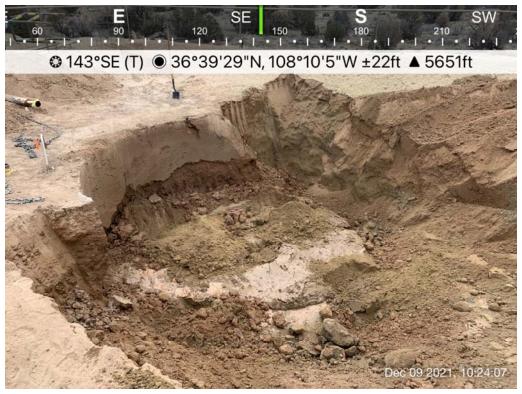
Photo 3: Former location of 95 bbls steel tank "A" following removal, 12/9/21.

Soils beneath the BGT were sampled for TPH, BTEX, and chloride per the above requirements. TPH, BTEX, and chloride were all non-detect based on laboratory analytical results.

Sampling results and field observations reveal no evidence of a release had occurred.

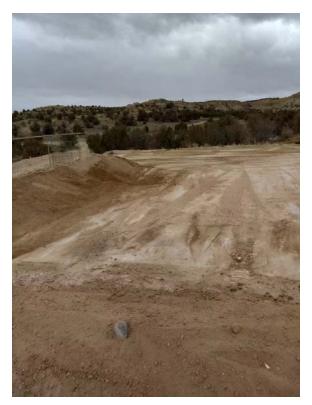
Photo 4: Former location of 95 bbls steel tank "A" following removal and regrading, 12/9/21.

No evidence of a release. Area backfilled / regraded. AST installed at location of former BGT.
- 10. SIMCOE shall reclaim the BGT location, and all areas associated with the BGT including associated roads to a safe and stable condition that blends with the surrounding undisturbed area. SIMCOE shall substantially restore the impacted surface area to the condition that existed prior to oil and gas operations by placement of the soil cover as provided in Subsection H of 19.15.17.13 NMAC, recontour the location and associated areas to a contour that approximates the original contour and blends with the surrounding topography and re-vegetate according to Subsection I of 19.15.17.13 NMAC. Area backfilled / regraded. AST installed at location of former BGT.
