Pit, Below-Grade Tank, or  
Proposed Alternative Method Permit or Closure Plan Application

**Hilcorp Energy Company  
San Juan Basin  
Below Grade Tank Closure Report**

**Lease Name: Hill 4**  
**API No.: 30-045-23307**

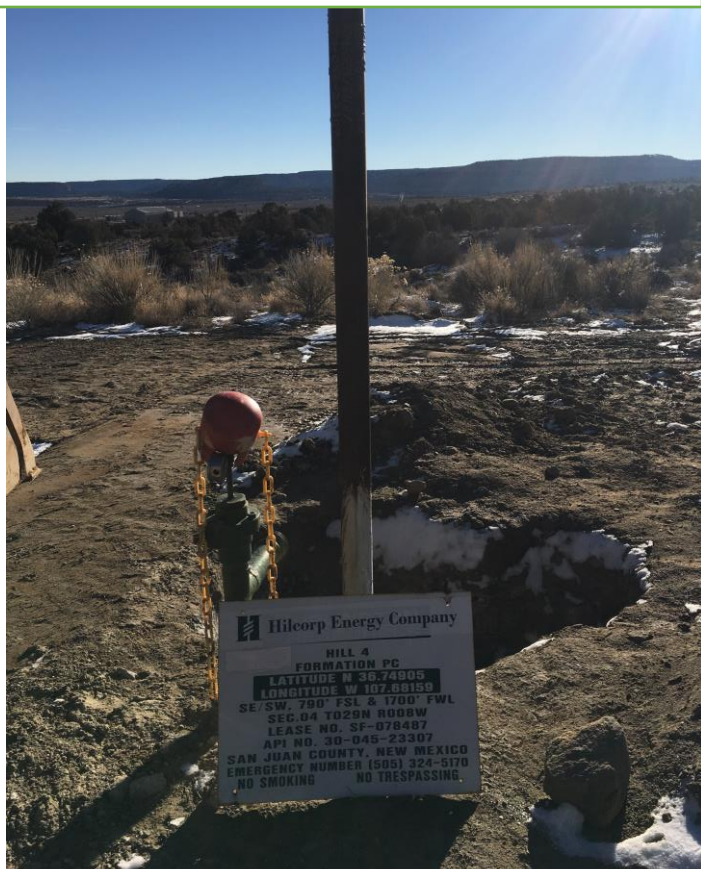
BGT Sampling Picture #1

**A five point composite sample was taken of the below-grade tank using sampling tools and all samples tested per Subsection B of 19.15.17.1 3(B)(1)(b). (Sample results attached). Form C-141 is attached.**

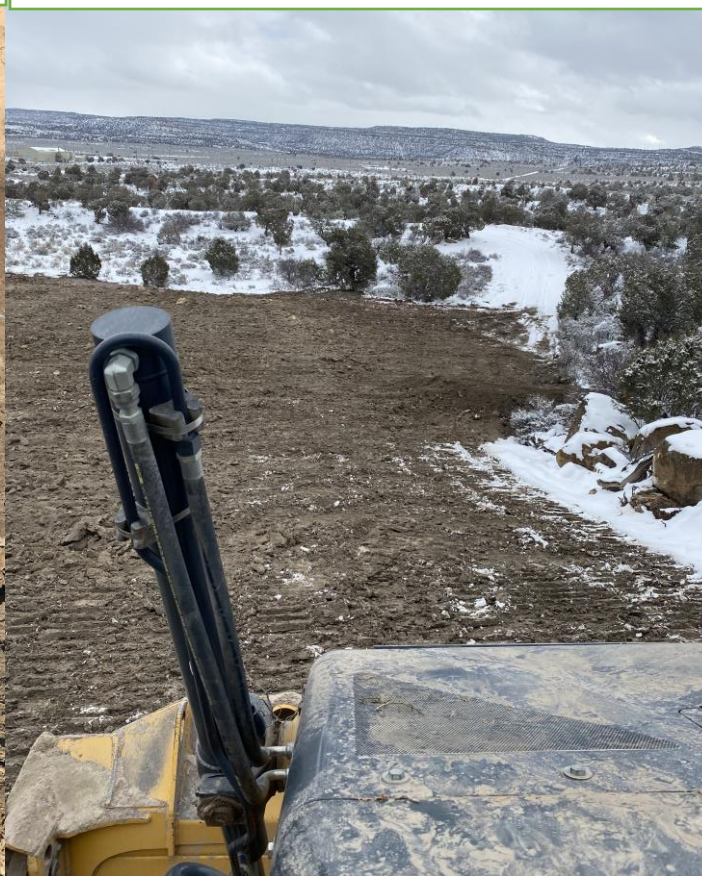
Reclaim Picture #1

**The below-grade tank area passed all requirements of Paragraph (4) of Subsection E of 19.15.17.13 NMAC and was backfilled with compacted, non-waste containing, earthen material.**

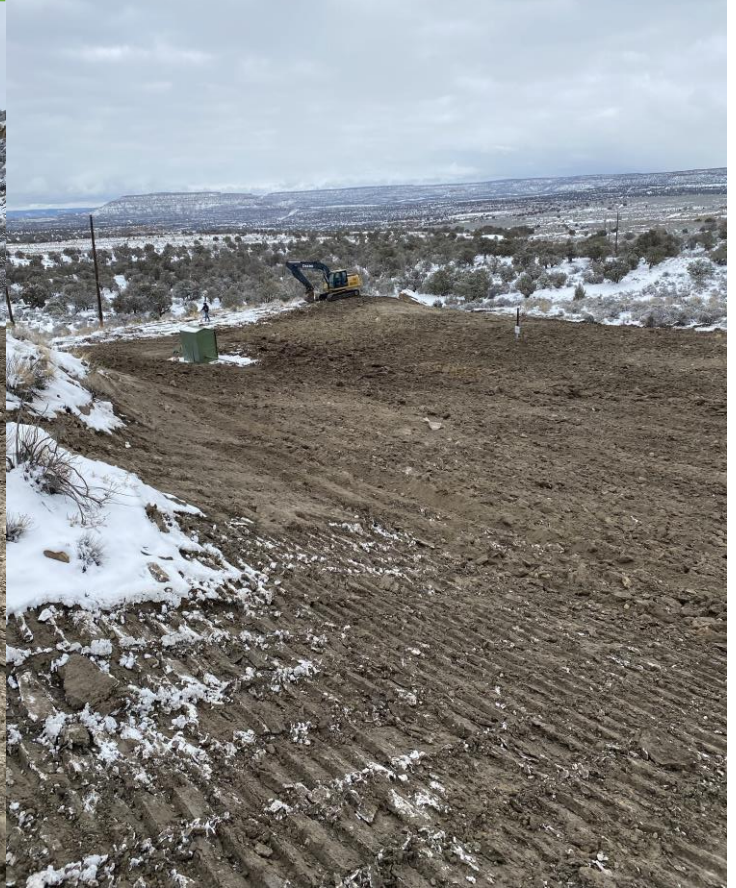
BGT Closure Picture #1

**The below-grade tank was disposed of in a division-approved manner.**

**All on-site equipment associated with the below-grade tank was removed.**
