Northeast Drinkard Unit #627

Closure Report

Pit Closure

RE: TERMINATION REQUEST

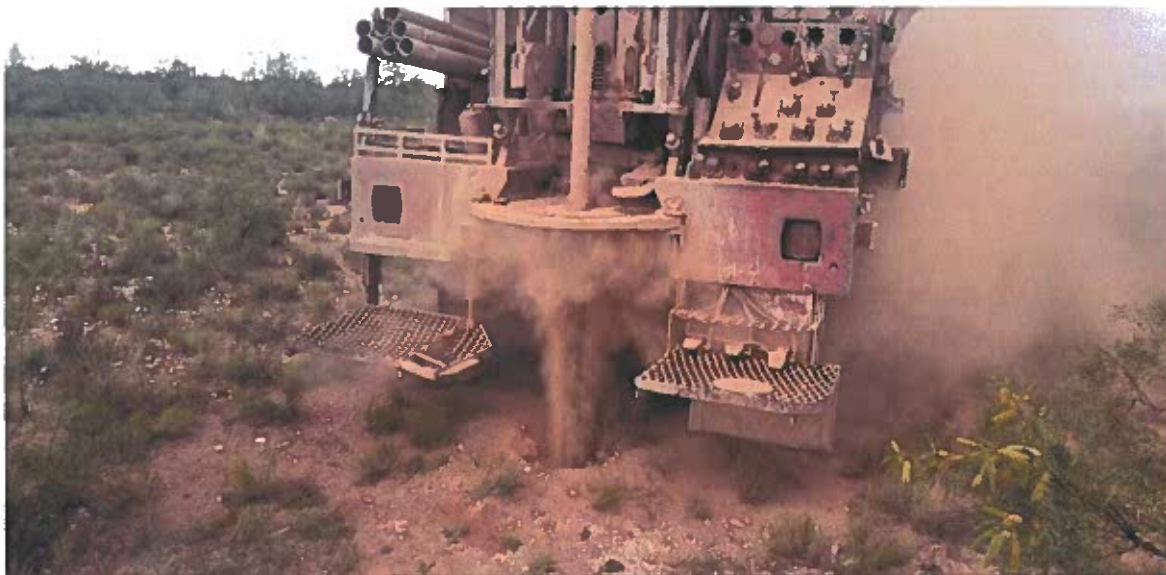
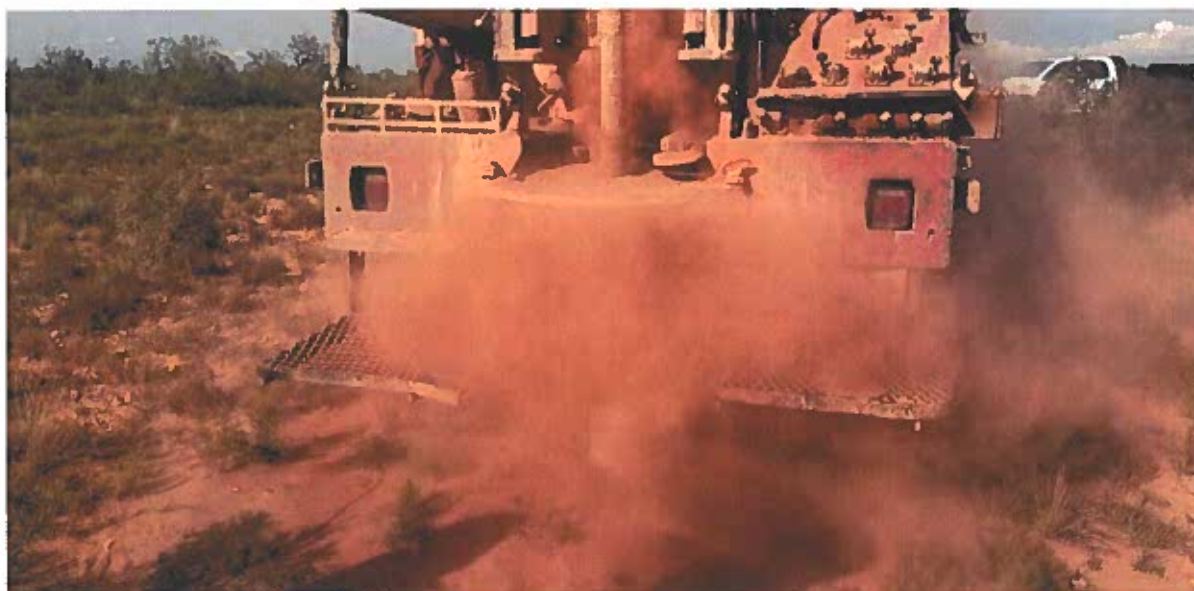
Apache Corporation: NEDU #627
Soil Bore #1

SB #1 was drilled up-gradient northwest of the pit to a total depth of 198'bgs, containing 93' of an impervious clay barrier and was dry, no groundwater encountered. SB #6 was also drilled up-gradient E/NE of the pit to a total depth of 104'bgs, containing 84' of an impervious clay barrier and was dry, no groundwater encountered.

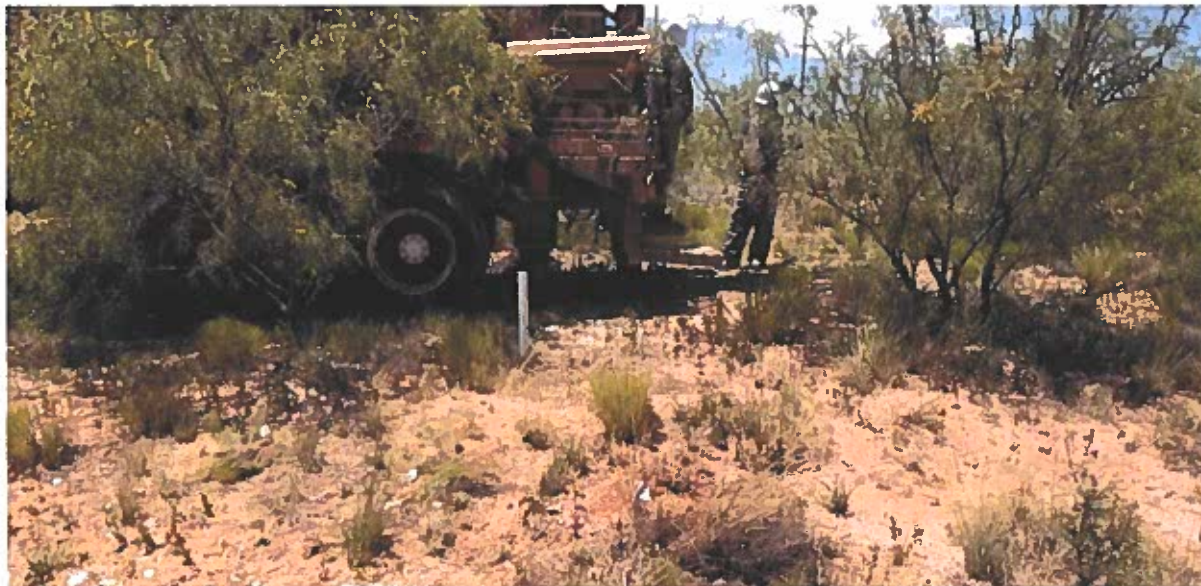
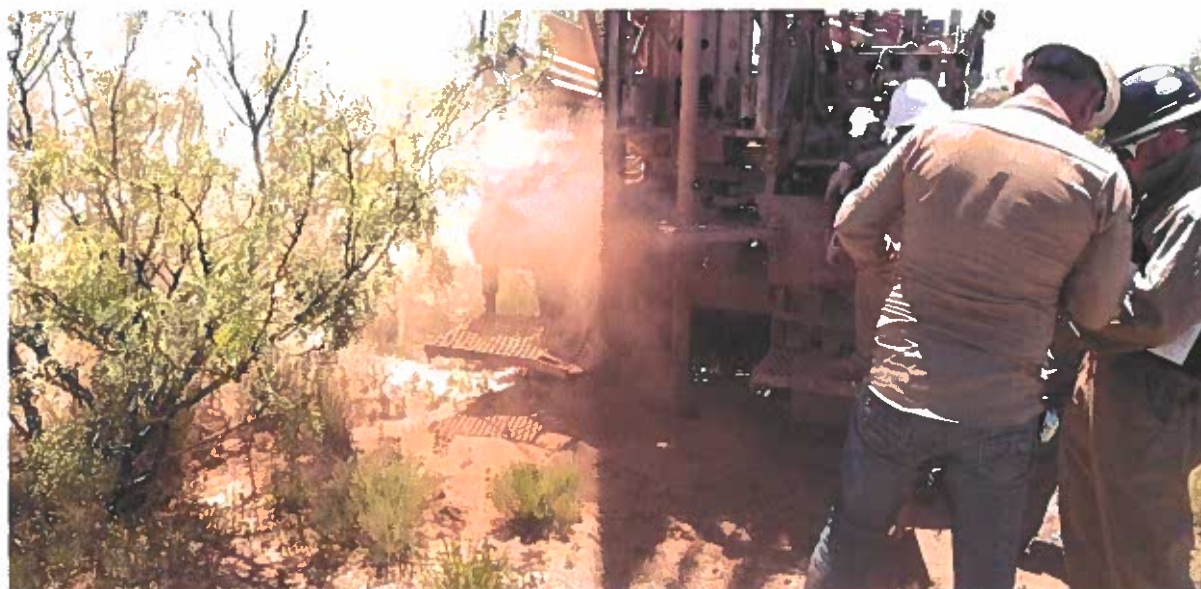
Apache Corporation: NEDU #627
Soil Bore #2

SB #2, SB #3, SB #4 and SB #5 were drilled downgradient in a south easterly direction (see attached Site Map for details). SB#2 (18'bgs) thru SB#5 (22'bgs) contained perched drilling fluids (see attached Soil Boring Logs).
