Pit, Below-Grade Tank, or
Proposed Alternative Method Permit or Closure Plan Application

**Hilcorp Energy Company
San Juan Basin
Below Grade Tank Closure Report**

Lease Name: Aztec Gas Com 1E

API No.: 30-045-31136

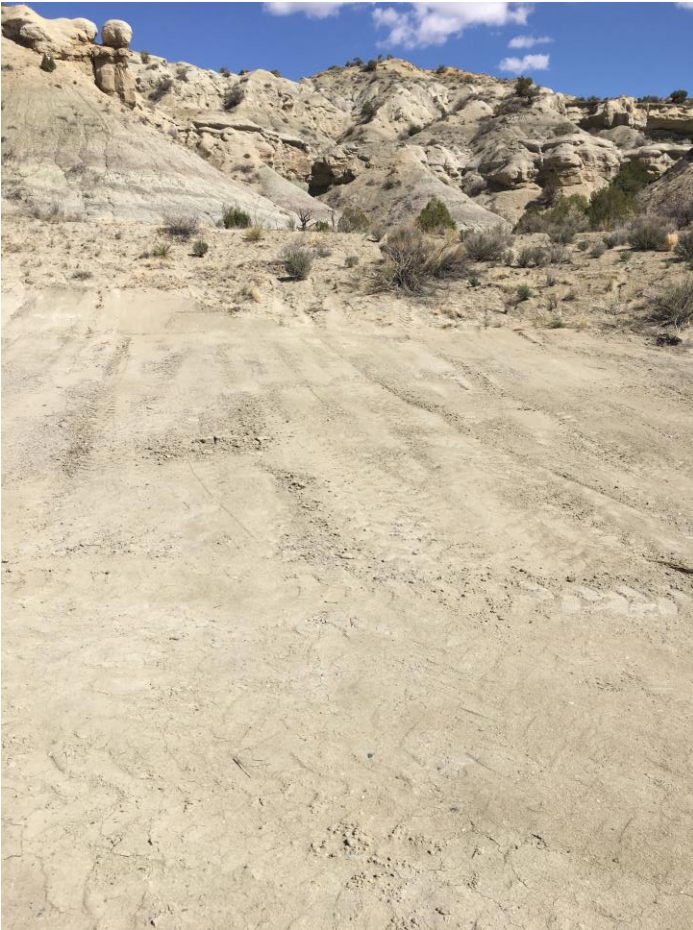
Backfill photo 4/4/22, 3:50 pm, facing East

The below-grade tank area passed all requirements of Paragraph (4) of Subsection E of 19.15.17.13 NMAC and was backfilled with compacted, non-waste containing, earthen material.

The below-grade tank area was re-contoured to match fit, shape, line, form and texture of the surrounding area. Re-shaping including drainage control, to prevent ponding and erosion. Natural drainages were unimpeded and water bars and/or silt traps were placed in areas where needed to prevent erosion on a large scale. Final recontour has a uniform appearance with smooth surface, fitting the natural landscape.
