Hilcorp Energy Company San Juan Basin Below Grade Tank Closure Report

Lease Name: Martin Gas Com G 1E API No.: 30-045-24205

Martin Gas Com G 1E 30-045-24205 BGT Closure Photos

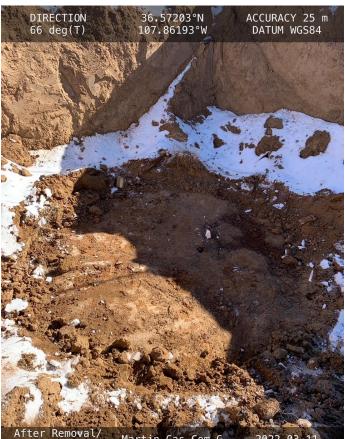
After Removal/ Composite Sample Points Martin Gas Com G 2022-03-11 #001E 09:09:10-07:00

A five point composite sample was taken of the below-grade tank using sampling tools and all samples tested per Subsection B of 19.15.17.1 3(B)(1)(b). (Sample results attached). Form C-141 is attached.

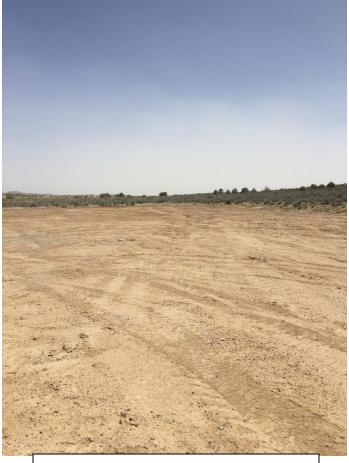
Backfill Photo 5/9/22 3:00 pm facing East

The below-grade tank area passed all requirements of Paragraph (4) of Subsection E of 19.15.17.13 NMAC and was backfilled with compacted, non-waste containing, earthen material.

The below-grade tank area was backfilled and more than four feet of cover was achieved and the cover included one foot of suitable material to establish vegetation at the site.
