Pit, Below-Grade Tank, or  
Proposed Alternative Method Permit or Closure Plan Application

1.  
Operator: Hilcorp Energy Company OGRID #: 372171  
Address: 382 Road 3100 Aztec, NM 87410  
Facility or well name: Aztec 7E  
API Number: 30-045-24404 OCD Permit Number: \_\_\_\_\_  
U/L or Qtr/Qtr L Section 14 Township 28N Range 11W County: San Juan  
Center of Proposed Design: Latitude 36.659276 Longitude -107.978786 NAD83  
Surface Owner: ☒ Federal ☐ State ☐ Private ☐ Tribal Trust or Indian Allotment

**Hilcorp Energy Company**  
**San Juan Basin: New Mexico Assets**  
Below Grade Tank Closure Report

**Lease Name:** Aztec 7E  
**API No.:** 30-045-24404

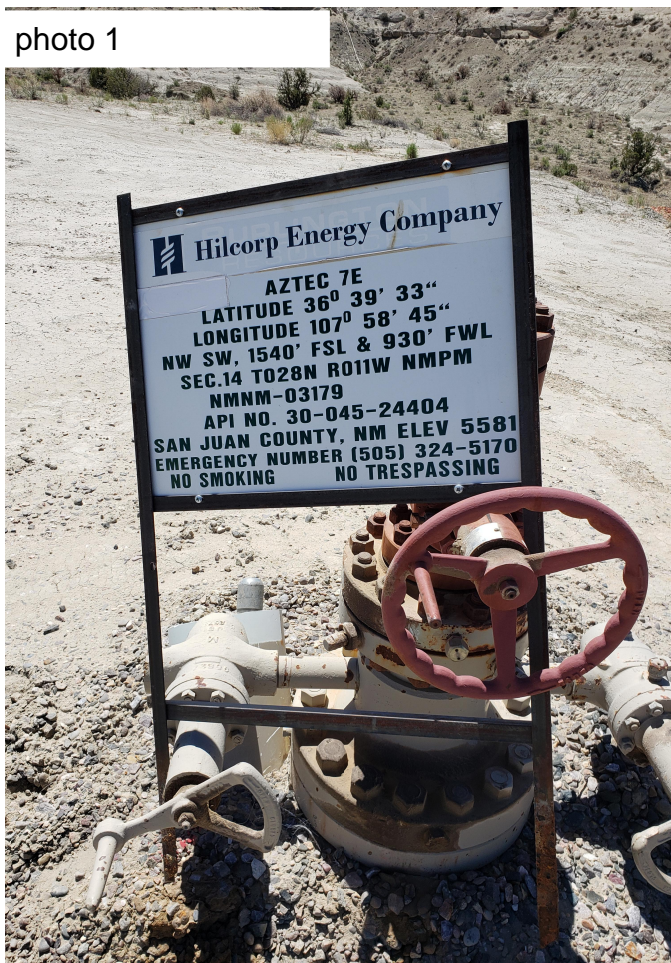
photo 1

PIC#1  
TAKEN  
FACING EAST  
PIC#2  
FACING NORTH  
TOWARD ORIGINAL  
BGT LOCATION
