Pit, Below-Grade Tank, or  
Proposed Alternative Method Permit or Closure Plan Application

1.  
Operator: Hilcorp Energy Company OGRID #: 372171  
Address: 382 Road 3100 Aztec, NM 87410  
Facility or well name: Hardie 5E – BGT #2  
API Number: 30-045-24935 OCD Permit Number: \_\_\_\_\_  
U/L or Qtr/Qtr A Section 23 Township 28N Range 8W County: San Juan  
Center of Proposed Design: Latitude 36.652119 Longitude -107.645266 NAD83  
Surface Owner: ☒ Federal ☐ State ☐ Private ☐ Tribal Trust or Indian Allotment

**Hilcorp Energy Company  
San Juan Basin: New Mexico Assets  
Below Grade Tank Closure Report**

**Lease Name:** Hardie 5E  
**API No.:** 30-045-24935

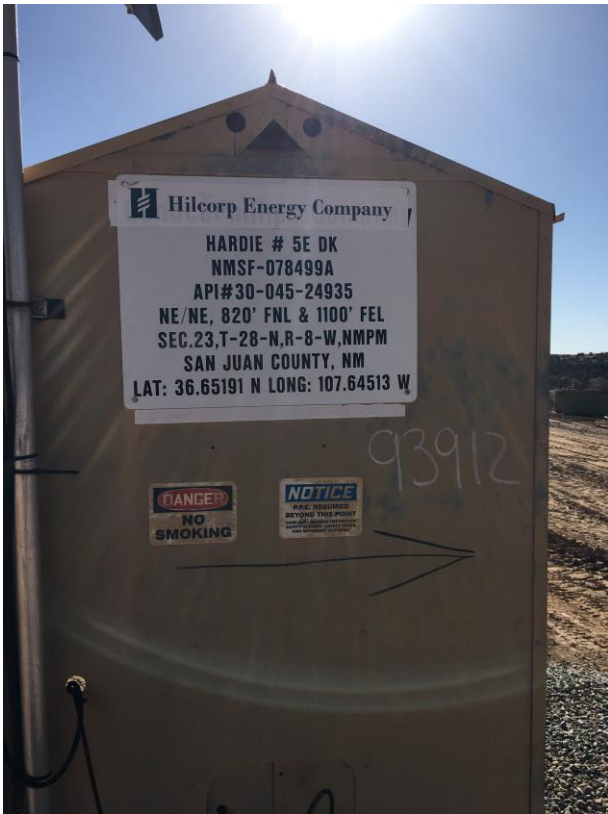
Sample Picture 1

**A five point composite sample was taken of the below-grade tank using sampling tools and all samples tested per Table I of 19.15.17.13 and the results are attached.**

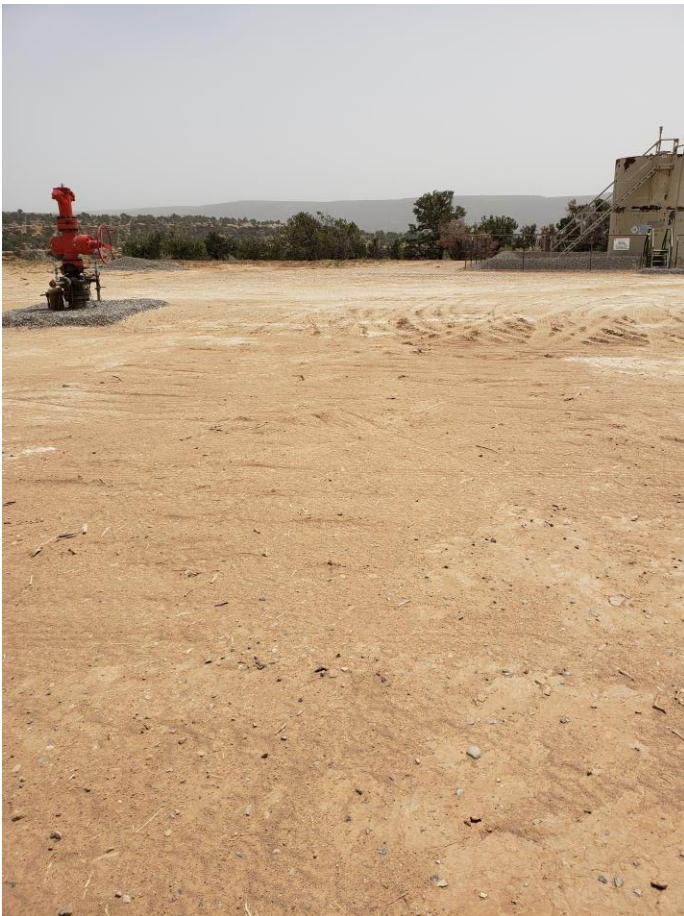
BGT Closure Picture

**The below-grade tank was disposed of in a division-approved manner. The liner was cleaned per 19.15.35.8.C(1)(m) NMAC and disposed of at the San Juan County Regional Landfill located on CR 3100.**

**All on-site equipment associated with the below-grade tank was removed.**
