Pit, Below-Grade Tank, or
Proposed Alternative Method Permit or Closure Plan Application

Hilcorp Energy Company
San Juan Basin
Below Grade Tank Closure Report

Lease Name: Scott Federal 27-11 23 1
API No.: 30-045-30892

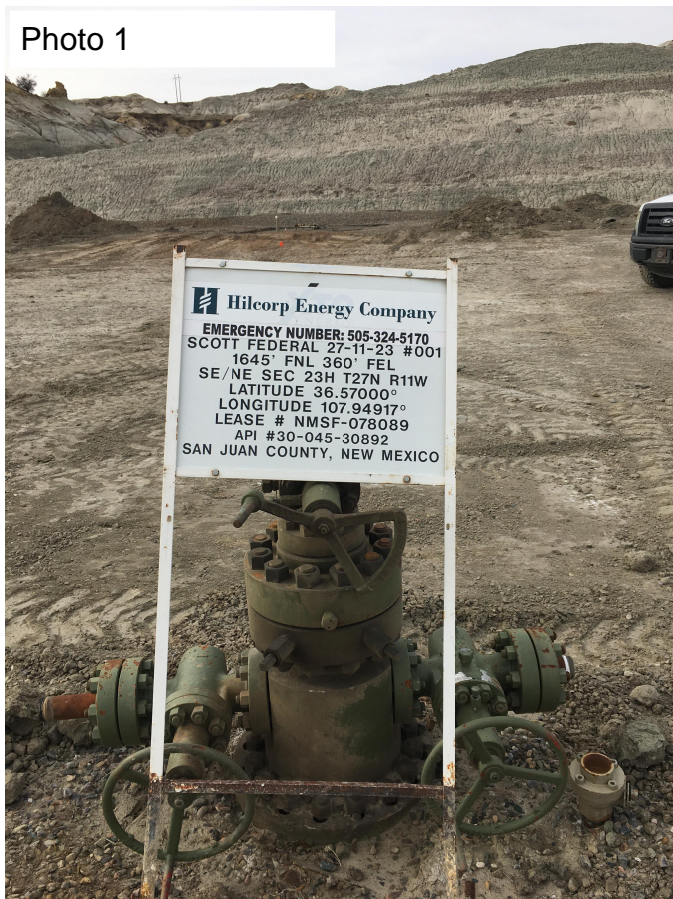
Photo 1

TAKEN FACING SOUTH
