# Proposed Alternative Method Permit or Closure Plan Application

#### Hilcorp Energy Company San Juan Basin Below Grade Tank Closure Report

Lease Name: Federal C 3 API No.: 30-045-33693

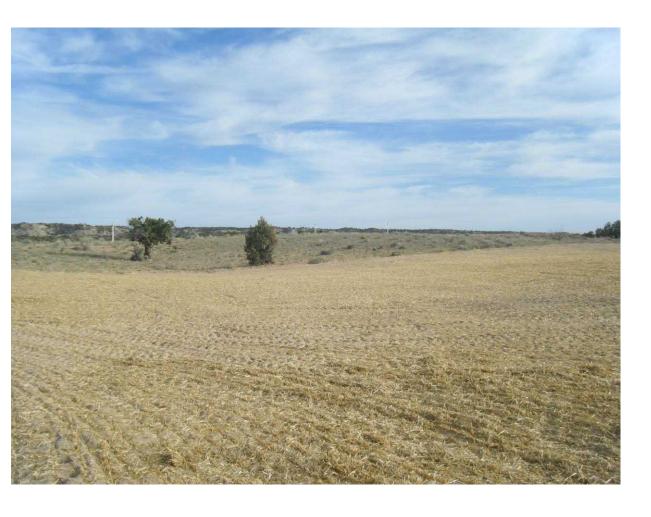
View Looking North

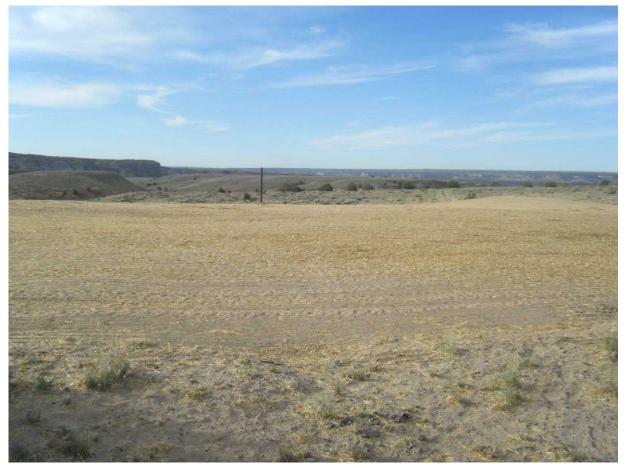
View Looking South
