Pit, Below-Grade Tank, or  
Proposed Alternative Method Permit or Closure Plan Application

**Hilcorp Energy Company  
San Juan Basin  
Below Grade Tank Closure Report**

**Lease Name: San Juan 28-6 Unit 37**

**API No.: 30-039-07175**

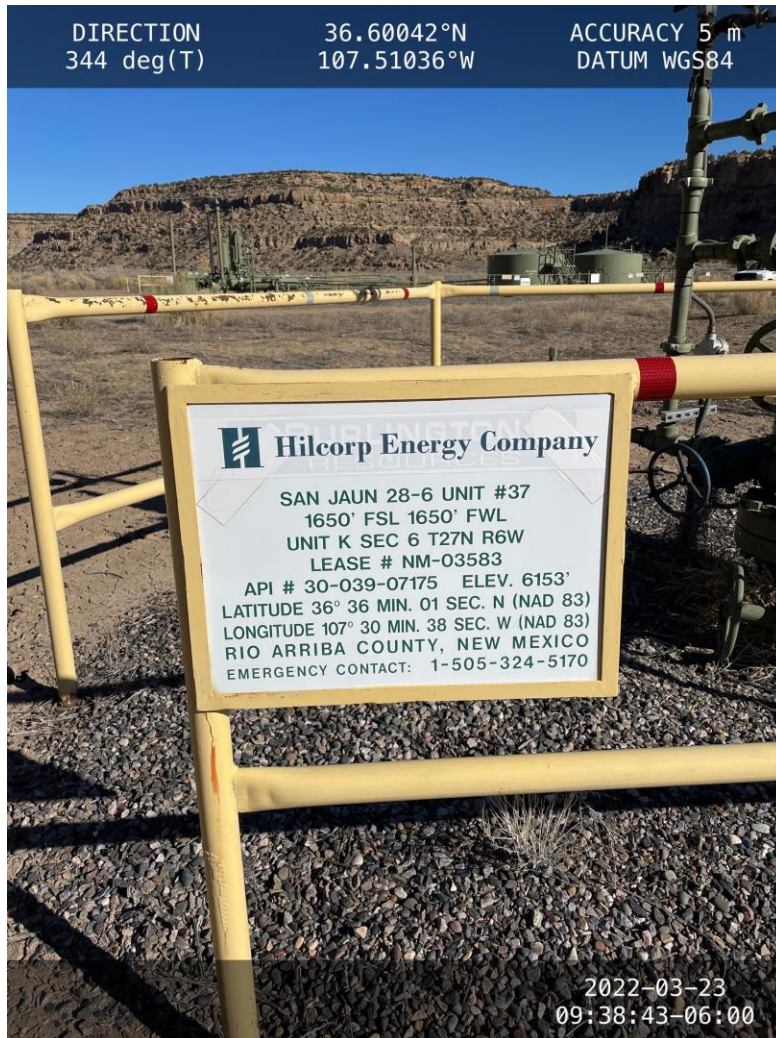
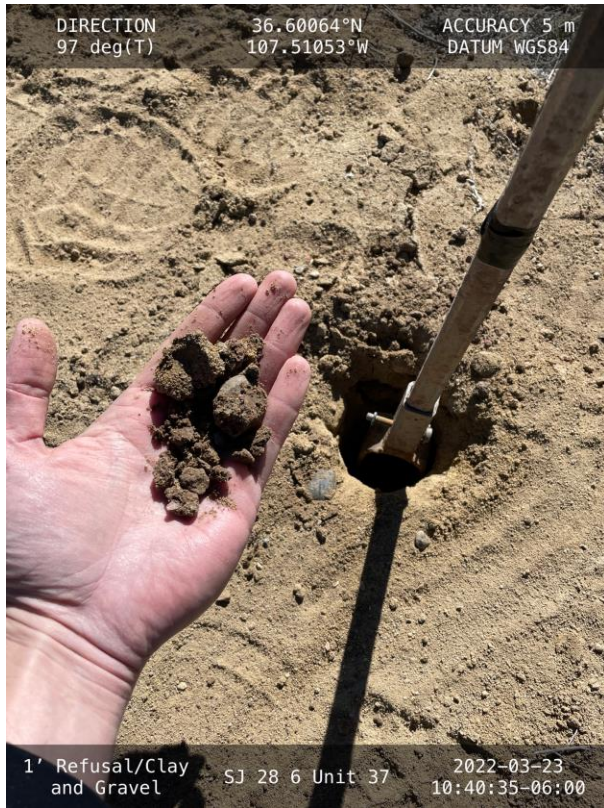
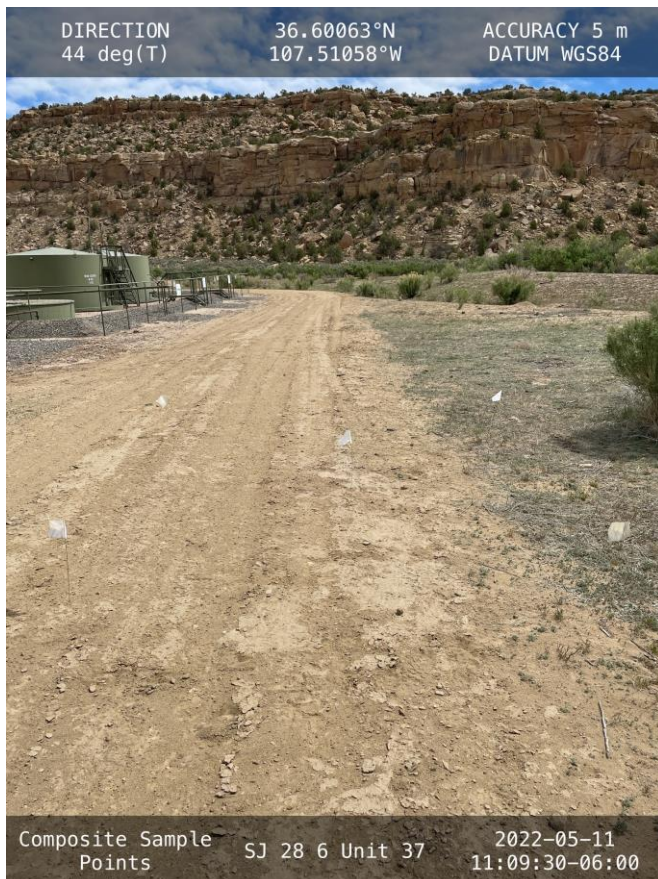
## SJ 28-6 Unit 37 Sample Pictures

BGT was closed out improperly by previous operator. OCD requested samples be taken and a BGT closure be filed.
