Pit, Below-Grade Tank, or  
Proposed Alternative Method Permit or Closure Plan Application

**Hilcorp Energy Company  
San Juan Basin  
Below Grade Tank Closure Report**

**Lease Name: San Juan 30-6 Unit 38**

**API No.: 30-039-09110**

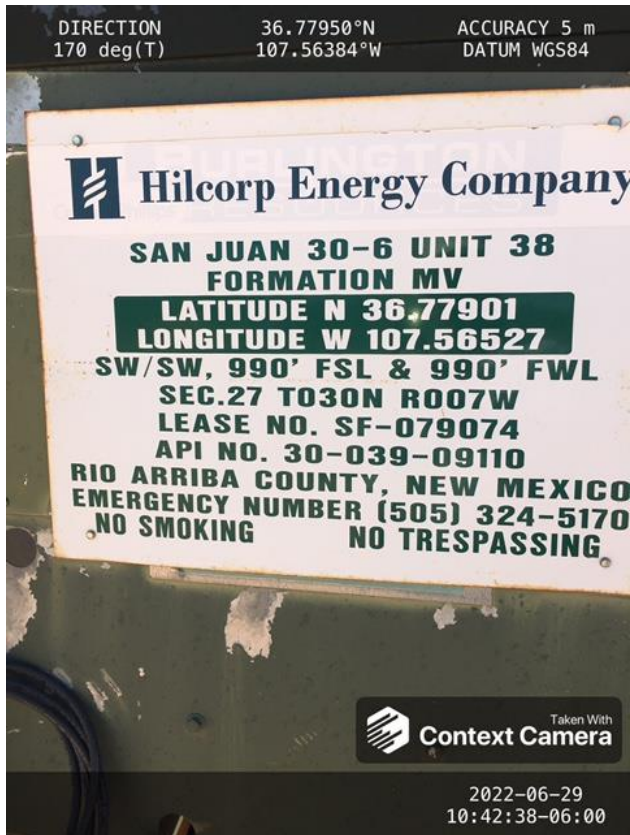
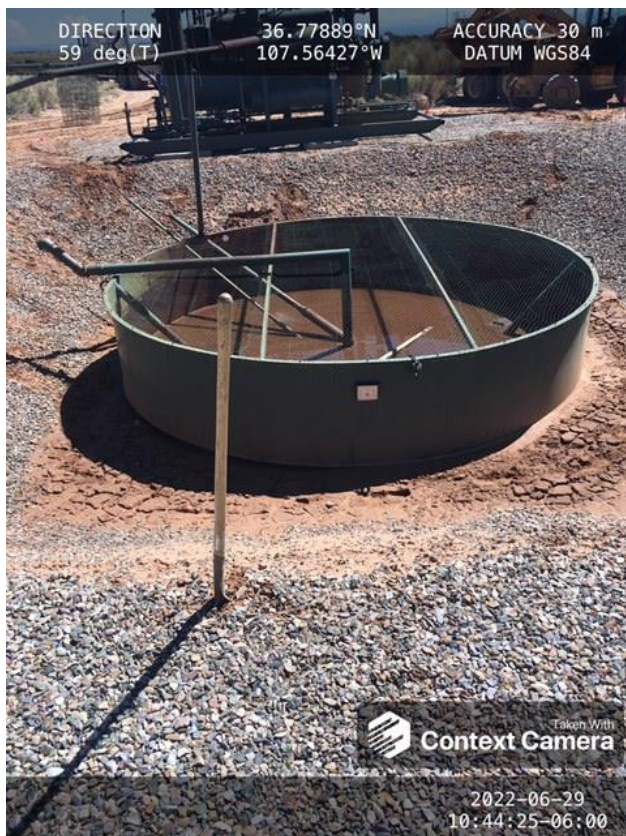
BGT prior to removal

**The below-grade tank was disposed of in a division-approved manner.**

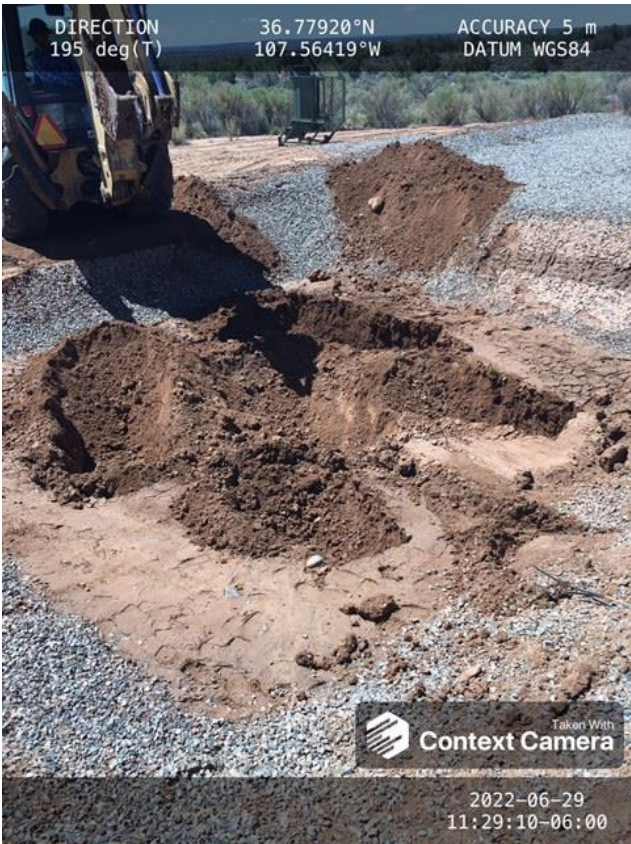
BGT Soil Samples Taken

**A five point composite sample was taken of the below-grade tank using sampling tools and all samples tested per Subsection B of 19.15.17.1 3(B)(1)(b). (Sample results attached). Form C-141 is attached.**

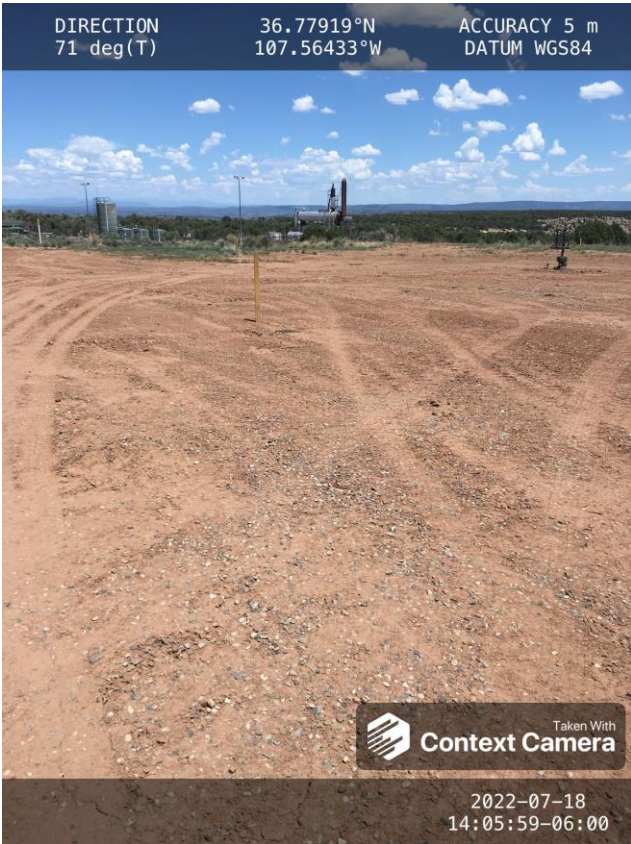
Backfill photo

**The below-grade tank area passed all requirements of Paragraph (4) of Subsection E of 19.15.17.13 NMAC and was backfilled with compacted, non-waste containing, earthen material.**
