Pit, Below-Grade Tank, or
Proposed Alternative Method Permit or Closure Plan Application

Hilcorp Energy Company
San Juan Basin
Below Grade Tank Closure Report

Lease Name: PO Pipkin 4

API No.: 30-045-06499

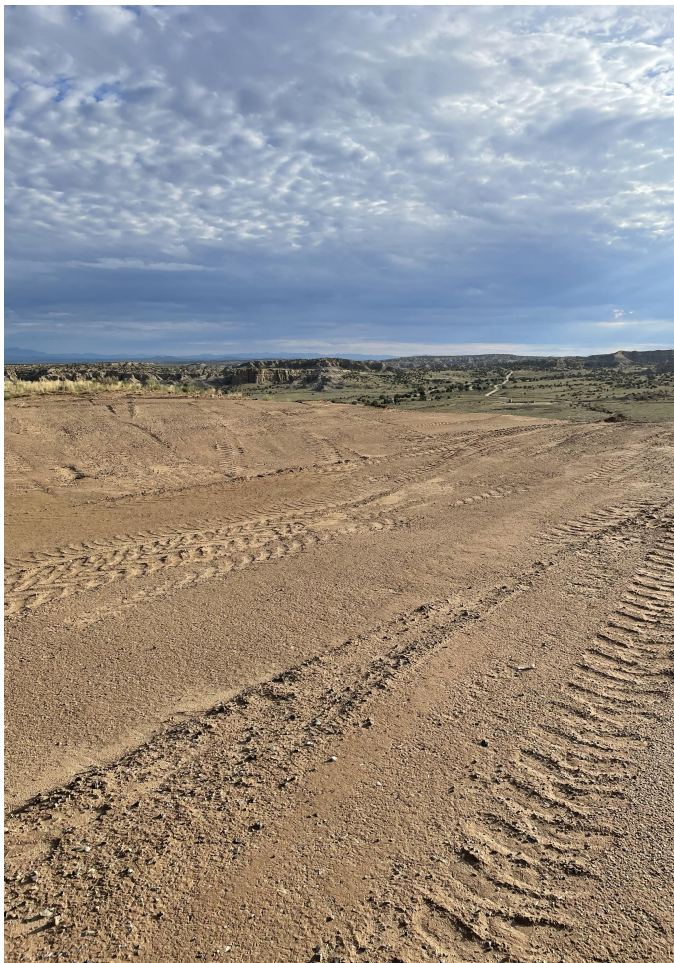
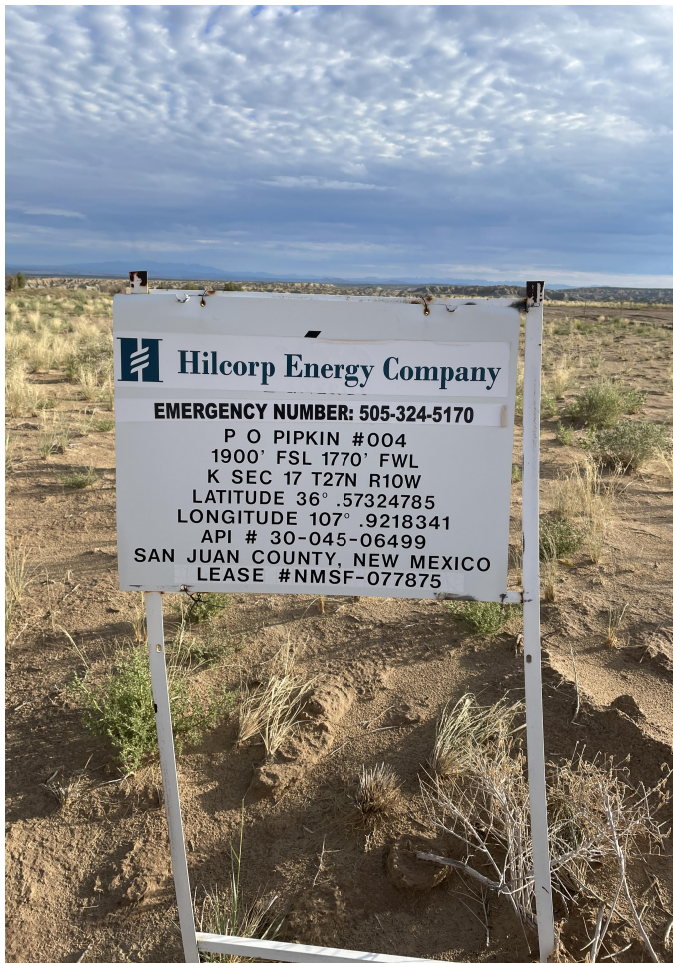
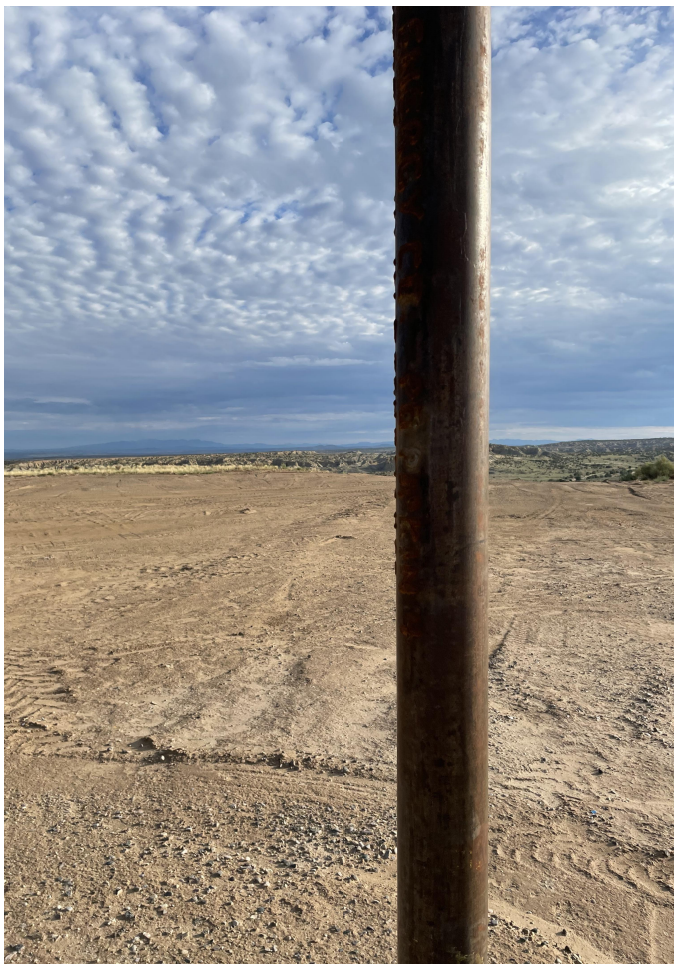
Post Closure Photos

The below-grade tank area passed all requirements of Paragraph (4) of Subsection E of 19.15.17.13 NMAC and was backfilled with compacted, non-waste containing, earthen material.
