Pit, Below-Grade Tank, or  
Proposed Alternative Method Permit or Closure Plan Application

1.  
Operator: LOGOS Operating, LLC OGRID #: 289408  
Address: 2010 Afton Place, Farmington, NM 87401  
Facility or well name: ROSA UNIT 014A  
API Number: 30-039-26280 OCD Permit Number: \_\_\_\_\_  
U/L or Qtr/Qtr P Section 23 Township 31N Range 06W County: Rio Arriba  
Center of Proposed Design: Latitude 36.8806992 Longitude -107.4260559 NAD83  
Surface Owner: ☒ Federal ☐ State ☐ Private ☐ Tribal Trust or Indian Allotment

19. **Closure Report (required within 60 days of closure completion):** 19.15.17.13 NMAC

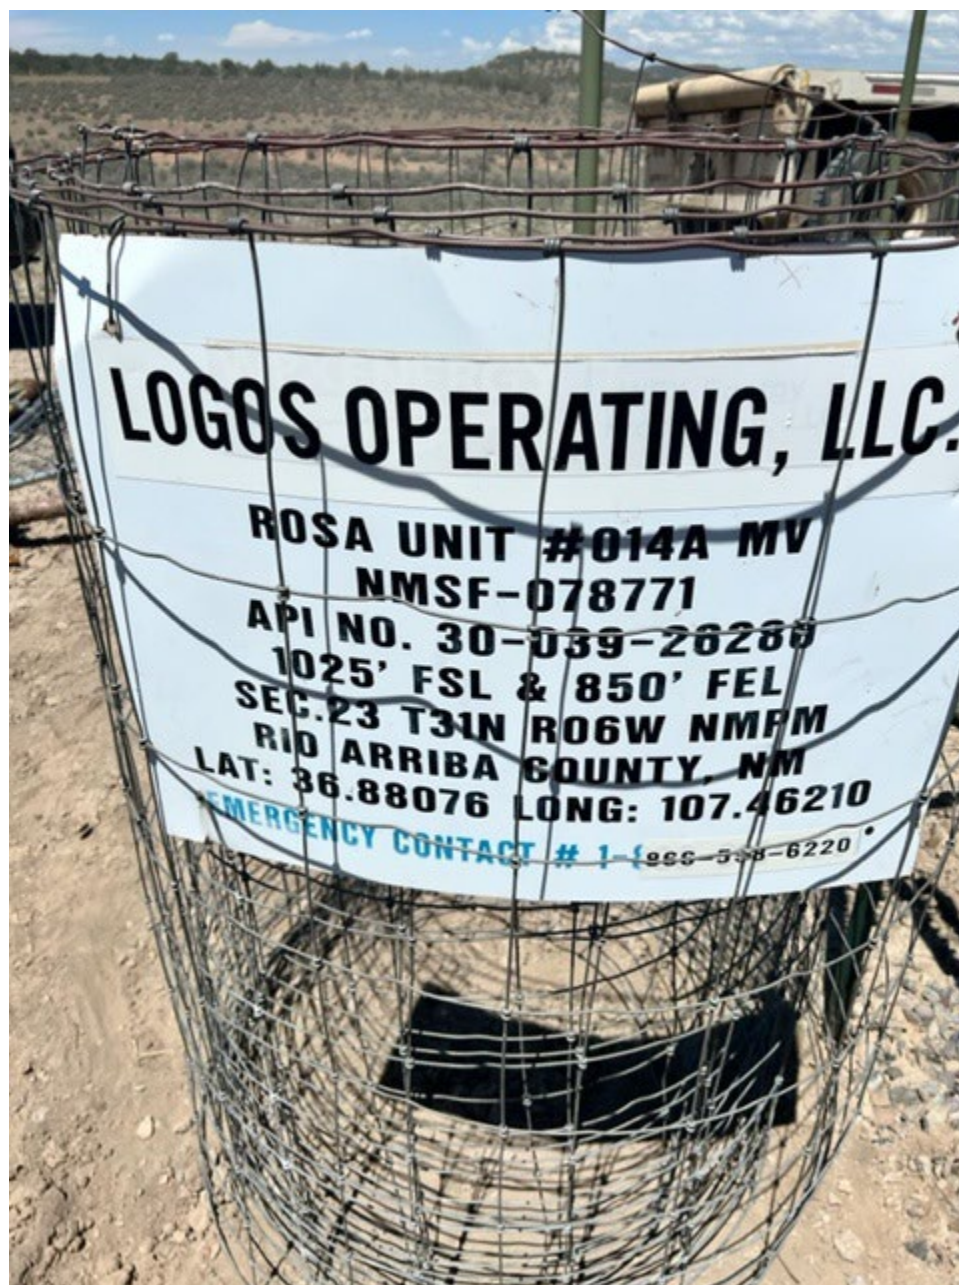
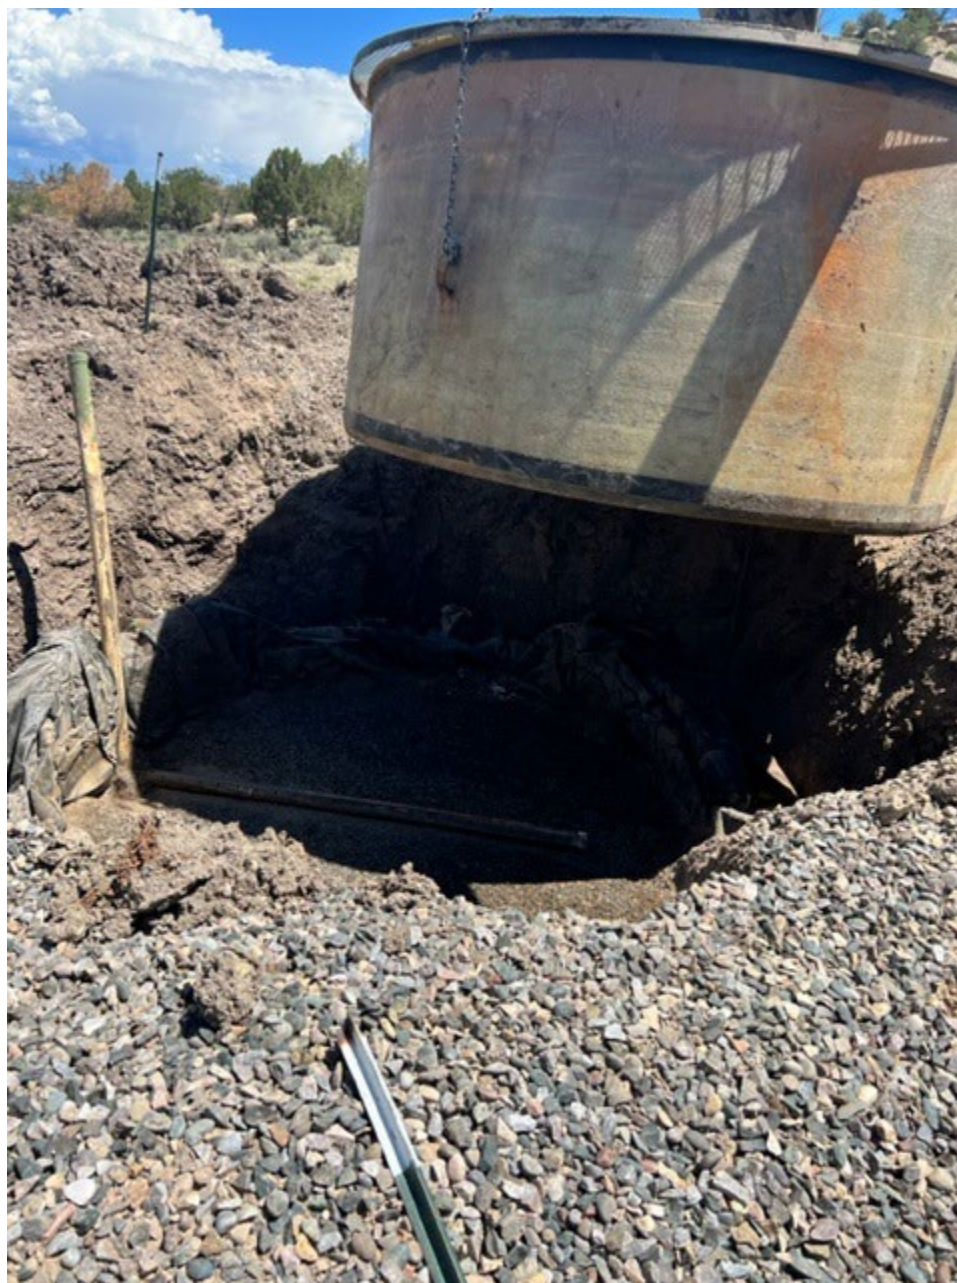
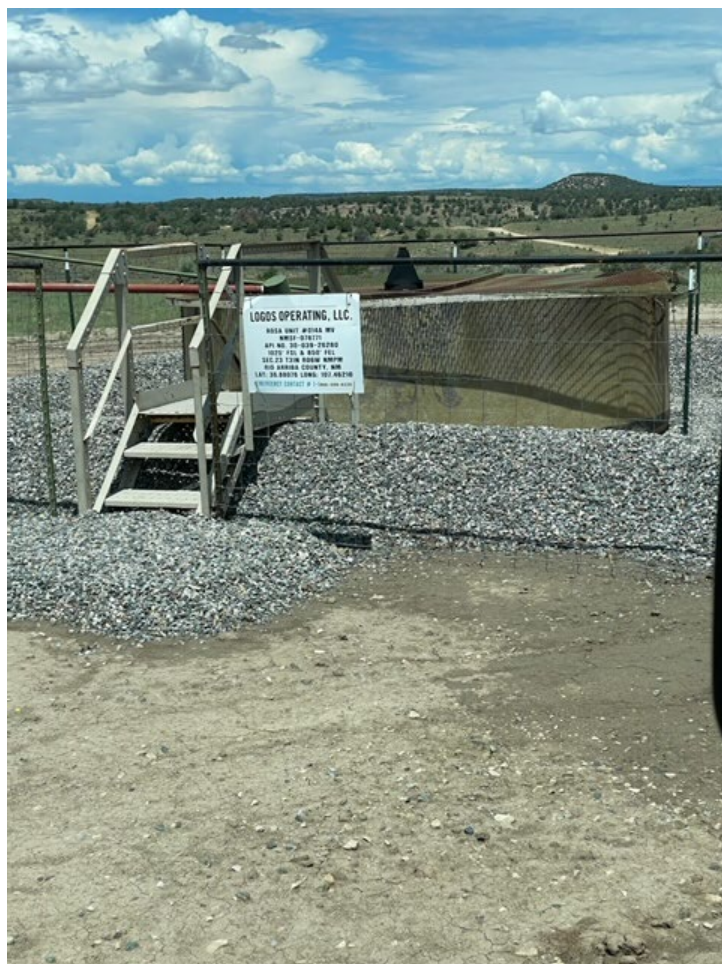
Rosa Unit 14A

On July 1, 2022, LOGOS Operating LLC. removed the fiberglass below grade tank on the Rosa Unit #014A. When the BGT was removed no visible signs of staining or wet soil was observed. LOGOS collected (1) 5-point composite sample from where the BGT was removed. The closure samples were analyzed by Envirotech Labs, and all constituents analyzed were non-detect. Emmanuel Adeloje with the BLM was onsite and witnessed all confirmation sampling.

7. Upon closing of the BGT, Logos will reclaim the unused BGT location to a safe and stable condition that blends with the surrounding undisturbed area as provided in Paragraph 2 of subsection H of 19.15.17.13 as well as recontouring the area in accordance with paragraph 5 in subsection H of 19.15.17.13 NMAC. The soil cover will be constructed to prevent ponding of water and erosion of the cover material.

8. The reclamation of the BGT area will contain a uniform vegetative cover that reflects a life-form ratio of plus or minus fifty (50%) of pre-disturbance levels and a total percent plant cover of at least seventy (70%) of pre-disturbance levels, excluding noxious weeds. The re-vegetation and reclamation obligations imposed by other applicable federal or tribal agencies that manage the lands will supersede these provisions and govern the obligations. Logos will notify the division when reclamation and re-vegetation is complete.
9. Logos will submit a closure report on form C-144 within 60 days of closure completion. The closure report will contain the following:
