Pit, Below-Grade Tank, or
Proposed Alternative Method Permit or Closure Plan Application

1.
Operator: LOGOS Operating, LLC OGRID #: 289408
Address: 2010 Afton Place, Farmington, NM 87401
Facility or well name: ROSA UNIT 015B
API Number: 30-039-29505 OCD Permit Number: _____
U/L or Qtr/Qtr J Section 29 Township 31N Range 5W County: Rio Arriba
Center of Proposed Design: Latitude 36.8700752 Longitude -107.382515 NAD83
Surface Owner: ☒ Federal ☐ State ☐ Private ☐ Tribal Trust or Indian Allotment

3.
☒ **Below-grade tank:** Subsection I of 19.15.17.11 NMAC
Volume: 120 bbl Type of fluid: Produced Water
Tank Construction material: Fiberglass with banded 20 mil HDPE liner
☐ Secondary containment with leak detection ☐ Visible sidewalls, liner, 6-inch lift and automatic overflow shut-off
☒ Visible sidewalls and liner ☐ Visible sidewalls only ☐ Other _____
Liner type: Thickness 20 mil ☒ HDPE ☐ PVC ☐ Other _____

Rosa Unit 15B

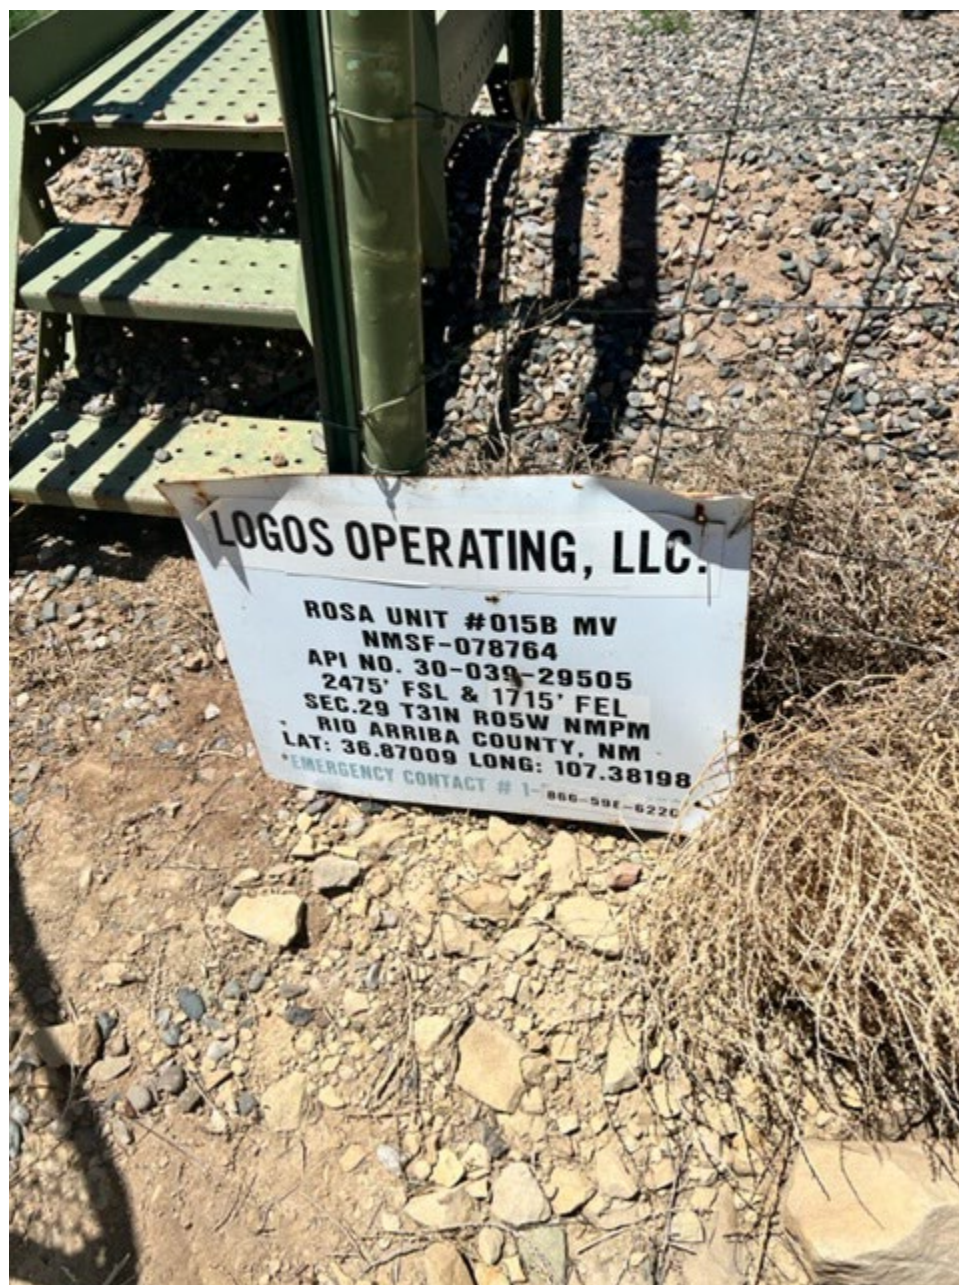
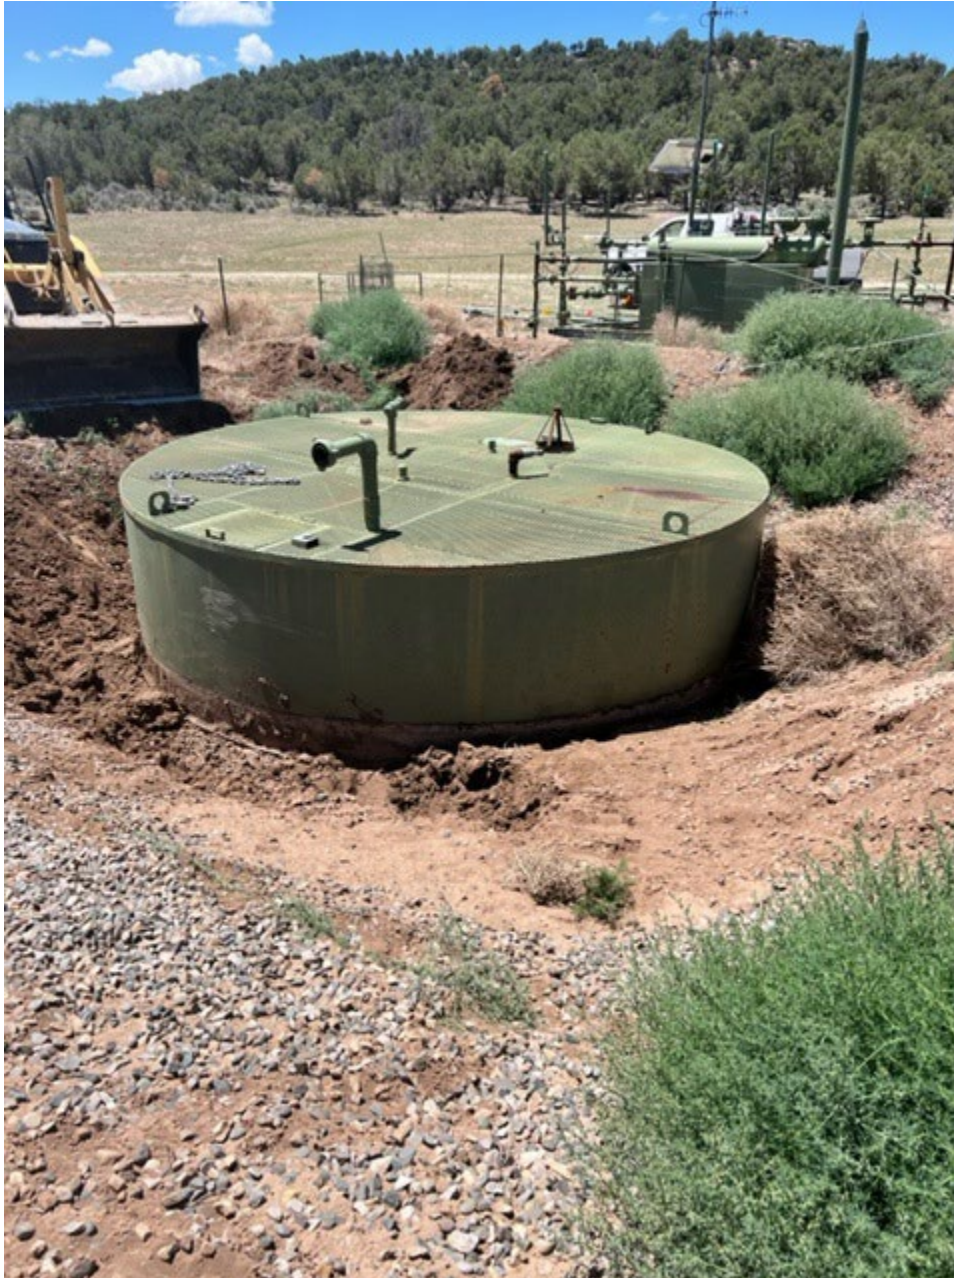
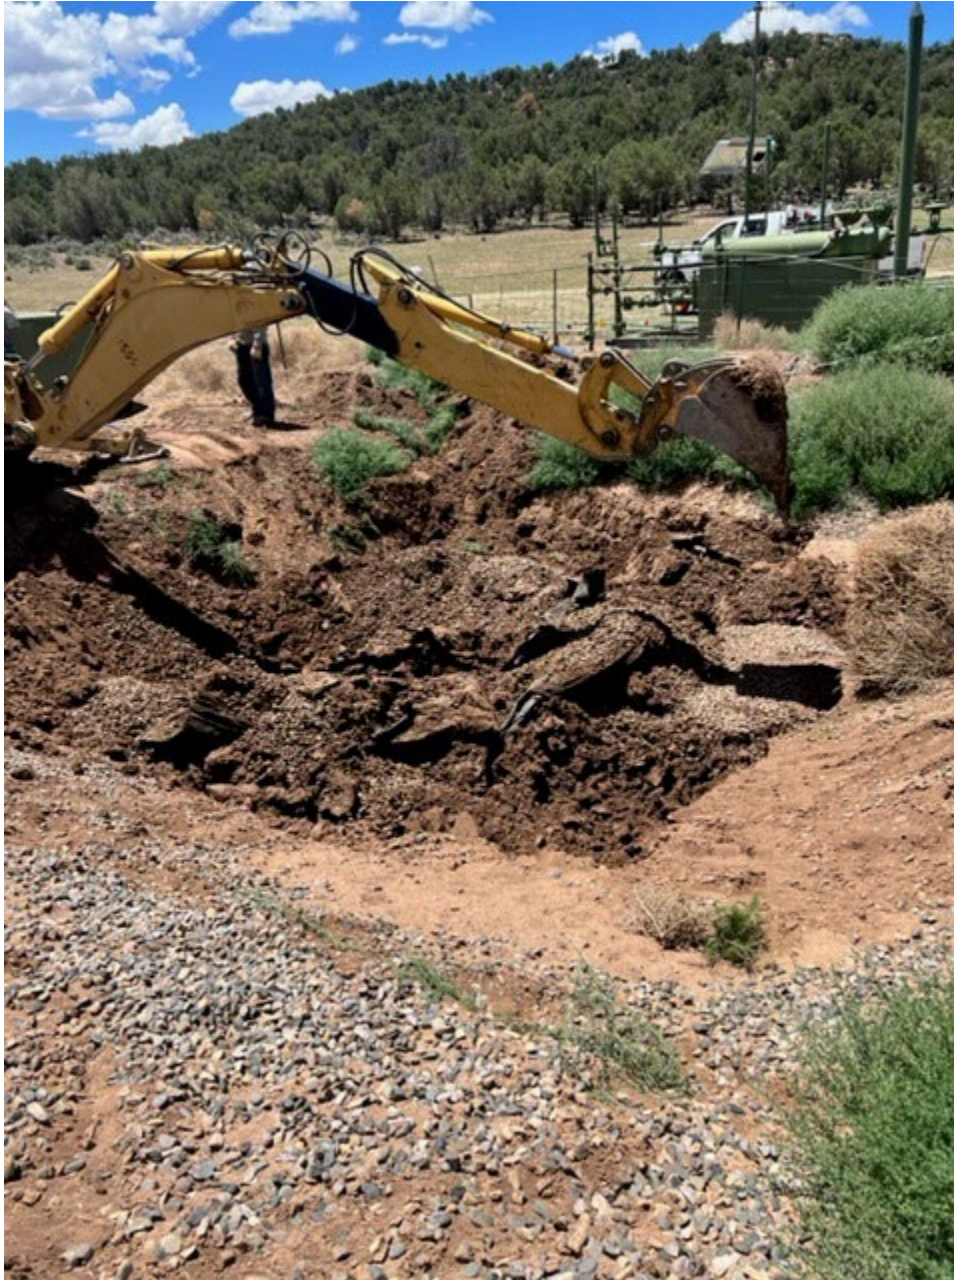
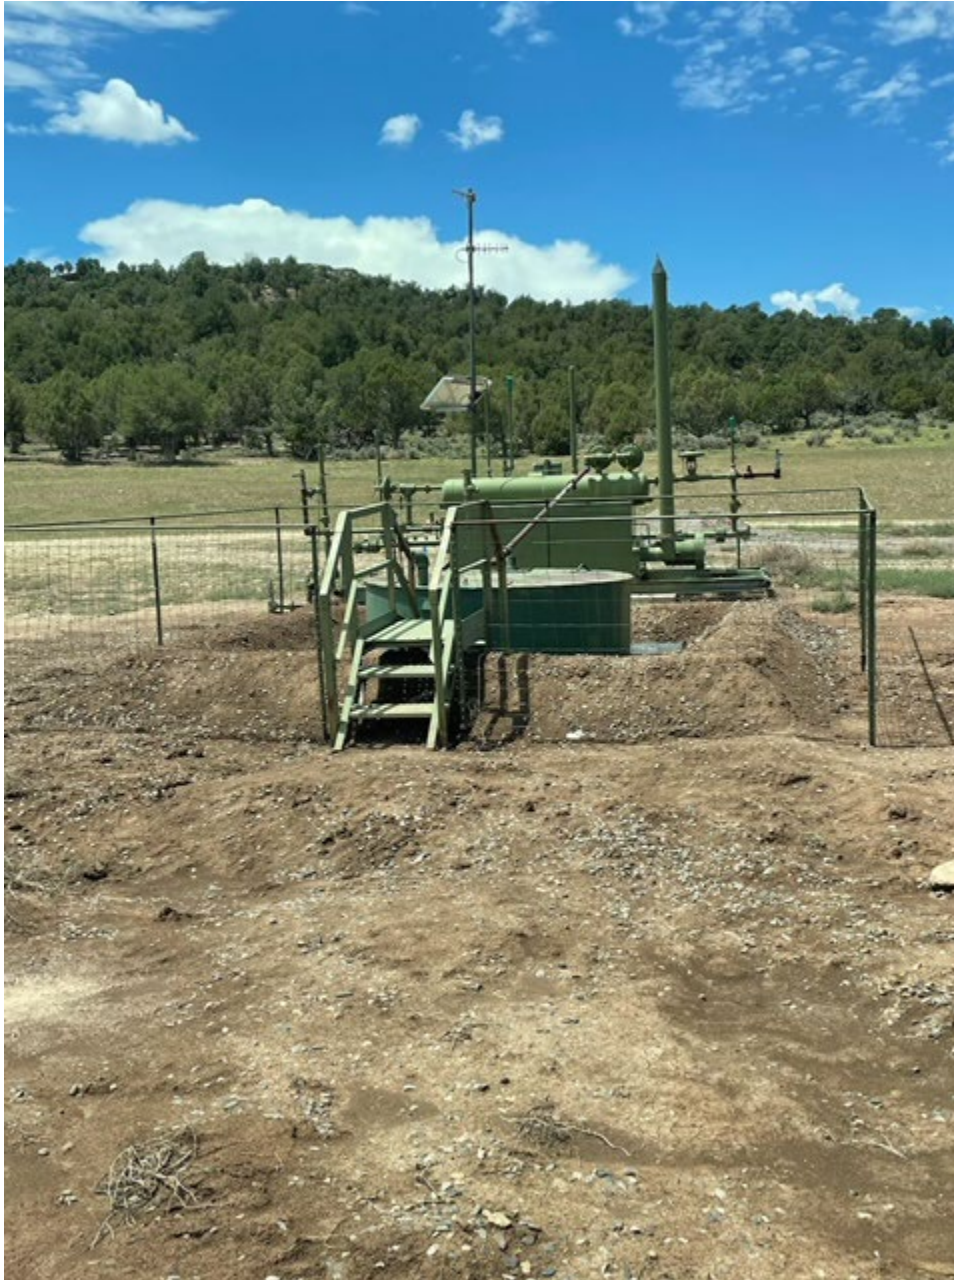
On July 1, 2022, LOGOS Operating LLC. removed the fiberglass below grade tank on the Rosa Unit #015B. When the BGT was removed no visible signs of staining or wet soil was observed. LOGOS collected (1) 5-point composite sample from where the BGT was removed. The closure samples were analyzed by Envirotech Labs, and all constituents analyzed were non-detect. Emmanuel Adeloje with the BLM was onsite and witnessed all confirmation sampling.

7. Upon closing of the BGT, Logos will reclaim the unused BGT location to a safe and stable condition that blends with the surrounding undisturbed area as provided in Paragraph 2 of subsection H of 19.15.17.13 as well as recontouring the area in accordance with paragraph 5 in subsection H of 19.15.17.13 NMAC. The soil cover will be constructed to prevent ponding of water and erosion of the cover material.

8. The reclamation of the BGT area will contain a uniform vegetative cover that reflects a life-form ratio of plus or minus fifty (50%) of pre-disturbance levels and a total percent plant cover of at least seventy (70%) of pre-disturbance levels, excluding noxious weeds. The re-vegetation and reclamation obligations imposed by other applicable federal or tribal agencies that manage the lands will supersede these provisions and govern the obligations. Logos will notify the division when reclamation and re-vegetation is complete.
9. Logos will submit a closure report on form C-144 within 60 days of closure completion. The closure report will contain the following:
