Pit, Below-Grade Tank, or  
Proposed Alternative Method Permit or Closure Plan Application

**Hilcorp Energy Company  
San Juan Basin  
Below Grade Tank Closure Report**

**Lease Name: San Juan 30-6 Unit 78**

**API No.: 30-039-07777**

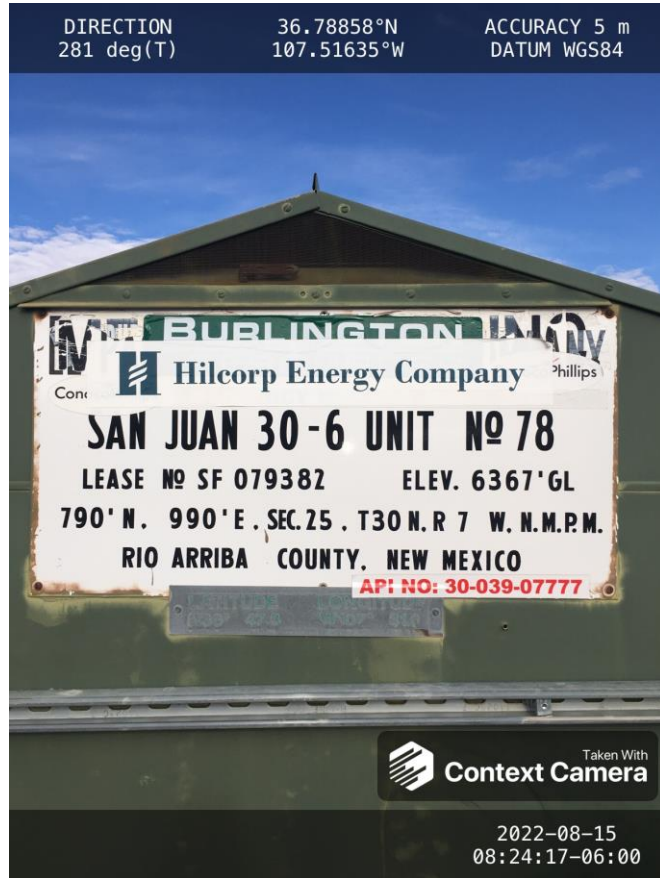
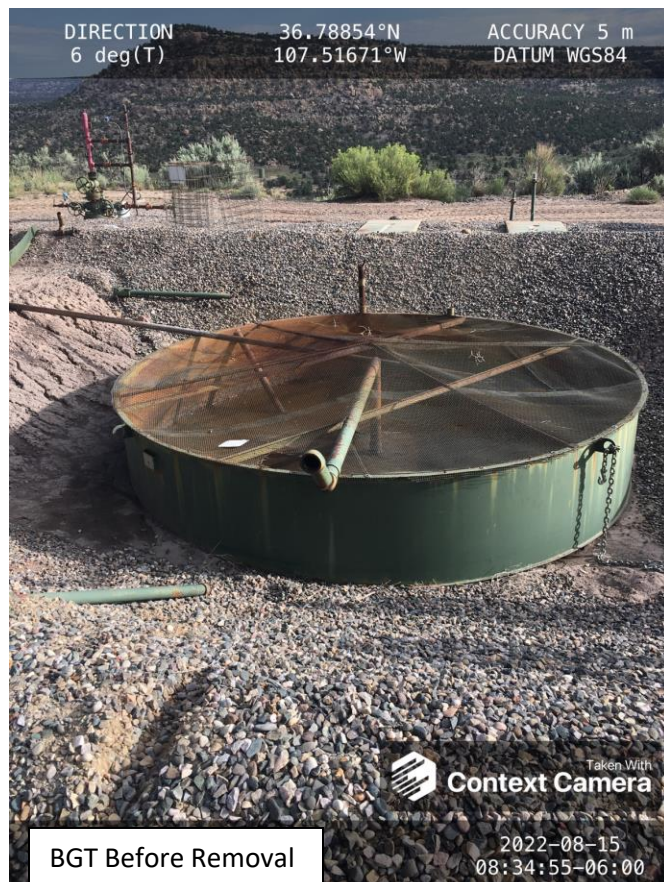
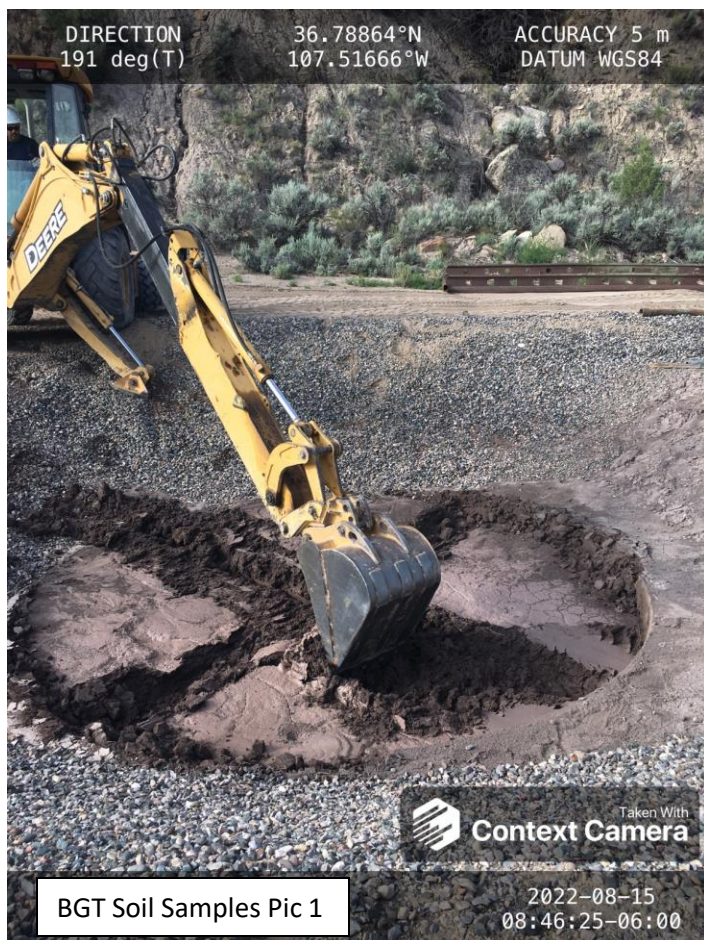
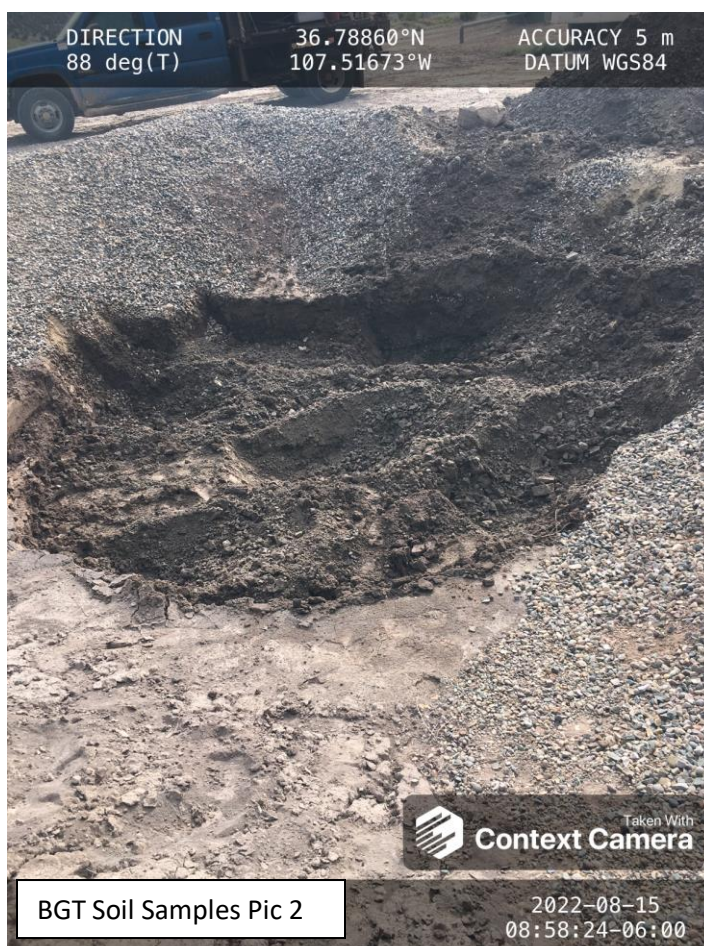
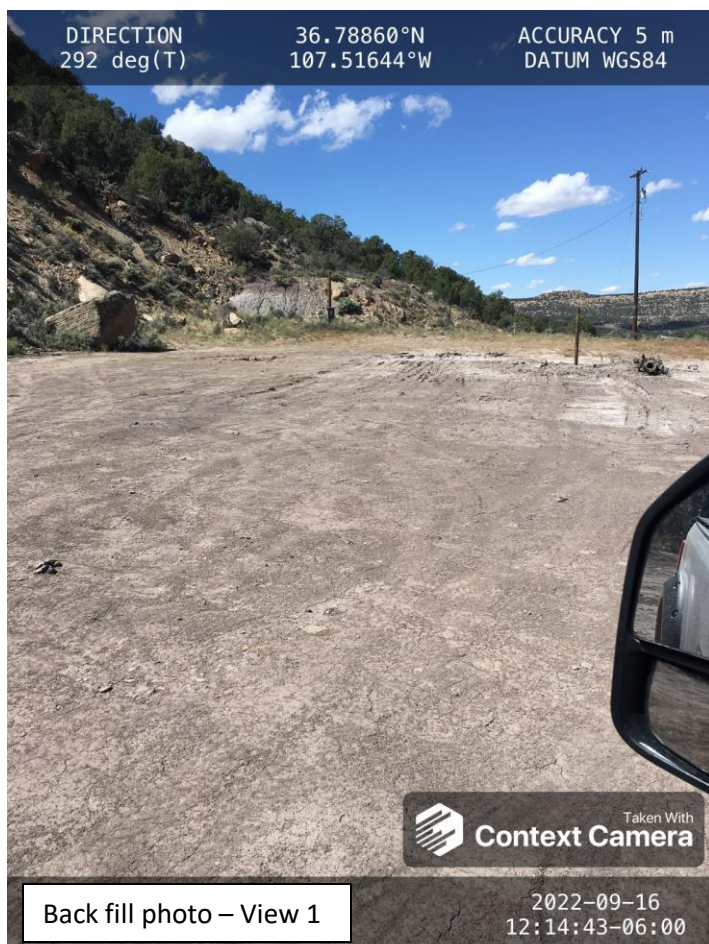
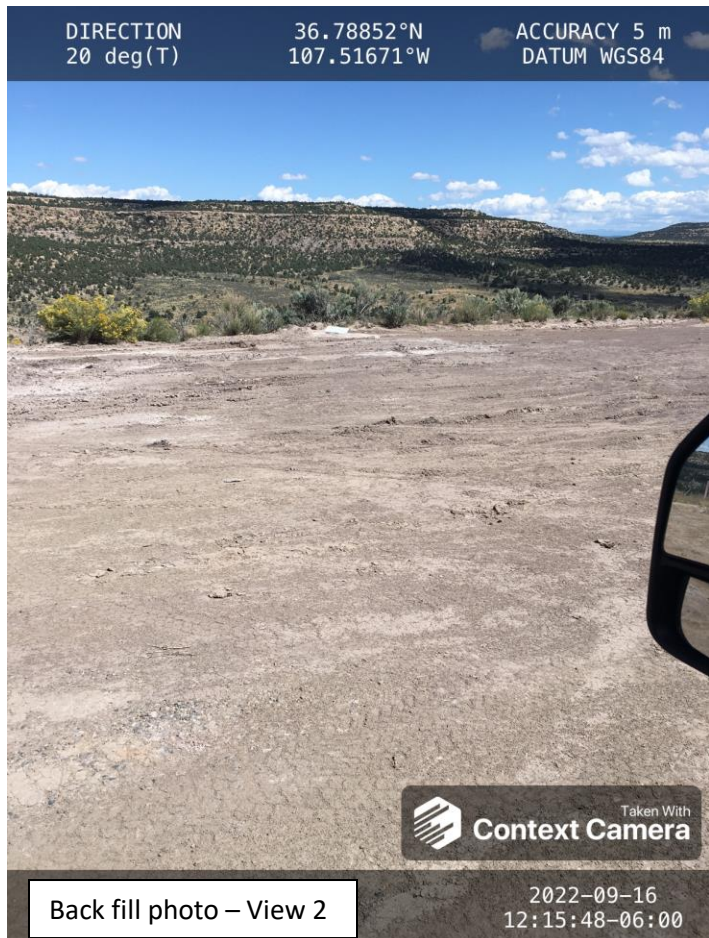
BGT Closure Pictures

**The below-grade tank area passed all requirements of Paragraph (4) of Subsection E of 19.15.17.13 NMAC and was backfilled with compacted, non-waste containing, earthen material.**
