Pit, Below-Grade Tank, or
Proposed Alternative Method Permit or Closure Plan Application

Hilcorp Energy Company
San Juan Basin: New Mexico Assets
Below Grade Tank Closure Report

Lease Name: Dawson A 1F
API No.: 30-045-31123

Dawson A #1F BGT Closure 10/17/2022

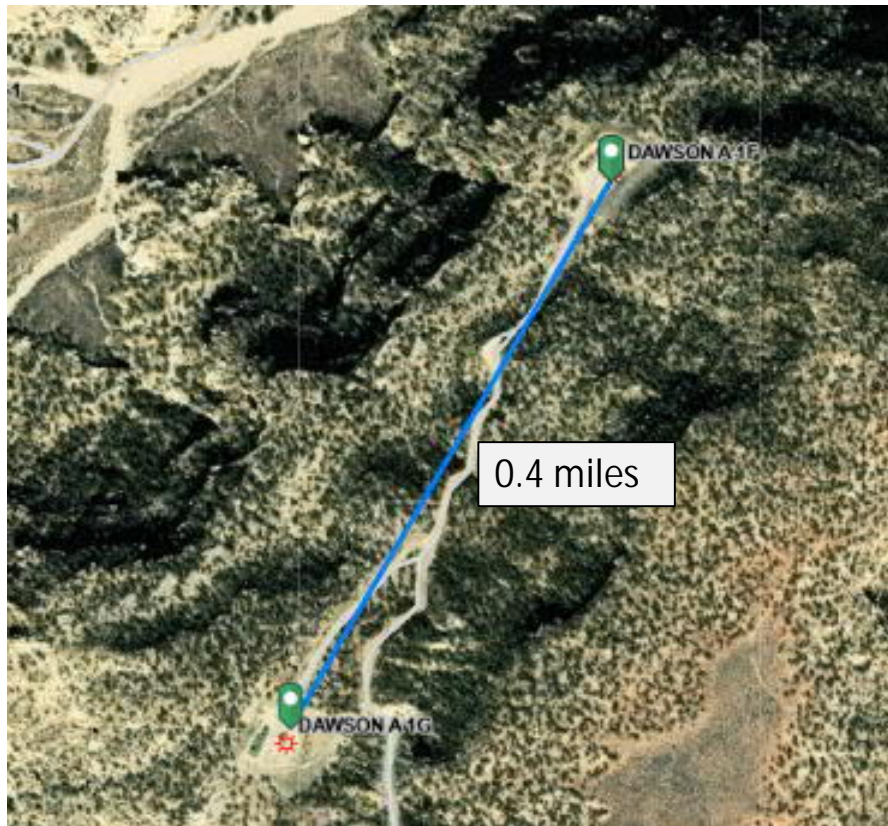
Depth to groundwater determination for adjacent well Dawson A #1G

- Dawson A #1F wellsite is approximately 0.4 miles due north of the Dawson A 1G well site.
- Both well sites are located on a ridge line approximately 5230 feet southwest of Largo Canyon. Dawson A #1F is approximately 127 feet lower elevation than Dawson A #1G.
- Data provided in the Dawson A #1G BGT permit support the determination that depth to groundwater is estimated to be greater than 100 feet.
- Given the topographic similarities and proximity of these locations, it is believed depth to groundwater at the Dawson A #1F is also greater than 100 feet.
