| Pit, Below-Grade Tank, or | | | |
|---|--|--|--|
| Proposed Alternative Method Permit or Closure Plan Application | | | |

Hilcorp Energy Company San Juan Basin Below Grade Tank Closure Report

Lease Name: Campbell Federal 25 14 API No.: 30-045-28839

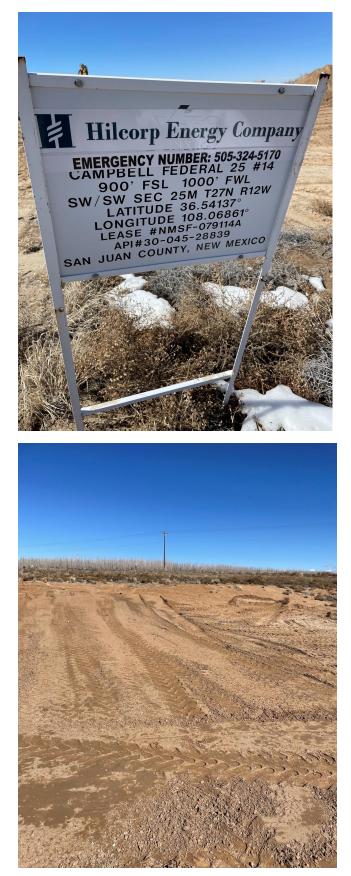
Post Closure Photos

The below-grade tank area was re-contoured to match fit, shape, line, form and texture of the surrounding area. Re-shaping including drainage control, to prevent ponding and erosion. Natural drainages were unimpeded and water bars and/or silt traps were placed in areas where needed to prevent erosion on a large scale. Final recontour has a uniform appearance with smooth surface, fitting the natural landscape.

The below-grade tank area was backfilled and more than four feet of cover was achieved and the cover included one foot of suitable material to establish vegetation at the site.
