<u>Pit, Below-Grade Tank, or</u> Proposed Alternative Method Permit or Closure Plan Application

| Operator: Hilcorp Energy Company OGRID #: 372171 |
|---|
| Facility or well name: Hamner 2E – BGT 1 |

Hilcorp Energy Company San Juan Basin Below Grade Tank Closure Report

Lease Name: Hamner 2E – BGT 1 API No.: 30-045-24689

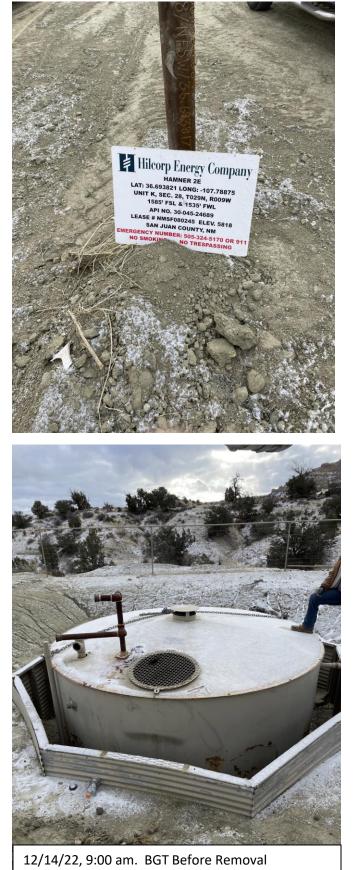
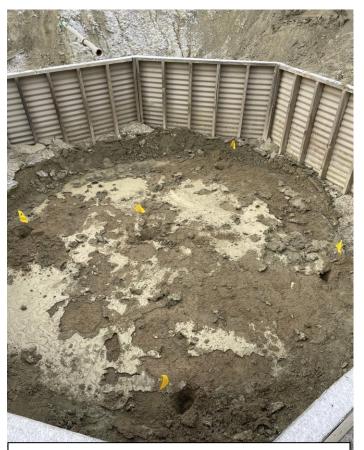
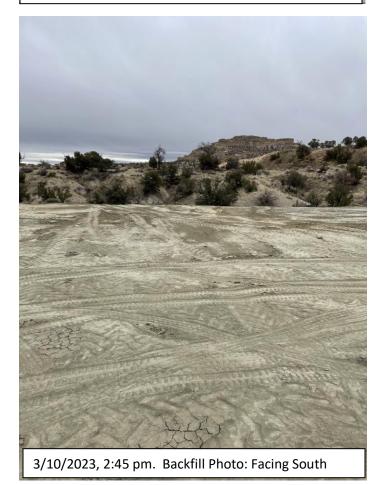
Hamner 2E 3004524689 BGT # 1 Closure Photos

12/14/22, 9:30 am. BGT Soil Samples Taken
