**RE: Closure Request  
Goldenchild Central Tank Battery  
Remediation Permit Numbers 2RP-4751  
Eddy County, New Mexico**

LT Environmental, Inc. (LTE), on behalf of XTO Energy, Inc. (XTO), presents the following Closure Request report detailing excavation and soil sampling activities at the Goldenchild Central Tank Battery (Site), located in Unit P, Section 6, Township 25 South, Range 29 East, in Eddy County, New Mexico (Figure 1). The purpose of the excavation and soil sampling activities was to address impacts to soil, resulting from a produced water release at the Site.

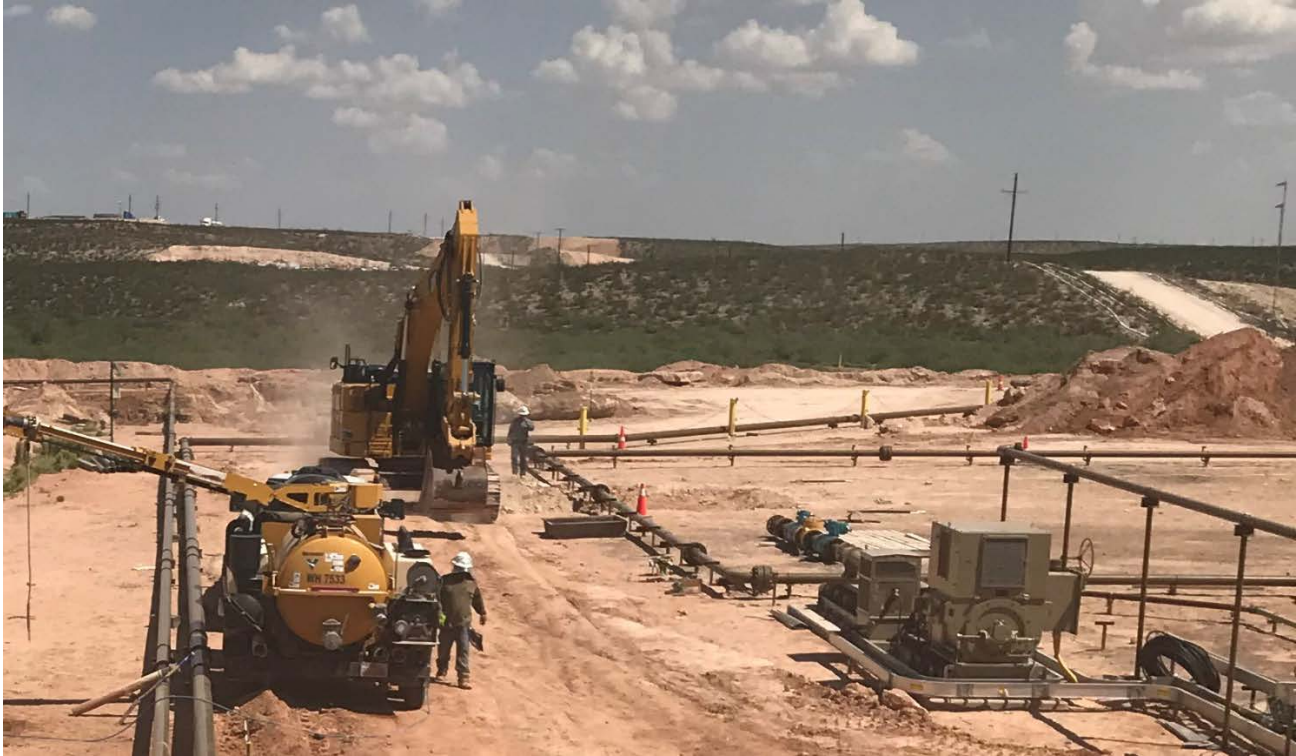
East facing view of the open excavation.

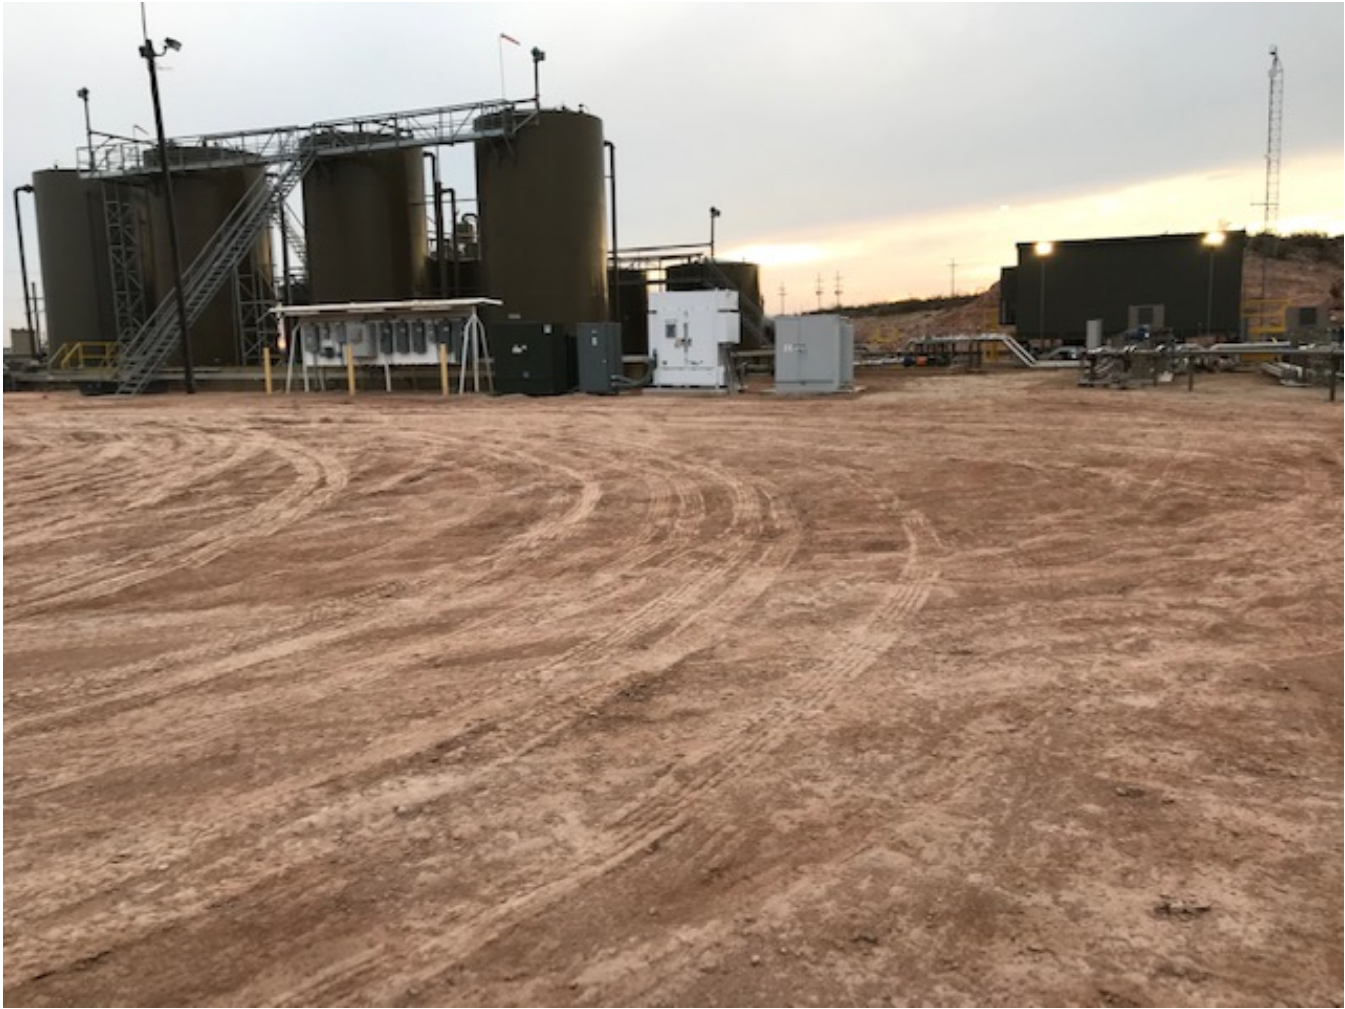
**Southwest facing view of the backfilled excavation area.**

Initial response efforts and excavation of impacted soil have mitigated impacts at this Site. XTO requests no further action for RP Number 2RP-4751. XTO will backfill the excavation with material purchased locally and recontour the Site to match pre-existing site conditions. An updated NMOCD Form C-141 is included in Attachment 1.
