Pit, Below-Grade Tank, or
Proposed Alternative Method Permit or Closure Plan Application

**Hilcorp Energy Company
San Juan Basin
Below Grade Tank Closure Report**

Lease Name: Rhodes C 102

API No.: 30-045-28944

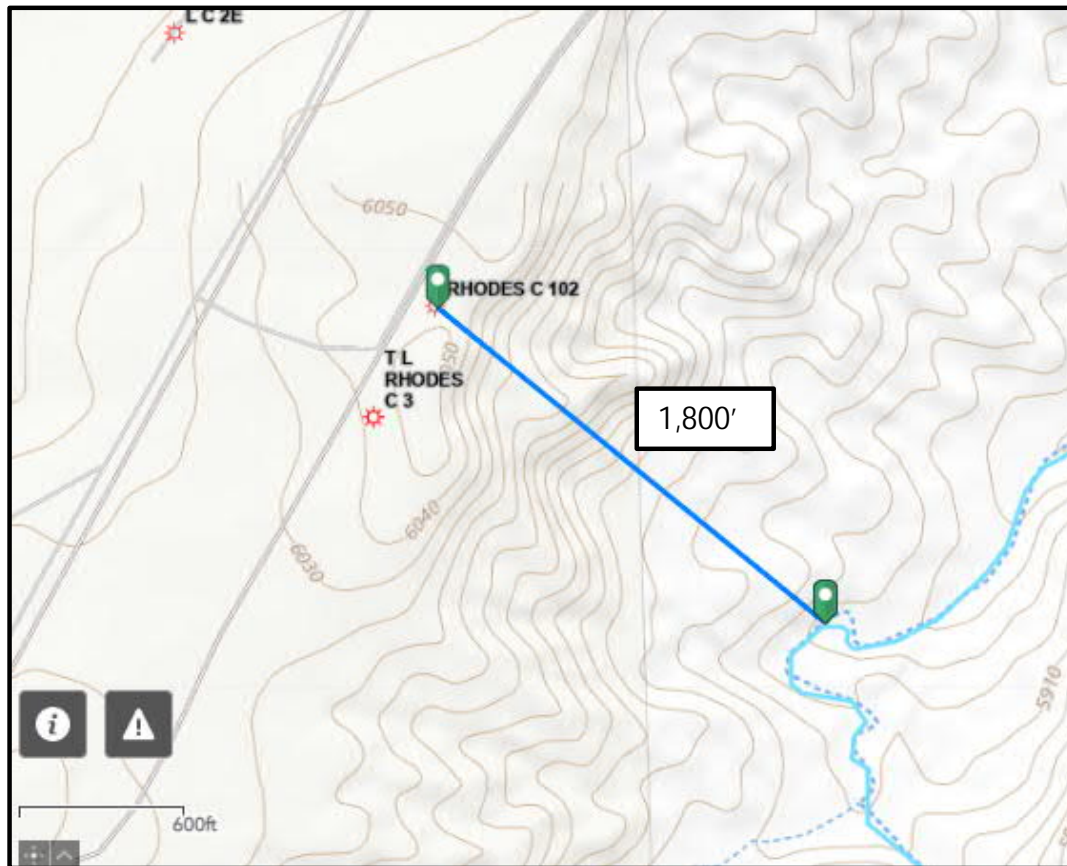
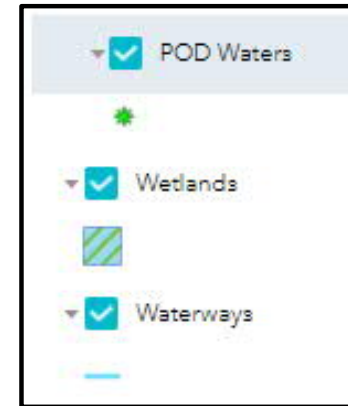
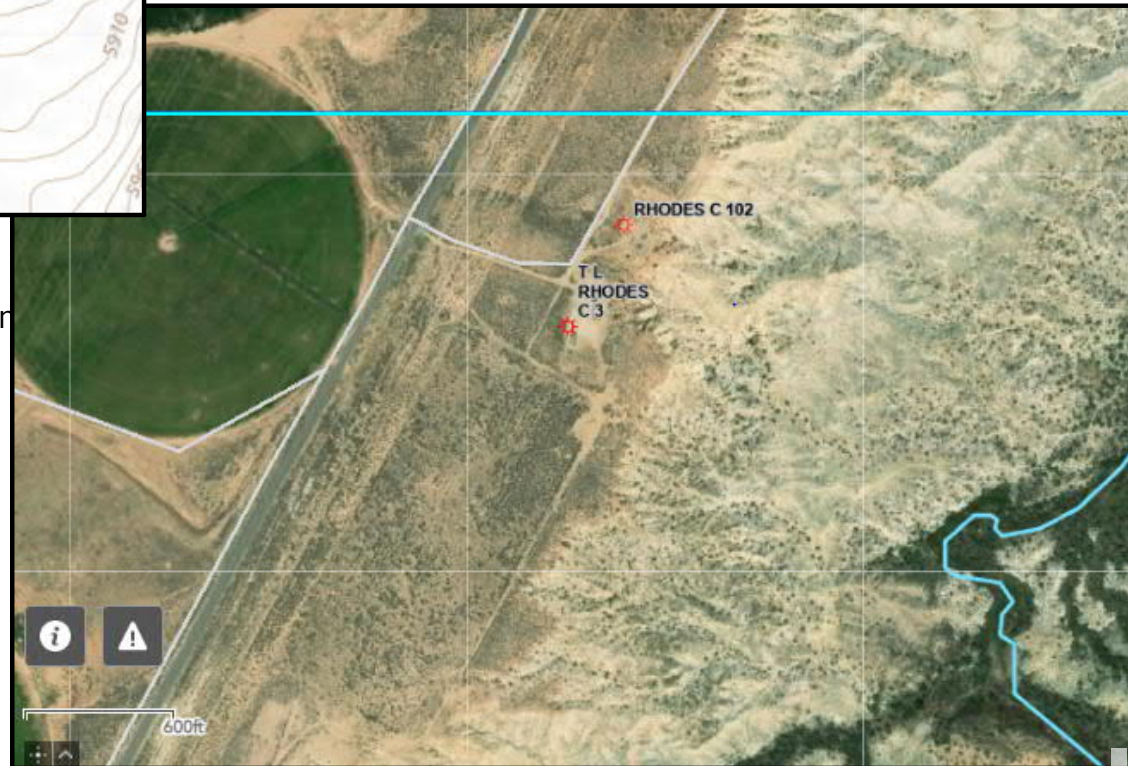
NMAC 19.15.29 Siting Criteria for Closure Standards

The estimated depth to ground water at this point is 496 feet. This estimation is based on the data published on the New Mexico Engineer's iWaters Database website and water depth data from ConocoPhillips' Cathodic wells. Groundwater data available from the NM State Engineer's iWaters Database for wells near the proposed site are attached. The nearest stream is 1,695 feet to the southeast and is classified by the USGS as an intermittent stream. The nearest perennial stream is 2,650 feet to the south. The nearest water body is 2,617 feet to the south. It is classified by the USGS as an intermittent lake and is 0.3 acres in size. The nearest spring is 20,524 feet to the northeast. All stream, river, water body and spring information was determined as per the USGS Hydrographic Dataset (High Resolution), downloaded 3/2008. The nearest water well is 7,703 feet to the east. There is no wetland data available for this area. The slope at this location is 5 degree, to the east as calculated from USGS 30M National Elevation Dataset. This information is also discerned from the aerial and topographic map included. The surface geology at this location is NACIMIENTO FORMATION--Shale and sandstone with a Shale dominated formations of all ages substrate. The soil at this location is 'Shiprock fine sandy loam, 0 to 2 percent slopes' and is well drained and not hydric with slight erosion potential as taken from the NRCS SSURGO map unit, downloaded January 2008. The nearest underground mine is 12.1 miles to the west as indicated on the Mines, Mills and Quarries Map of New Mexico provided.

BGT is not shown to be within:

- 300 ft of any continuously flowing watercourse or any other significant water course.
- 200 feet of any lakebed, sinkhole or playa lake
- 300 feet of any occupied permanent residence
- 500 feet of a spring or private, domestic fresh water well.
- 1000 feet of any fresh water well
- 300 feet of a wetland
- Incorporated municipal boundaries
- Overlying a subsurface mine
- An unstable area
- A 100-year floodplain
