## <u>Pit, Below-Grade Tank, or</u> <u>Proposed Alternative Method Permit or Closure Plan Application</u>

## Hilcorp Energy Company San Juan Basin Below Grade Tank Closure Report

Lease Name: Cornell SRC 7
API No.: 30-045-08714

# Cornell SRC #7

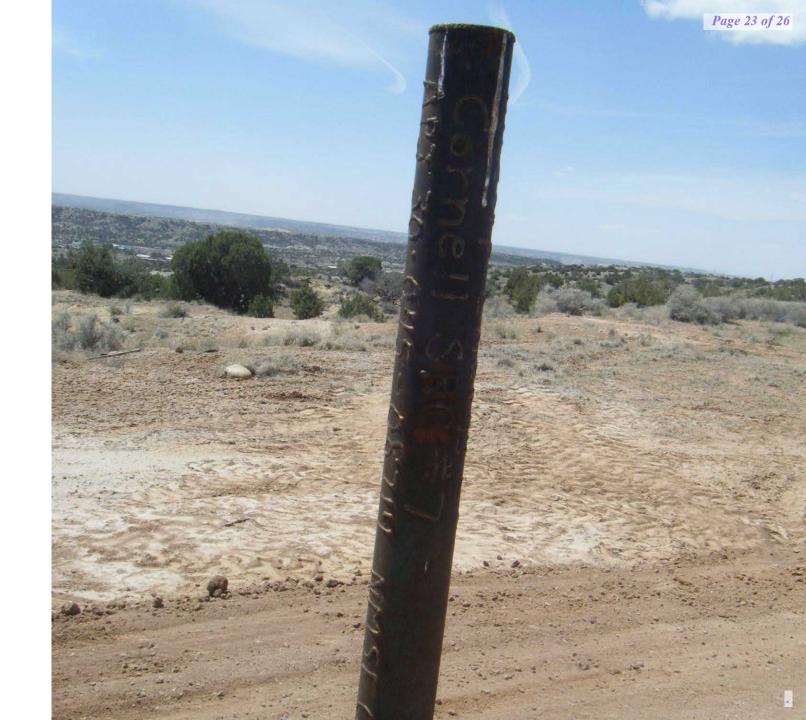
## Cornell SRC #7 04/19/23

Pit Closure Pictures.
