BGT1 Closure Report

**Hilcorp Energy Company
San Juan Basin
Below Grade Tank Closure Report**

Lease Name: Pearce Gas Com 1E

API No.: 30-045-24082

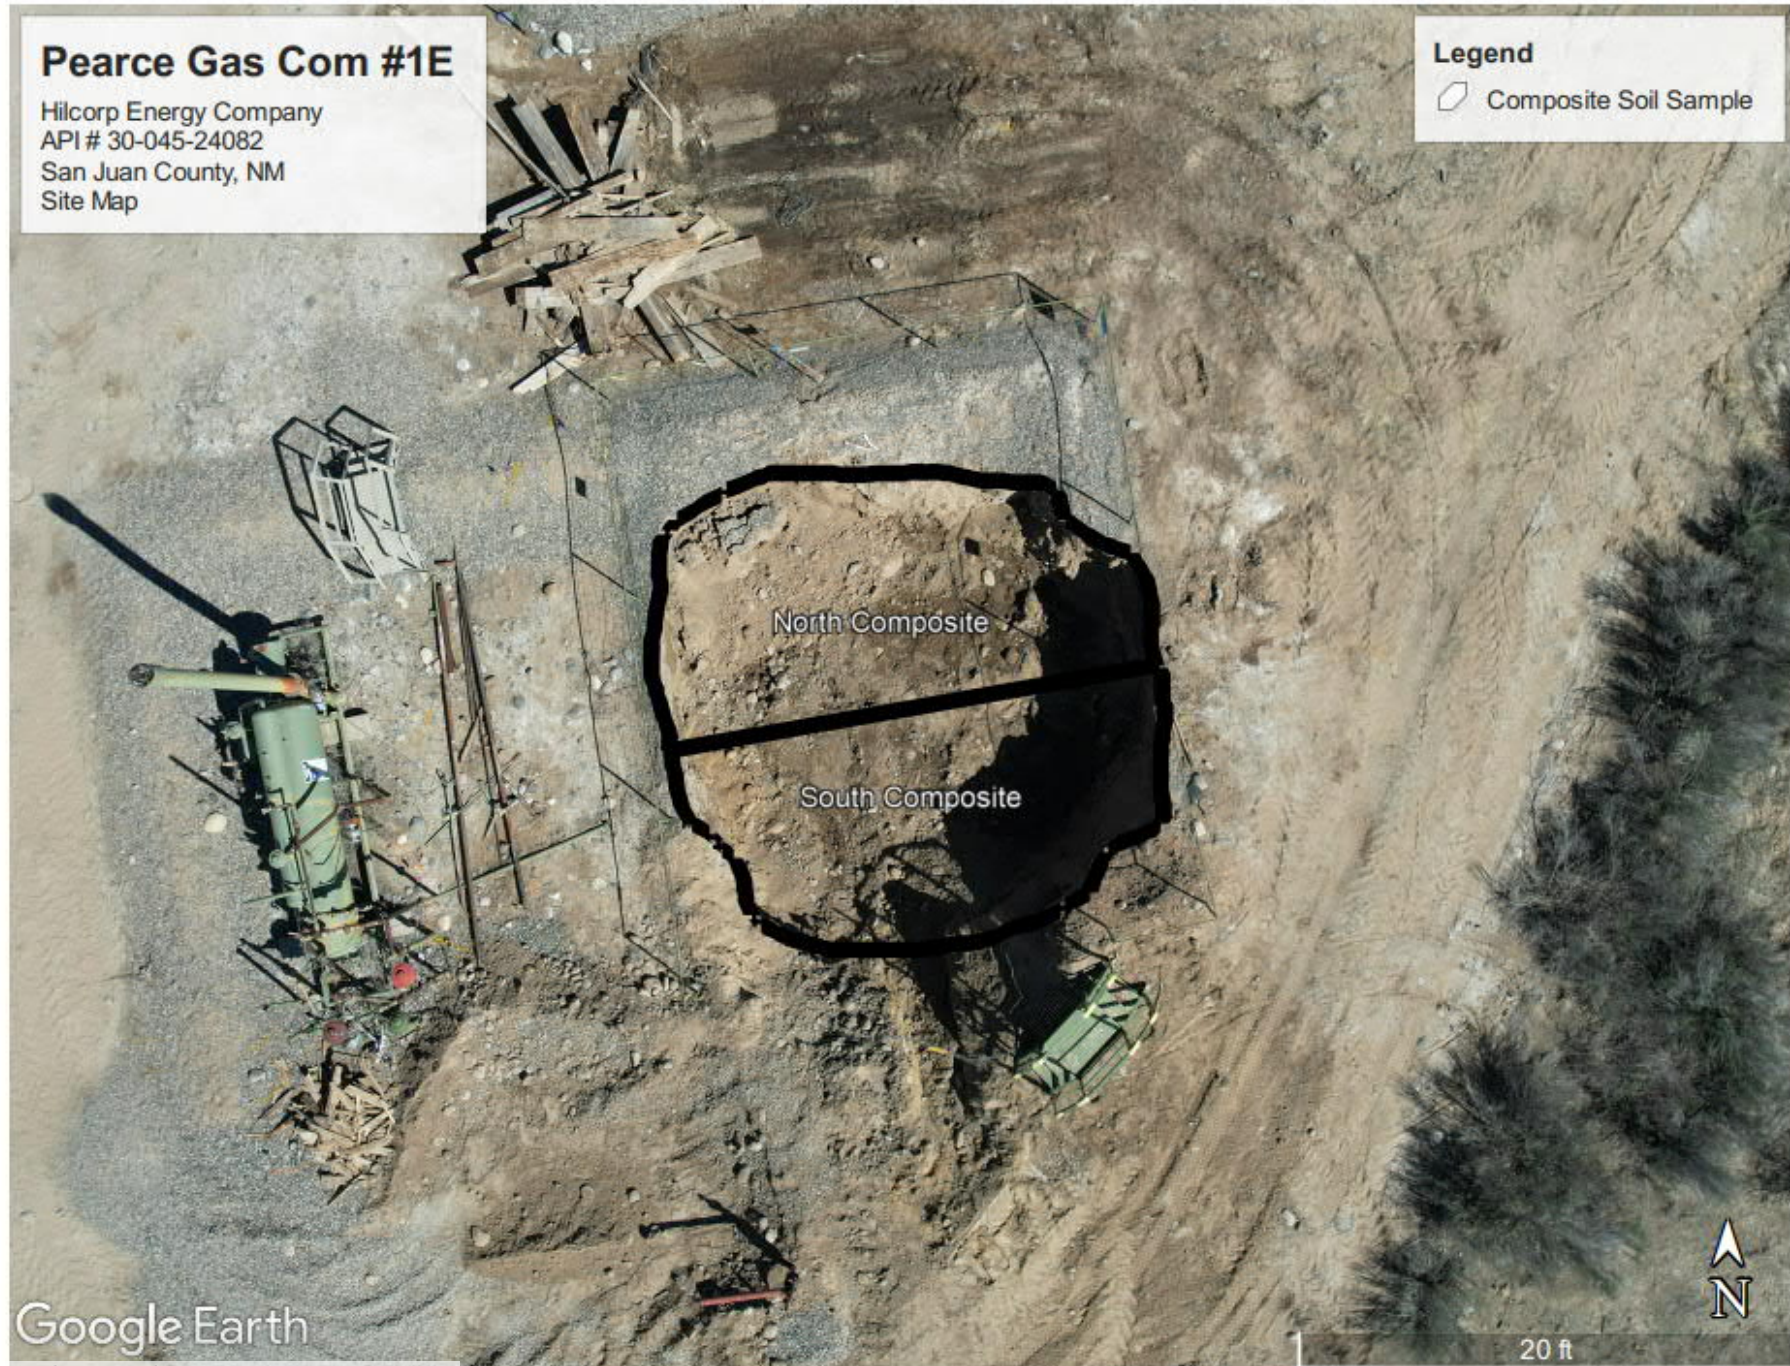
Pearce Gas Com #1E Site Map – 4/11/2023

Analytical results collected on 4/11/2023 following the excavation of impacted material were below BGT permit limits and closure criteria in NMAC 19.15.29 Table 1.
